2020 Lakes and Ponds Annual Report

Norton, Massachusetts

Project No. N490-000.16
October 30, 2020

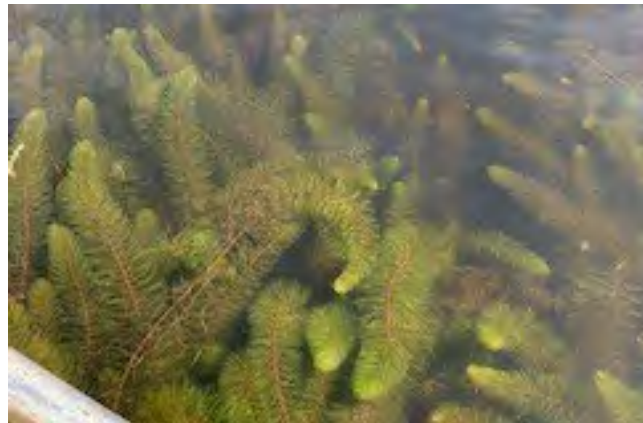
One of the denser variable-leaf milfoil beds at Winnecunnet Pond during pre-treatment monitoring in May 2020..

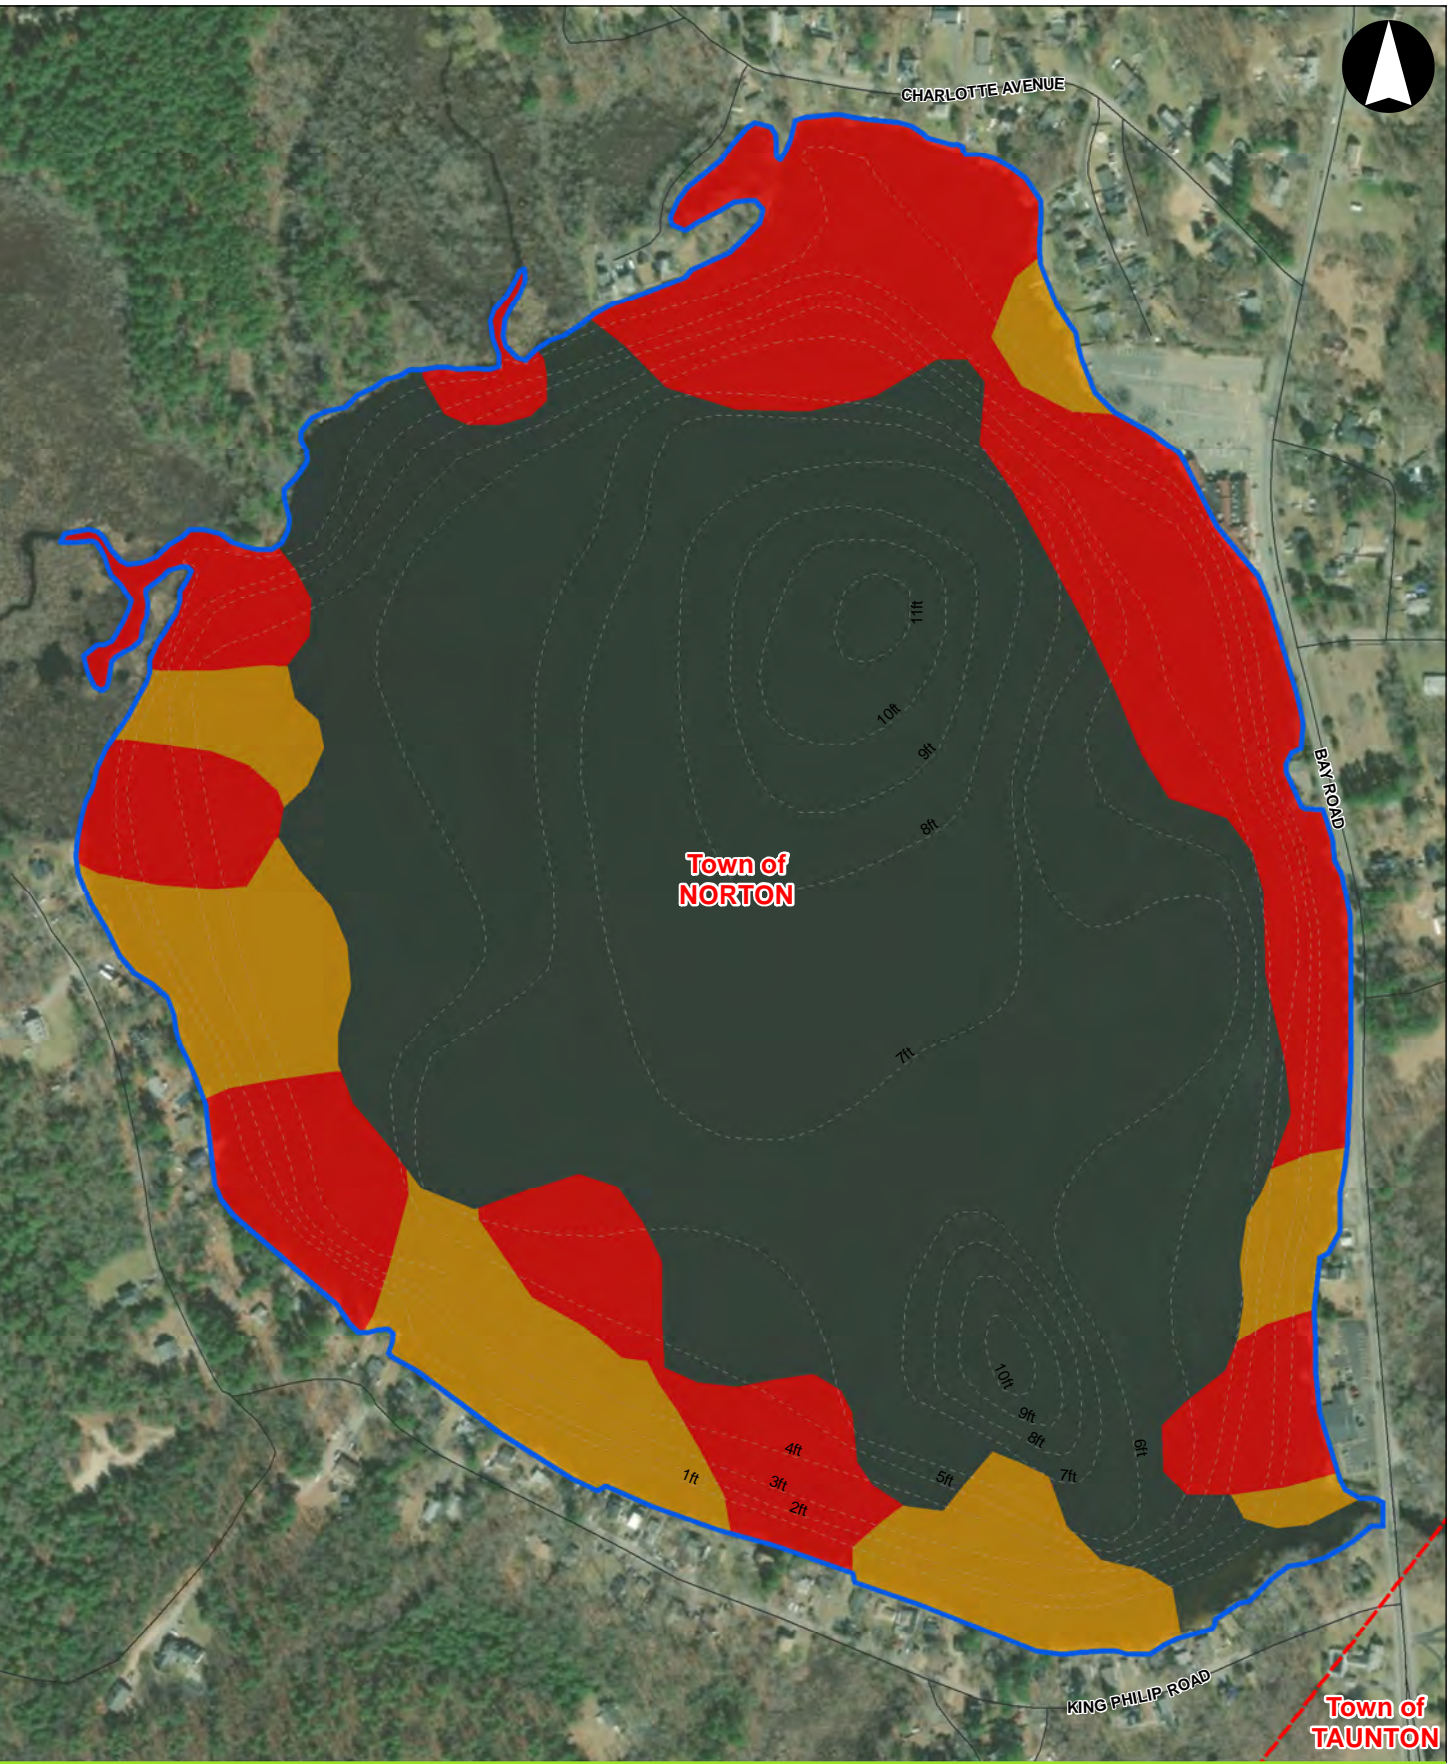
Figure 1

Pre-Treatment Variable-Leaf Milfoil Cover
Lake Winneconnet 2020

Variable-Leaf Milfoil Cover	Town Boundary
Sparse (0 acres)	
Patchy (19.4 acres)	
Dense (38.9 acres)

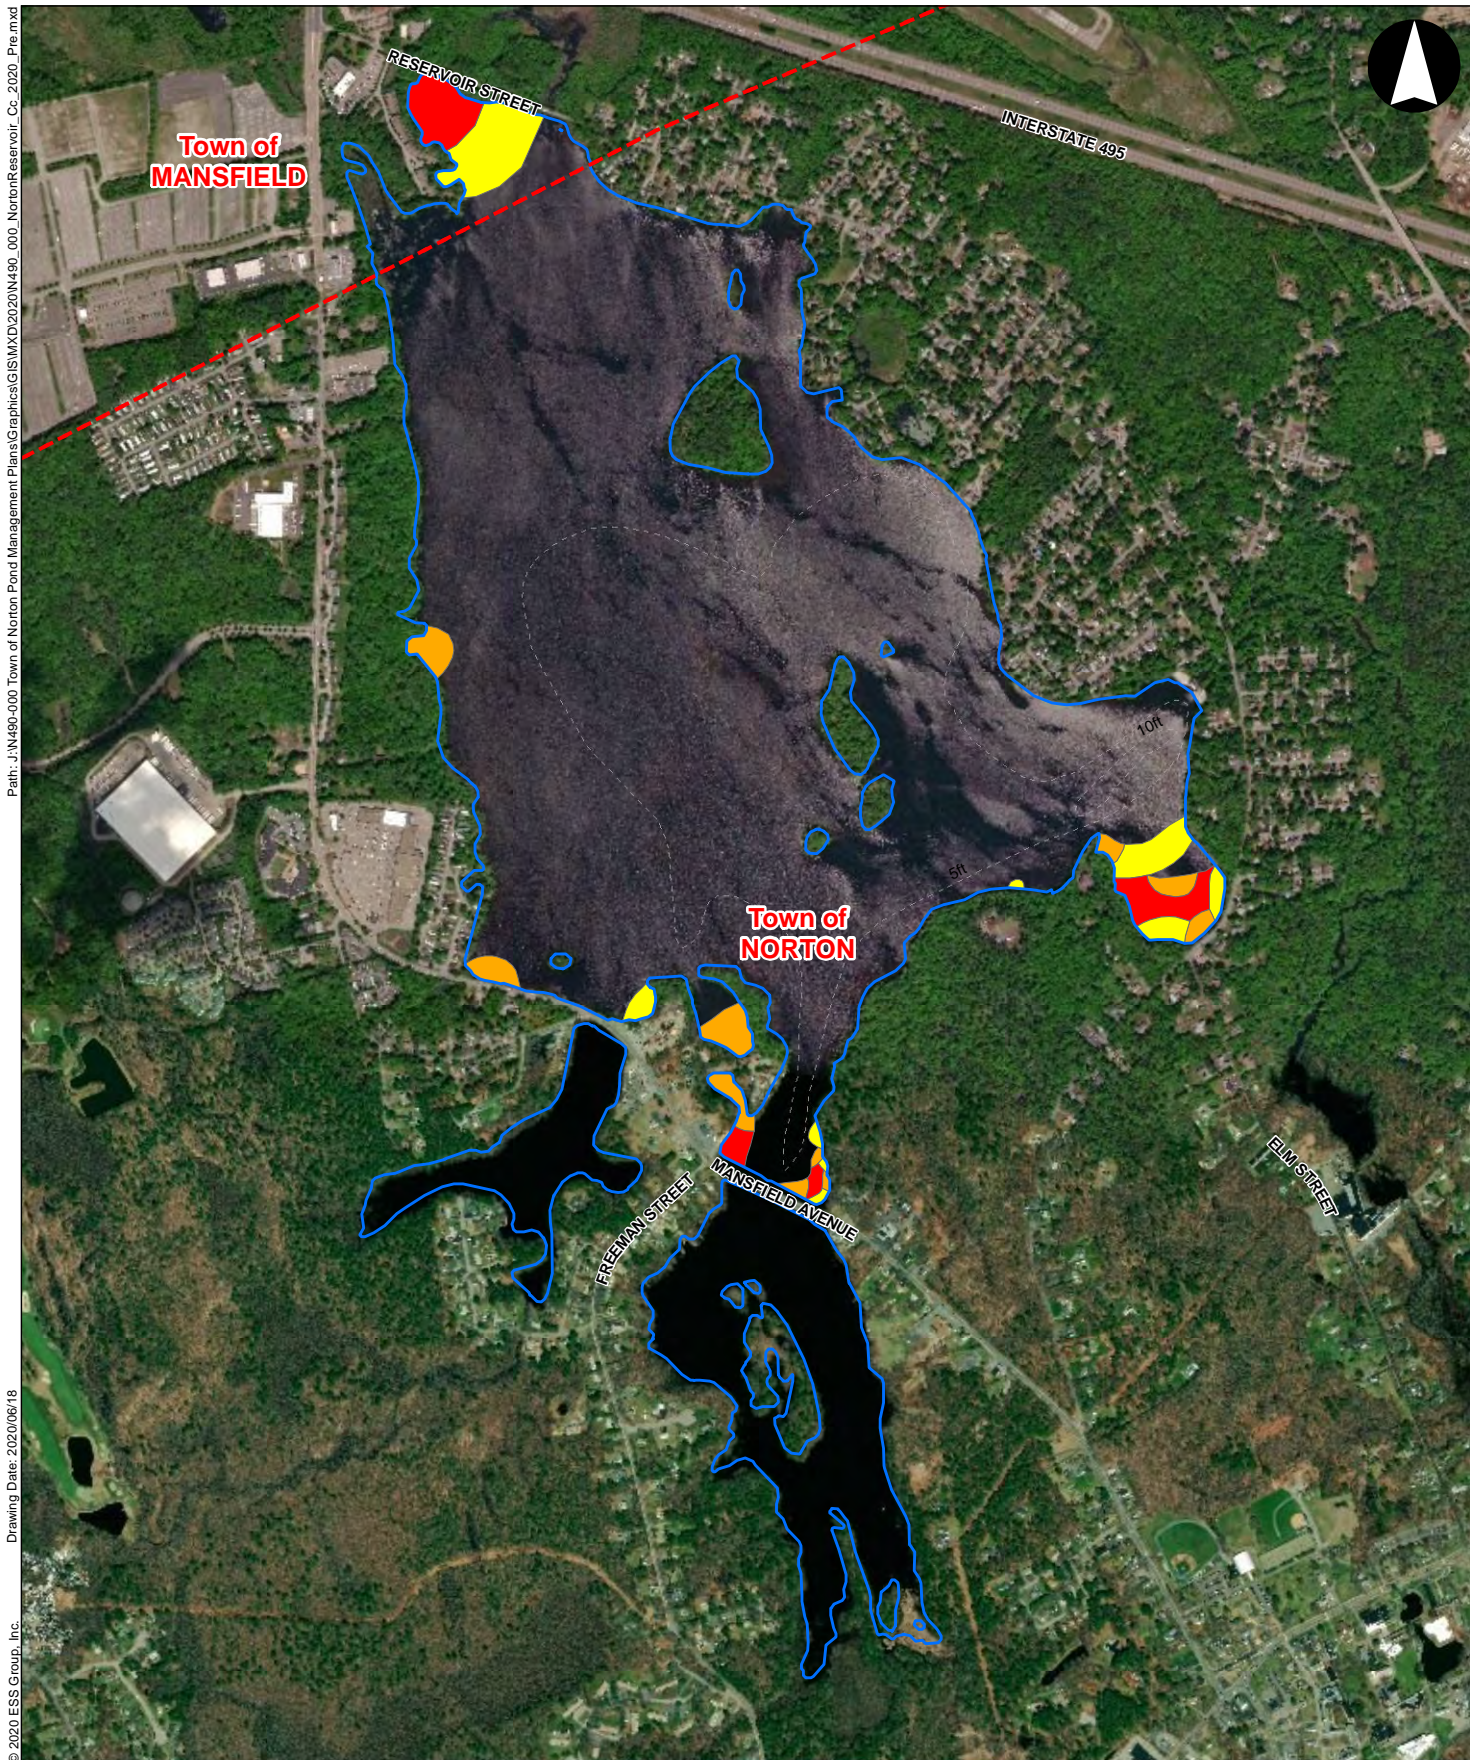
Figure 2

- Fanwort covered approximately 28 acres, primarily consisting of sparse beds (Figure 2). This represents a **decrease** of 15 acres compared to the pre-treatment survey in 2019.

- Town Boundary
- Fanwort Cover**
- Sparse (11.9 acres)
- Patchy (8.2 acres)
- Dense (8.3 acres)

Pre-treatment Fanwort Cover
Norton Reservoir
2020

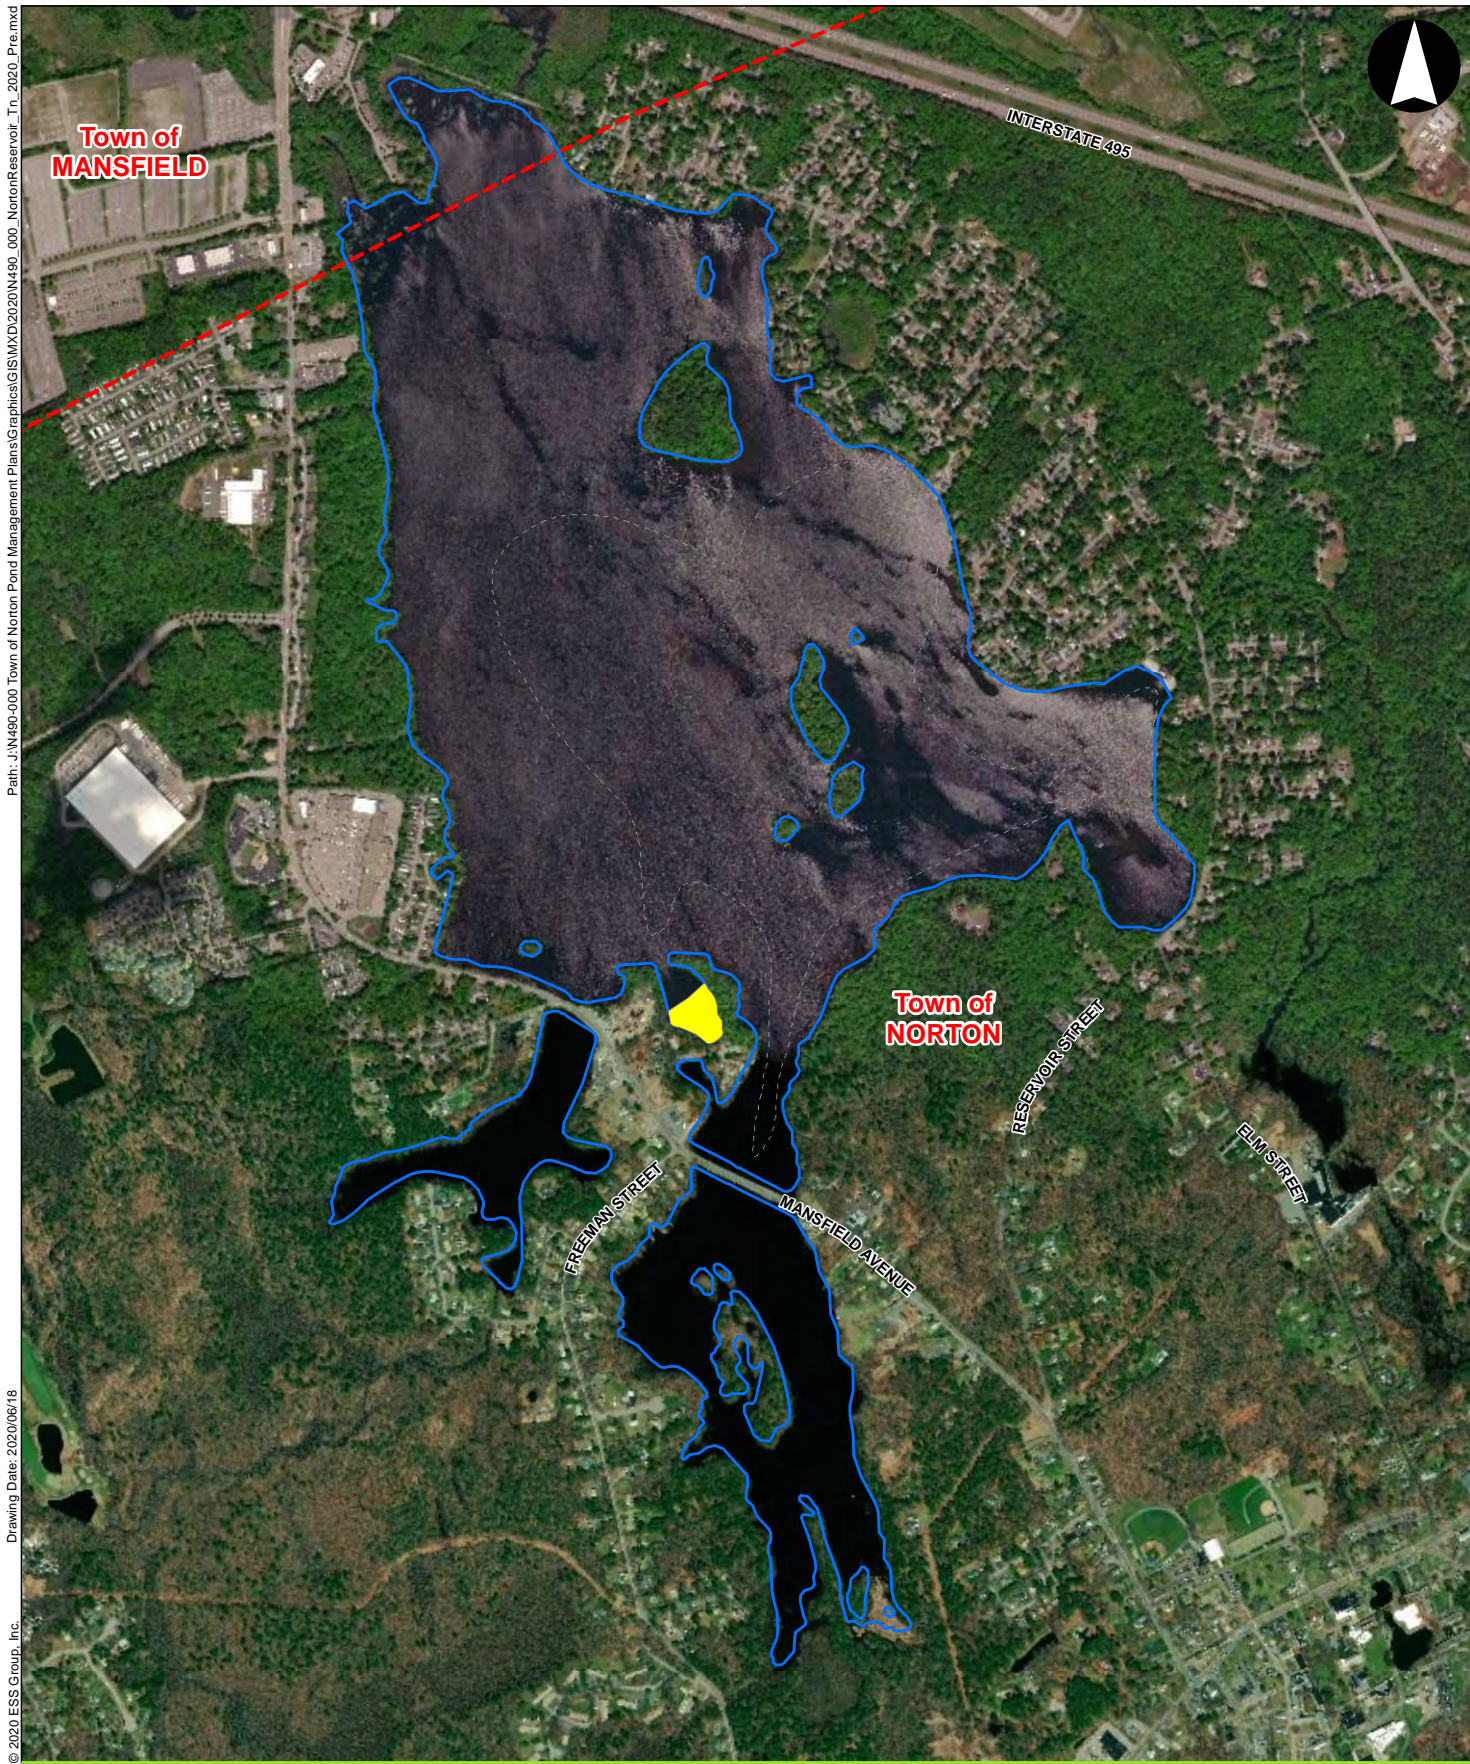
Figure 5

- Water chestnut was found in one bed in the main basin (Figure 5). Total water chestnut coverage observed was approximately 2 acres, which represents a **decrease** of almost 4 acres from the pre-treatment survey in 2019.

- Town Boundary
- Water Chestnut Cover
- Sparse (2.0 acres)

Pre-treatment Water Chestnut Cover
Norton Reservoir
2020

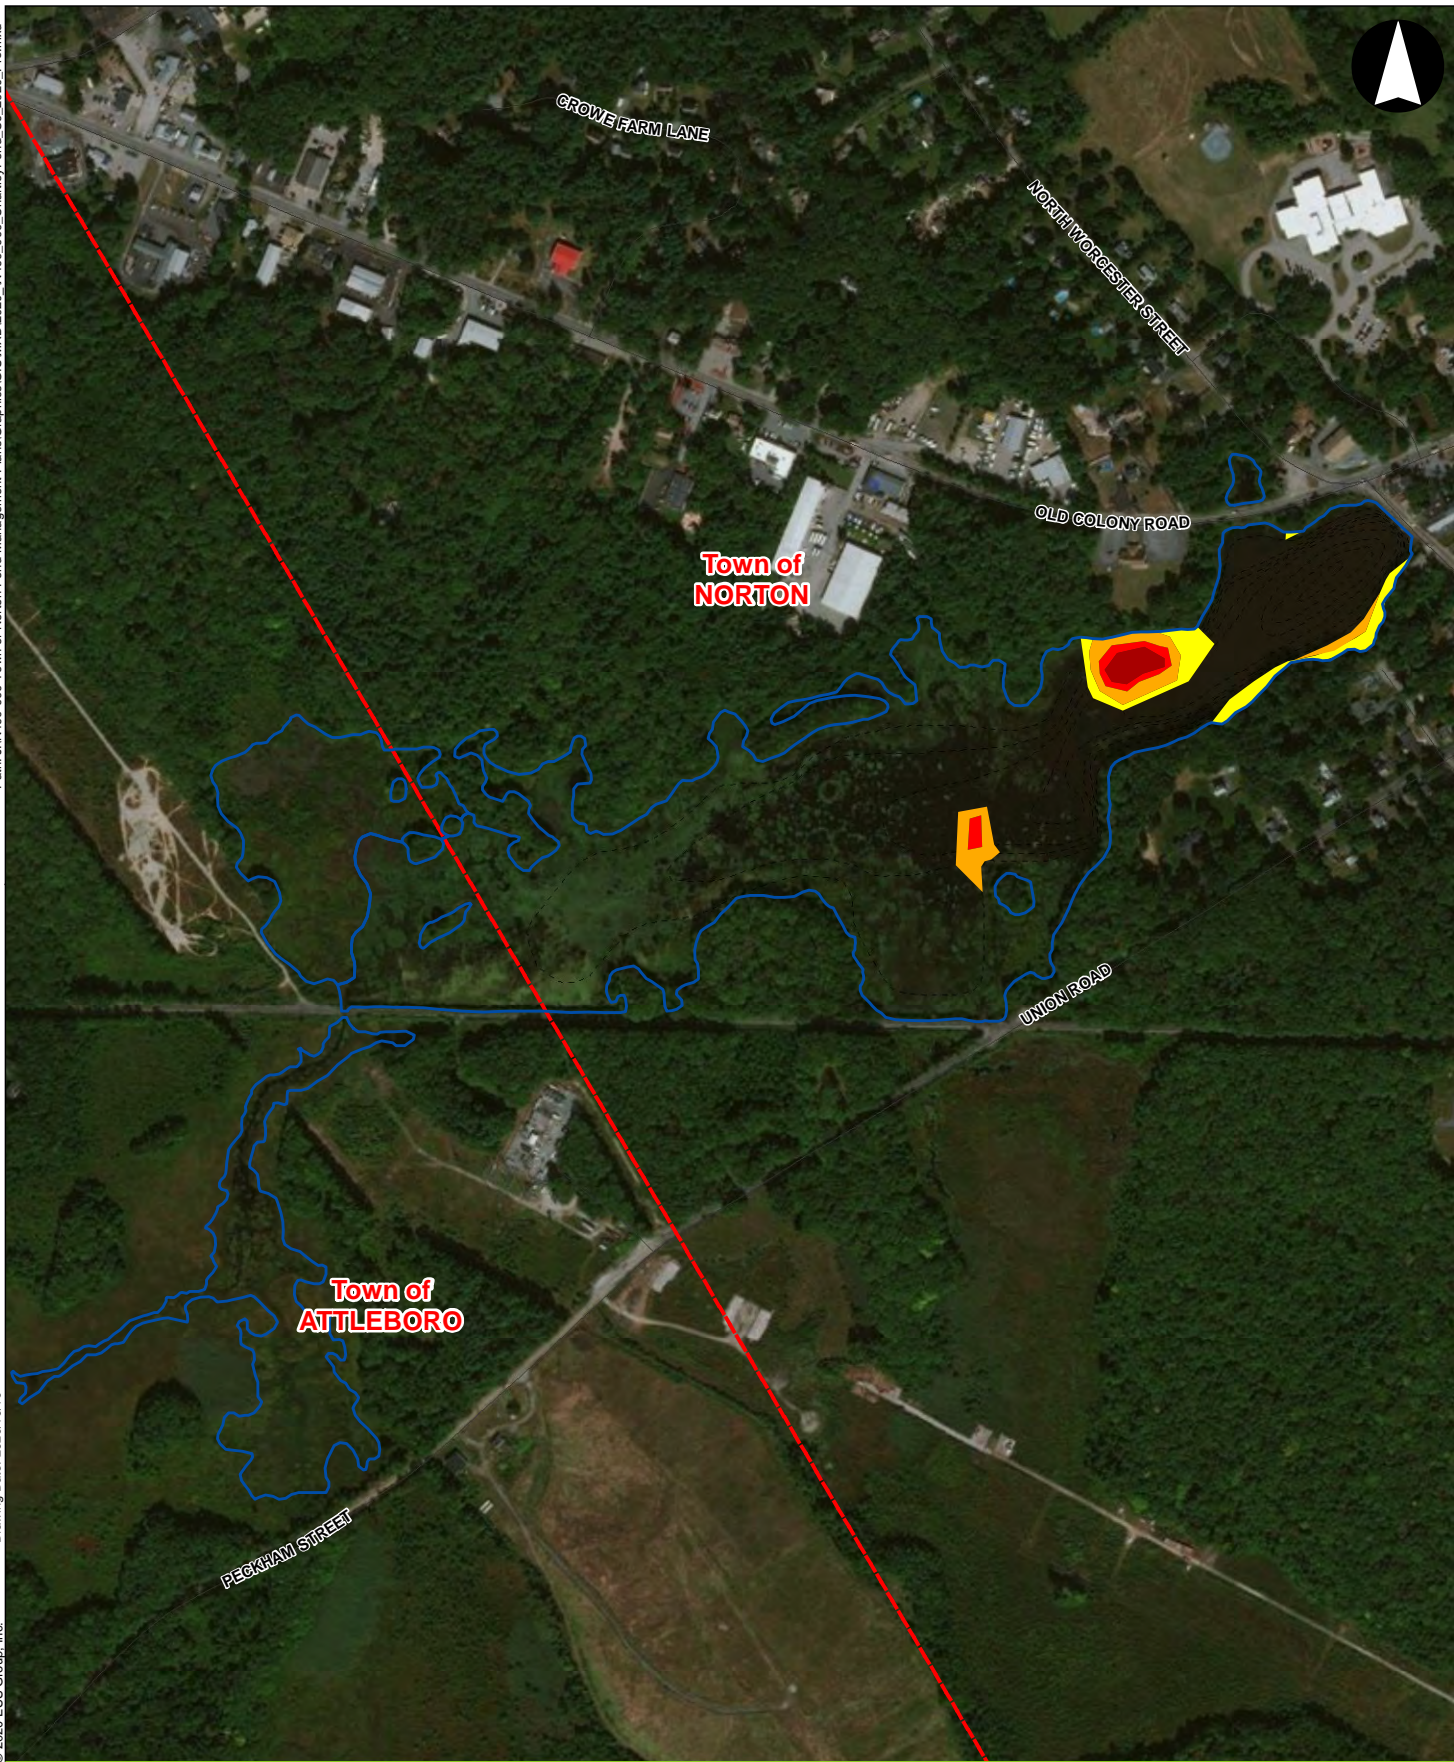
Figure 6

Pre-treatment Fanwort Cover
Chartley Pond
2020

- Sparse (1.1 acres)
- Patchy (1.1 acres)
- Dense (0.7 acres)

- Fanwort covered approximately 3 acres of the pond during the 2020 pre-treatment survey (Figure 6), similar to observations of late-season growth in 2019. However, this represents an **increase** of close to 3 acres from early-season growth in 2019.
- Variable-leaf milfoil was documented as sparse to dense beds covering approximately 6 acres of the pond (Figure 7), a substantial **decrease** from the 18 acres observed prior to treatment in June 2019.
- Water chestnut covered approximately 6 acres of the pond (Figure 8). This represents a substantial **decrease** in growth from pre-treatment conditions in 2019.

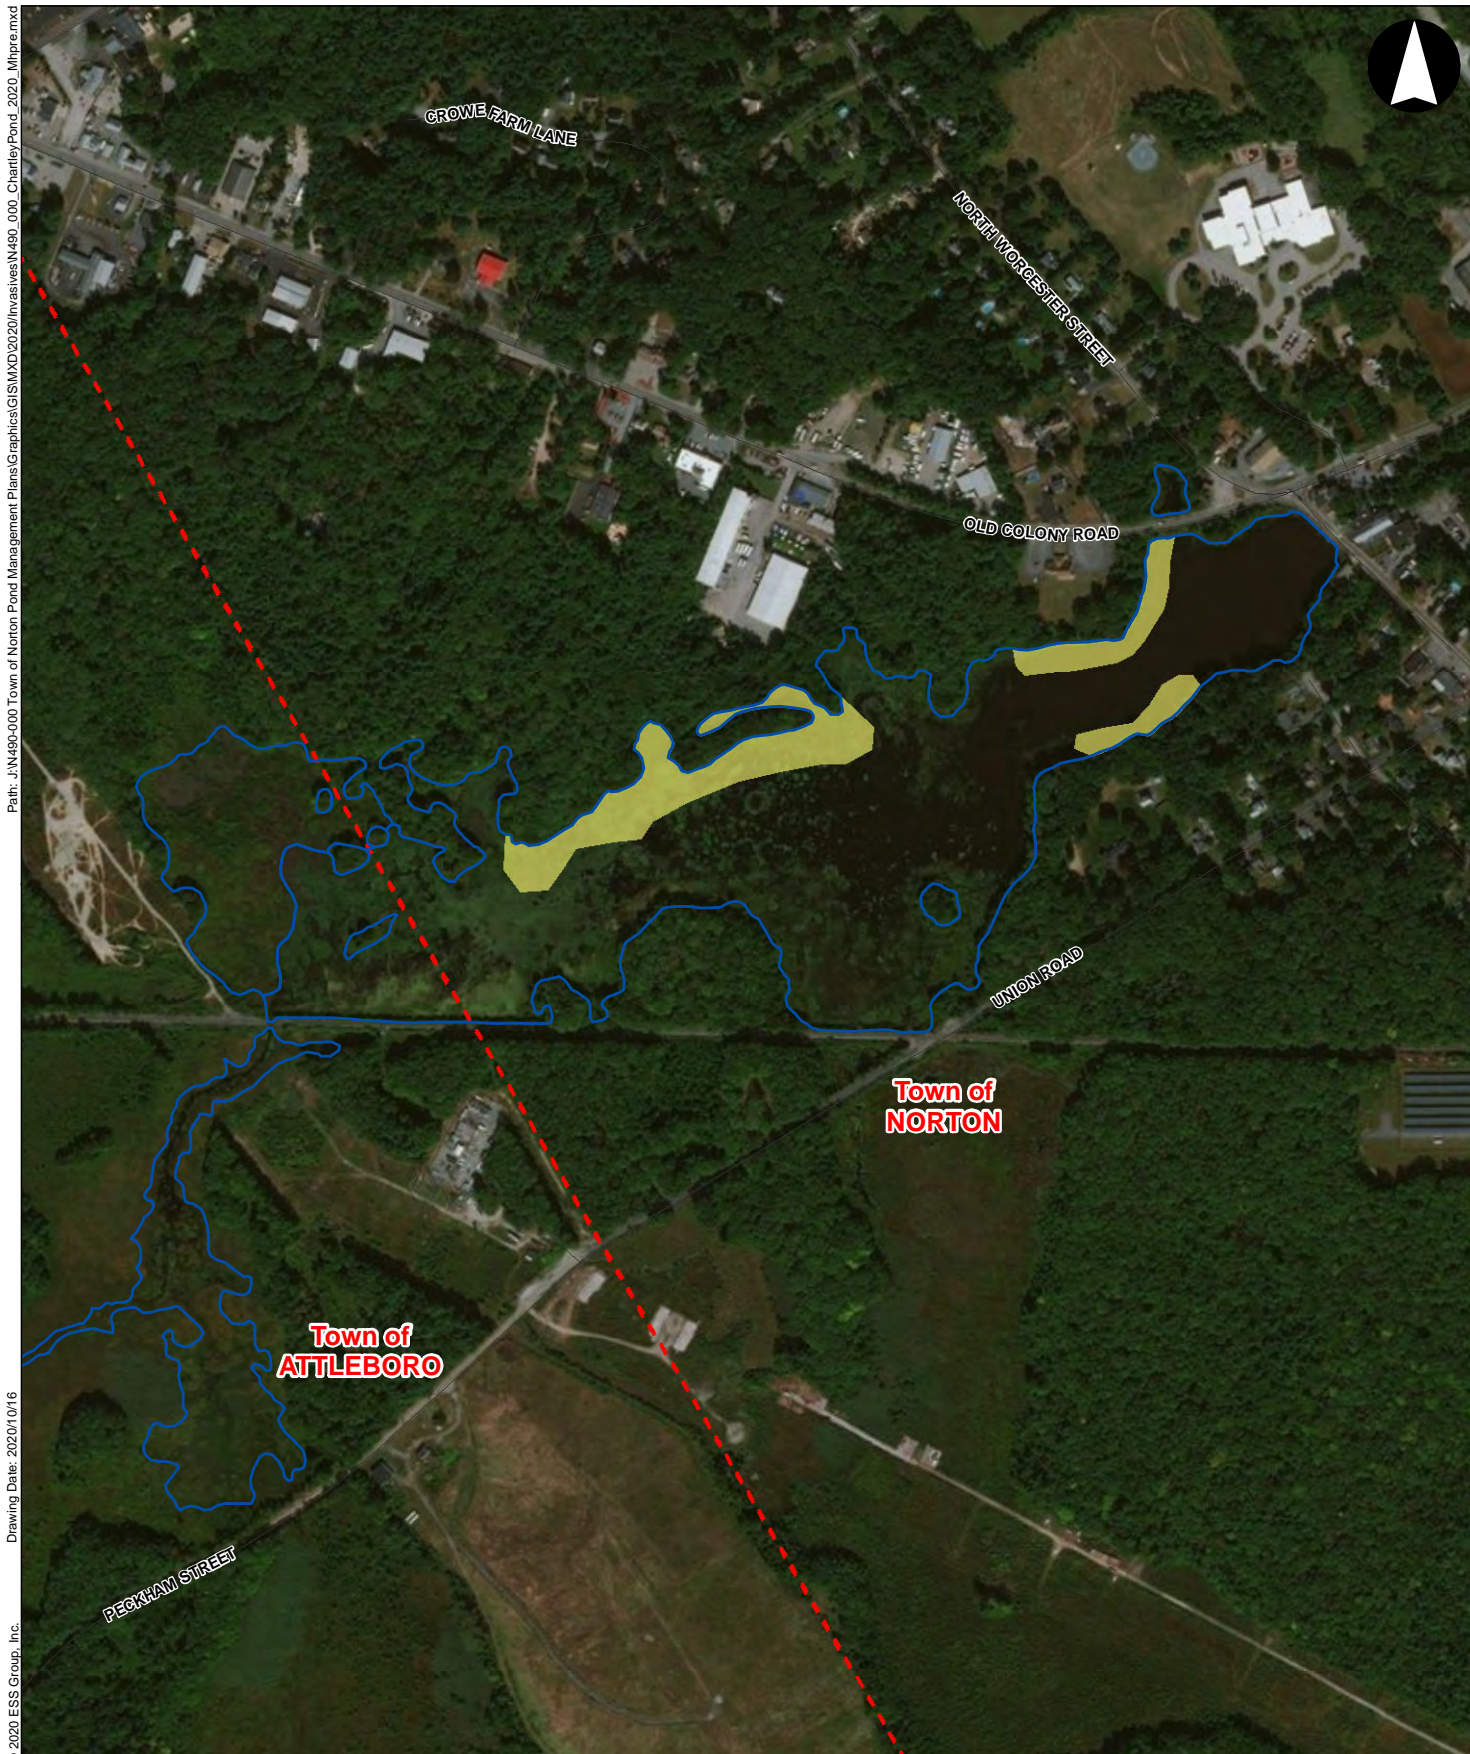
Figure 7

Pre-treatment Variable-Leaf Milfoil Cover
Chartley Pond
2020

- Sparse (6.0 acres)
- Patchy (0.0 acres)
- Dense (0.0 acres)

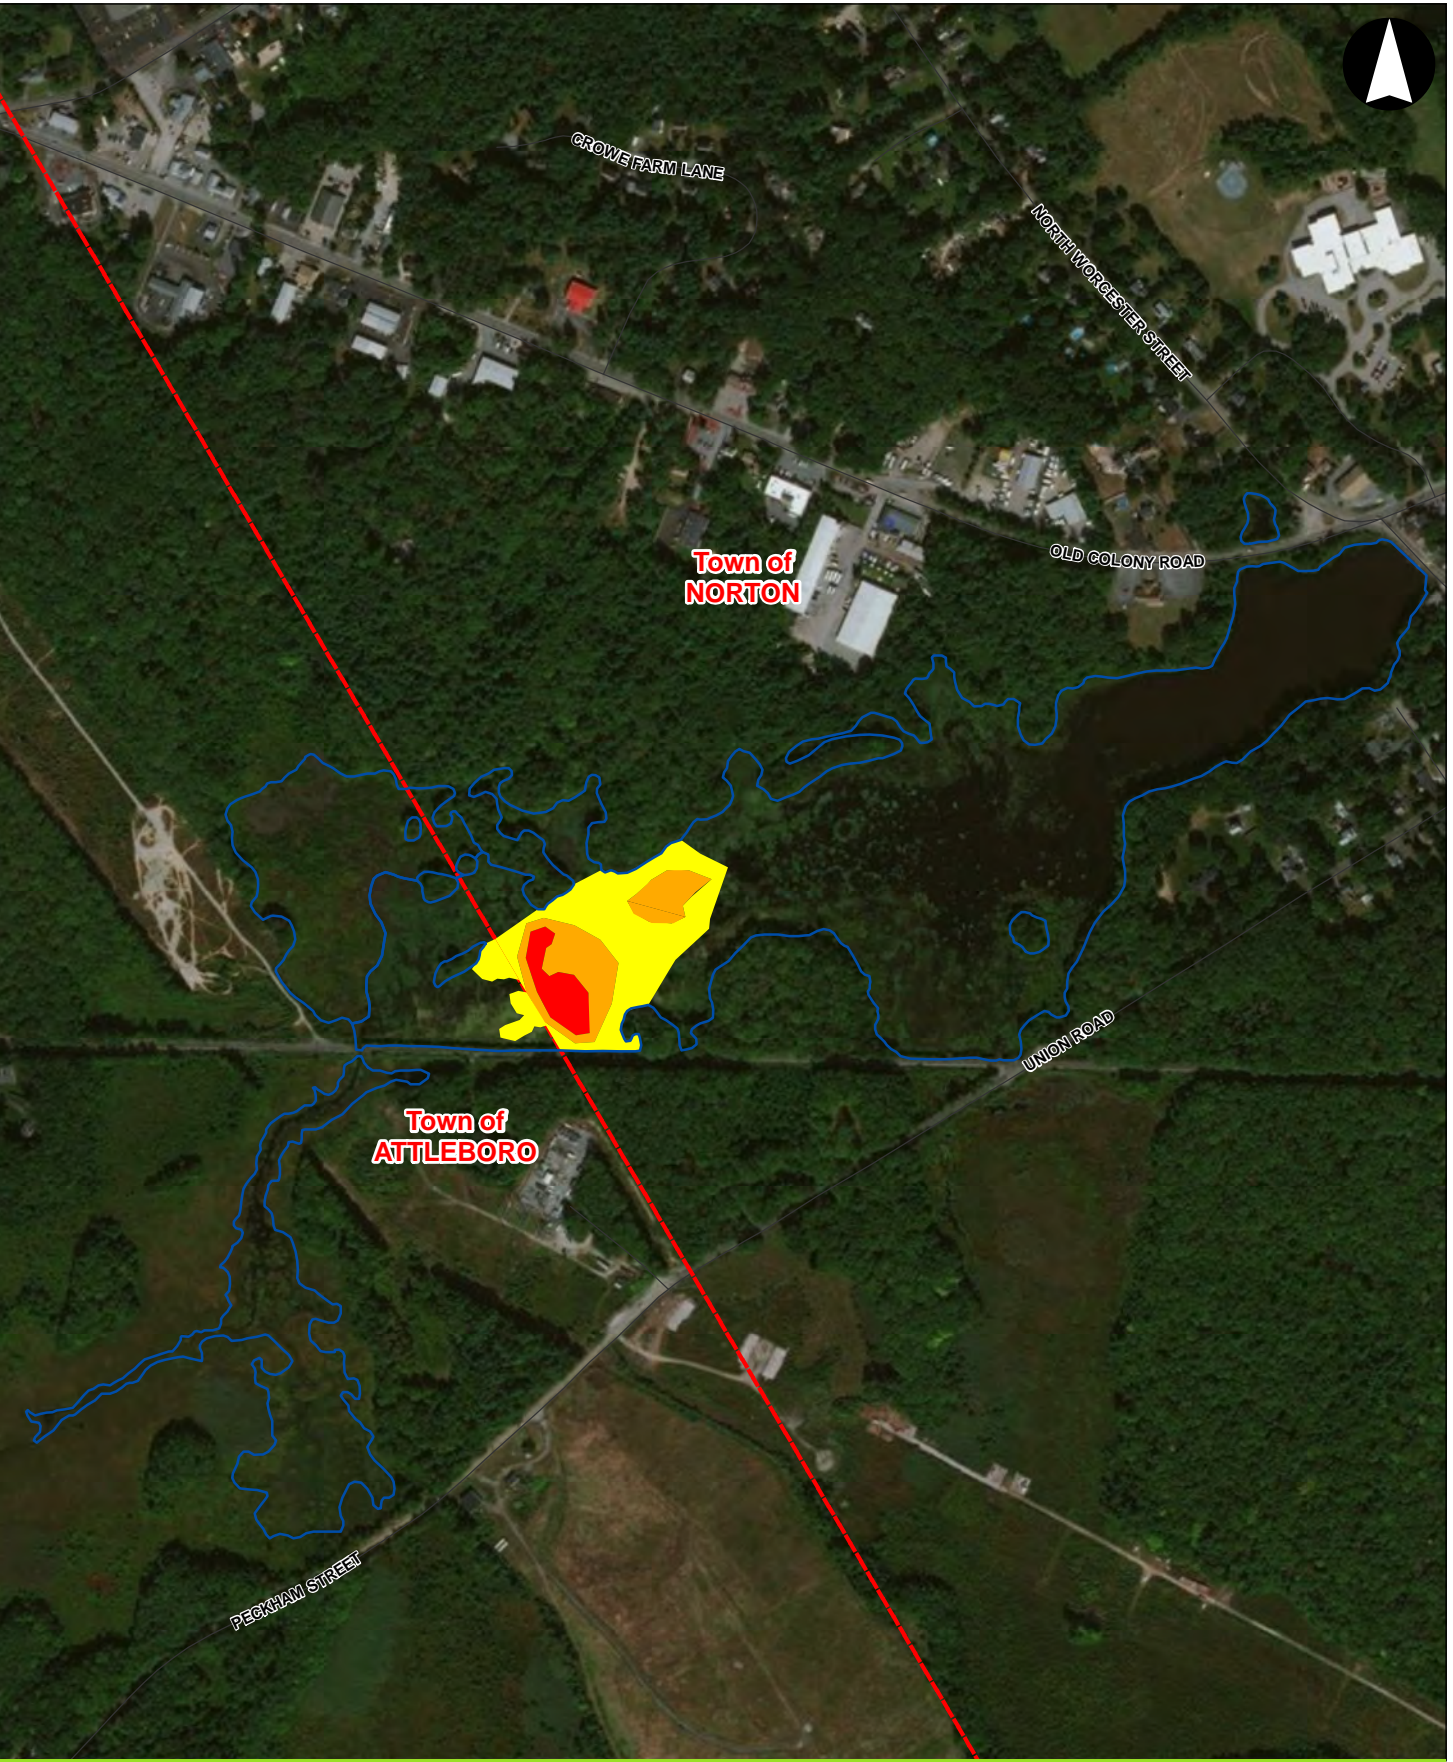
Figure 8

- Water Chestnut Cover**
- Sparse (3.9 acres)
 - Patchy (1.6 acres)
 - Dense (0.6 acres)

Pre-treatment Water Chestnut Cover
Chartley Pond
2020

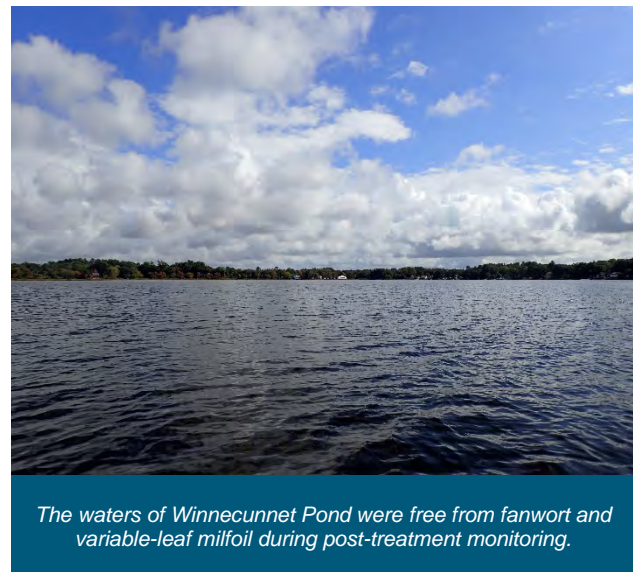
No target species were observed in Winnecunnet Pond during the late season surveys. This suggests that the 2020 Sonar treatment was highly effective in controlling both fanwort and variable-leaf milfoil within the pond. However, this will need to be verified in 2021 to better assess the potential for regrowth in the spring.

The waters of Winnecunnet Pond were free from fanwort and variable-leaf milfoil during post-treatment monitoring.

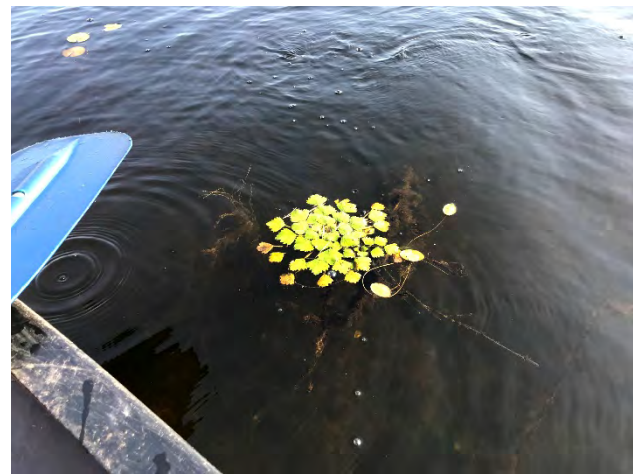
Water chestnut growth was sparse during post-treatment monitoring at Chartley Pond.

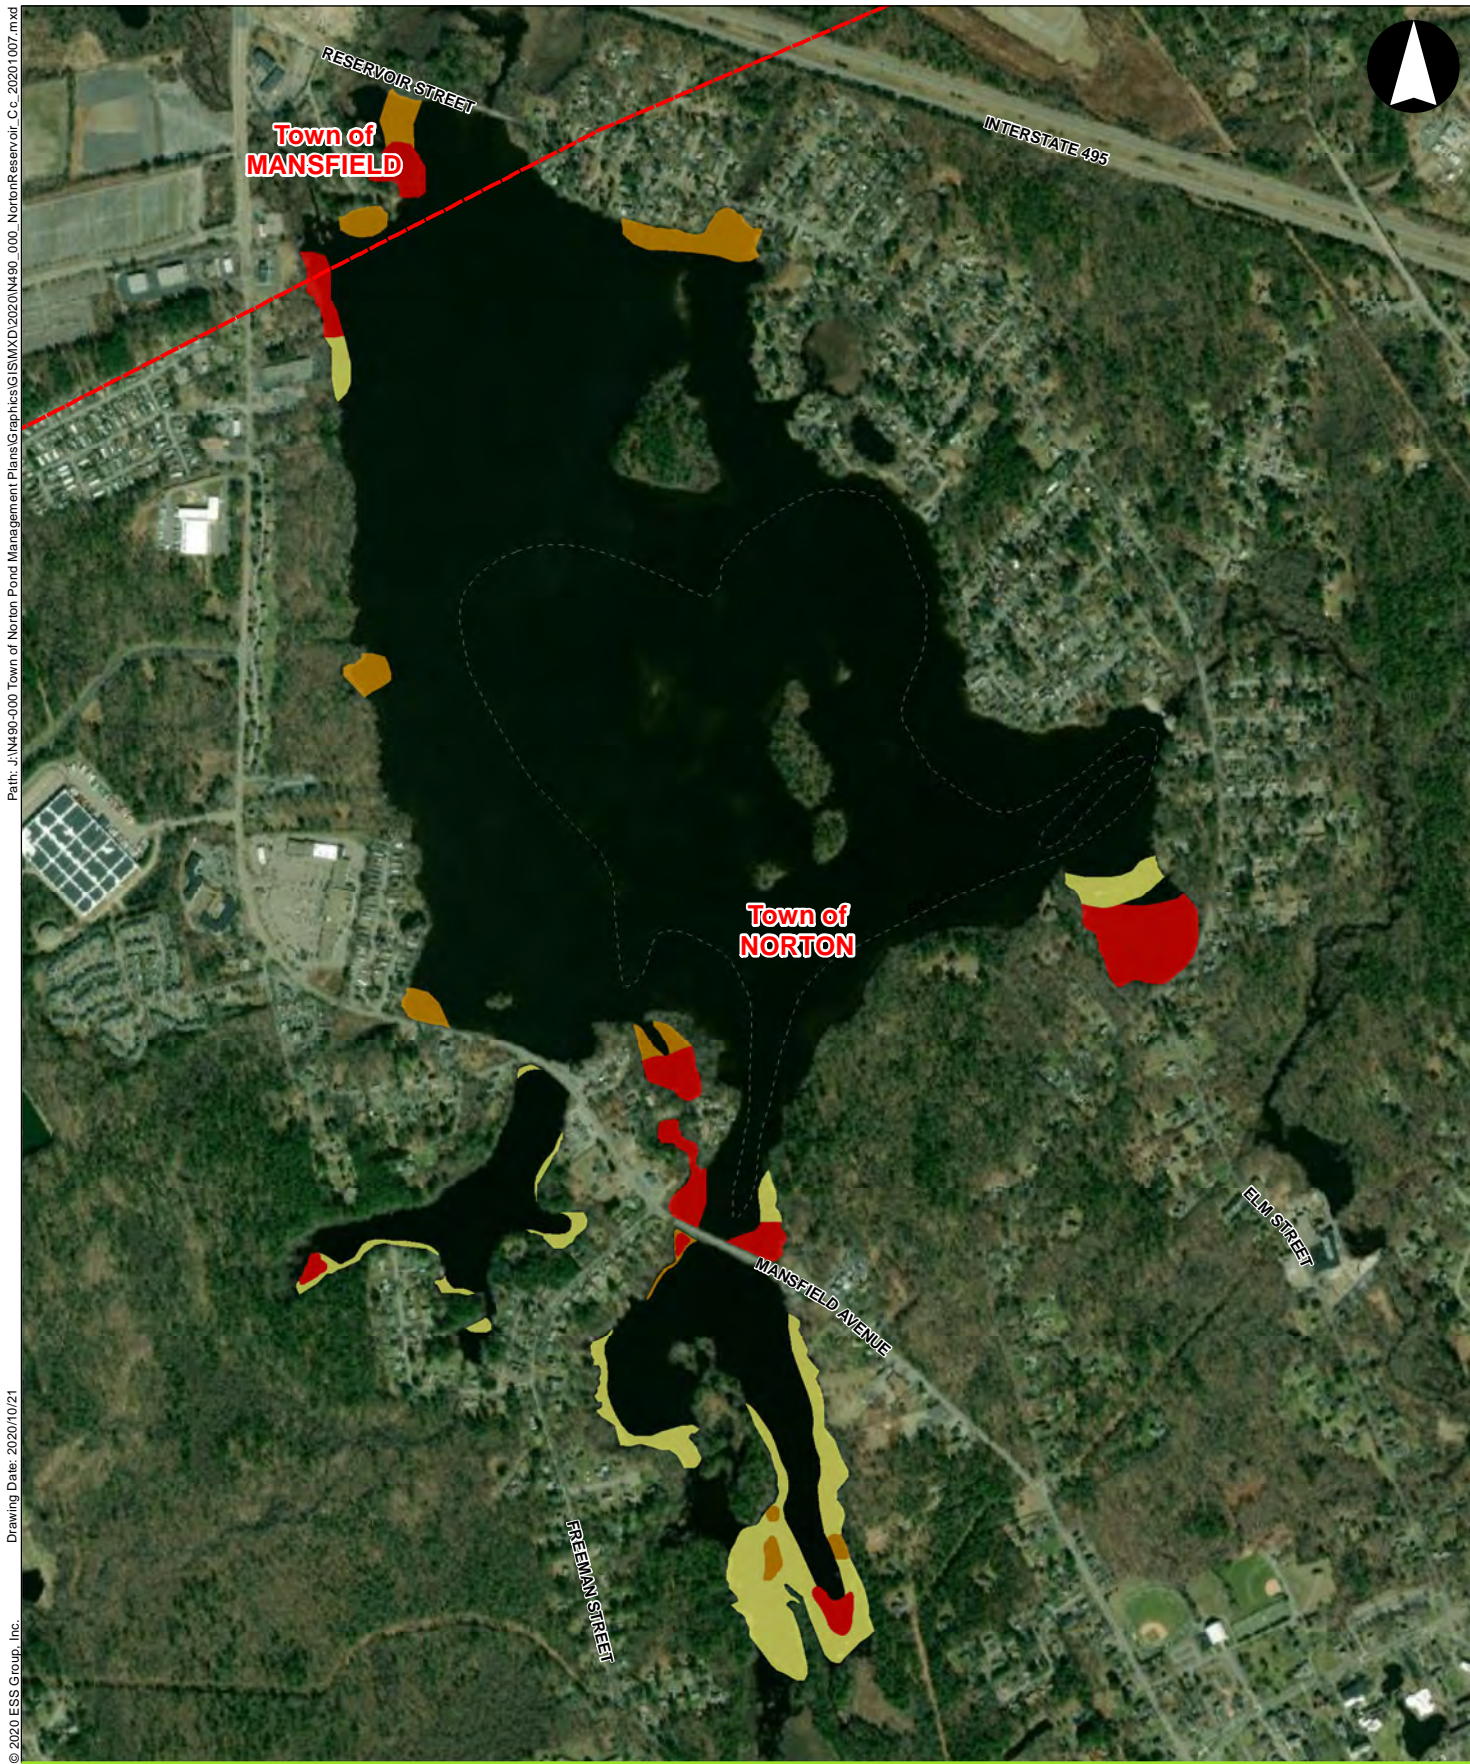
Figure 9

- Fanwort covered an estimated total of 54 acres (Figure 9), an apparent **increase of approximately 26 acres from pre-treatment conditions but a year-over-year decrease of 38 acres**. The beds located in the northern coves of the reservoir were reduced compared to recent years, although the plant was still present. Elsewhere, fanwort beds also appeared to recede from their overall 2019 footprint but were occasionally dense along the shoreline. Most plants were pale and chlorotic but many still retained green growing tips.

Fanwort Cover
Norton Reservoir
2020

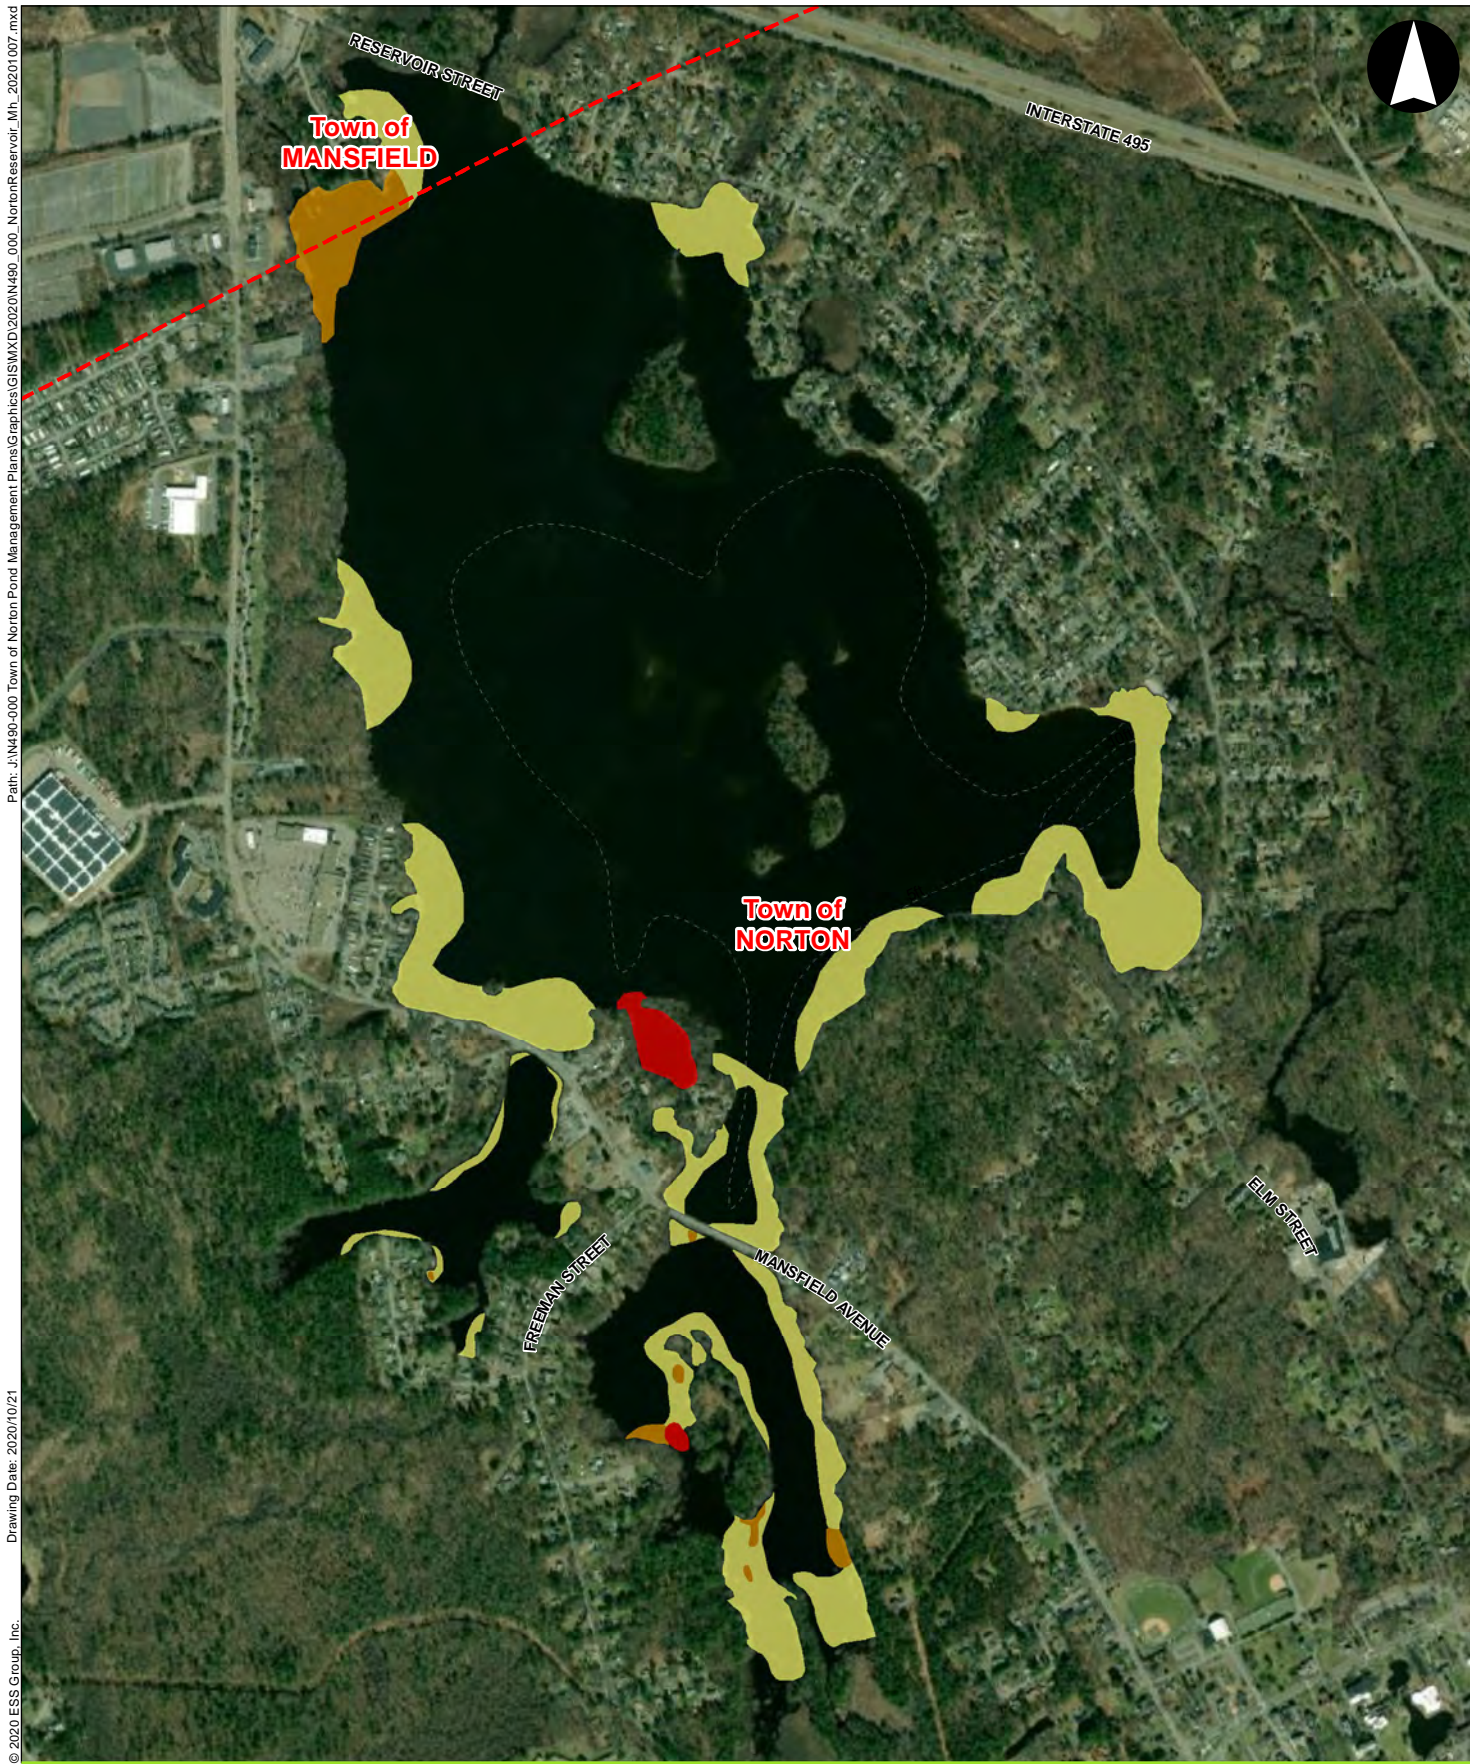
Figure 10

- Variable-leaf milfoil covered an estimated total of 100 acres (Figure 10), a **decrease of approximately 7 acres from pre-treatment conditions but a year-over-year increase of 22 acres**. Most remaining beds were in poor to fair condition and sparse to patchy with only a few small beds where the growth remained dense.
- Water chestnut covered an estimated total of 1 acre (Figure 11), a **decrease of approximately 1 acre from pre-treatment conditions and similar year-over-year to 2019**. Remaining beds were sparse.

- Sparse (85.7 acres)
- Patchy (10.2 acres)
- Dense (4.2 acres)

Variable-leaf Milfoil Cover
Norton Reservoir
2020
