2020 Lakes and Ponds Annual Report

Norton, Massachusetts

Project No. N490-000.16
October 30, 2020

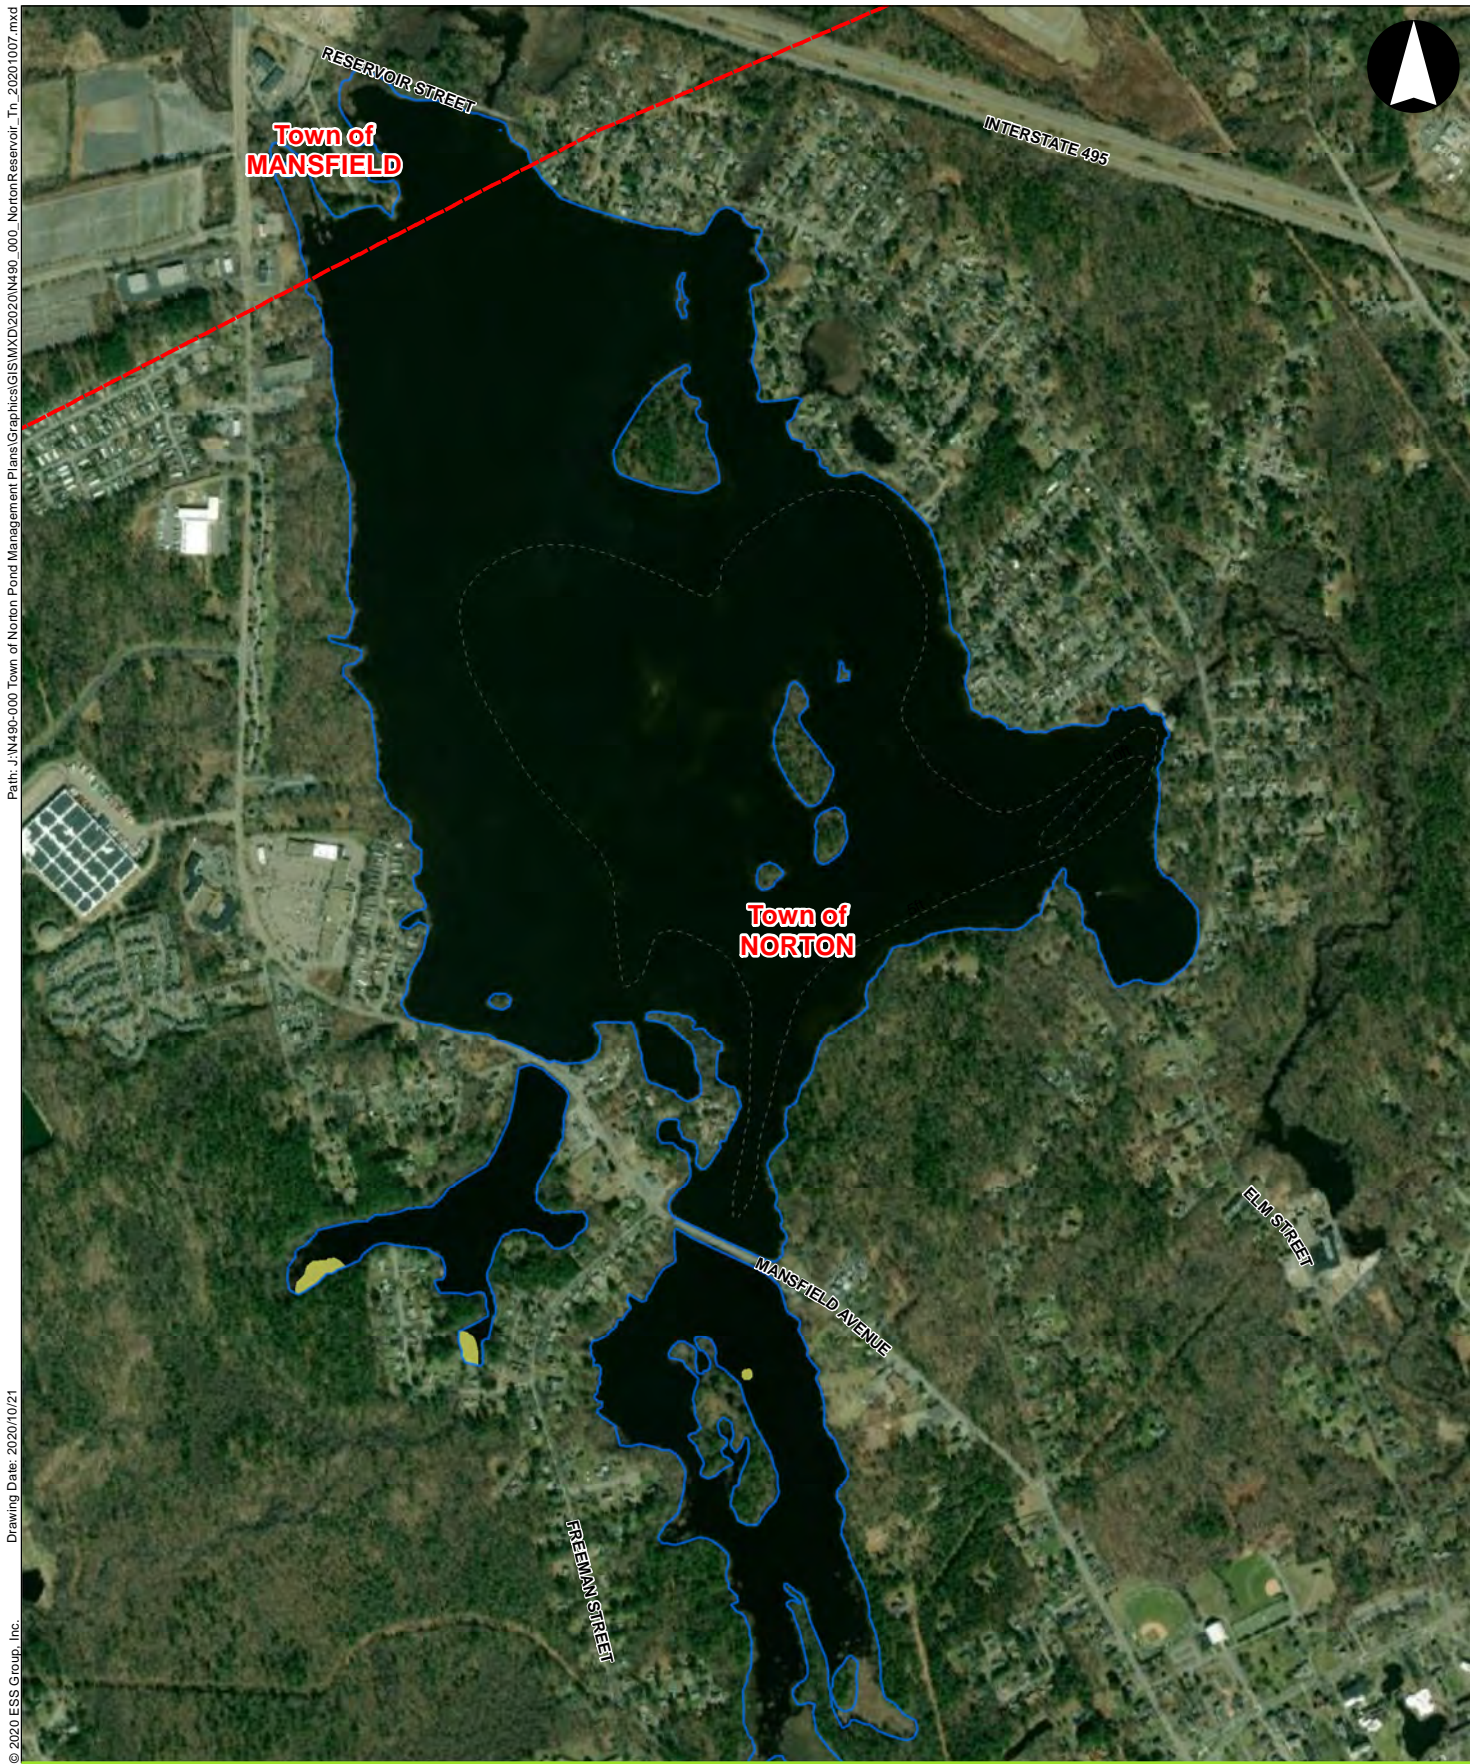
Figure 11

- Sparse (1.4 acres)
- Patchy (0 acres)
- Dense (0 acres)

Water Chestnut Cover
Norton Reservoir
2020

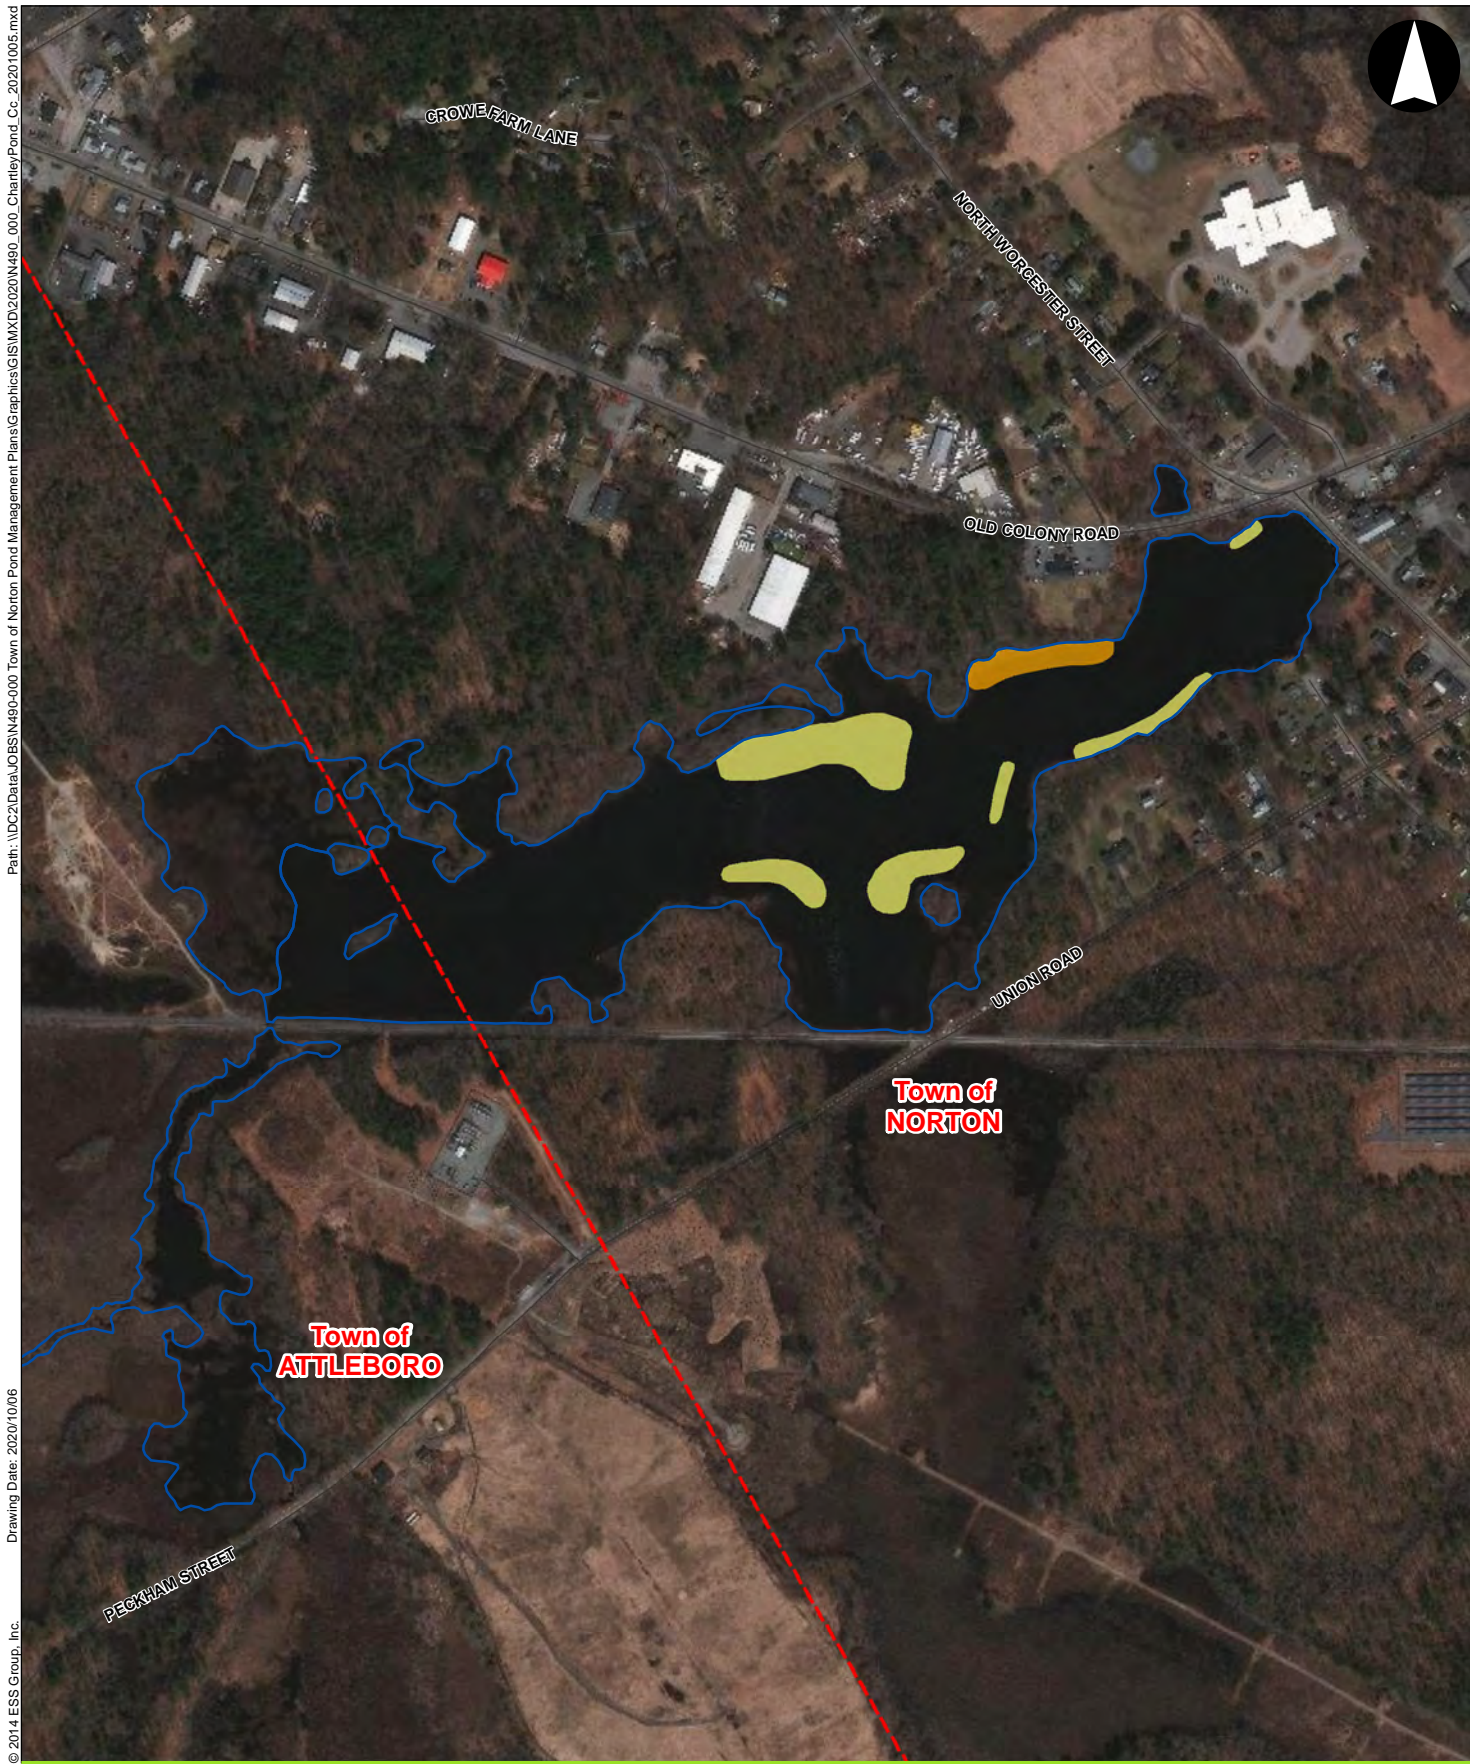
Figure 12

- Fanwort covered an estimated total of 5 acres (Figure 12), an **increase from pre-treatment conditions and year-over-year**. However, the density of the plants within the beds was greatly decreased, resulting in sparse growth. The beds were also less contiguous than in 2019.
- Variable-leaf milfoil covered an estimated total of 3 acres, a **reduction of approximately 6 acres from pre-treatment conditions and also a year-over-year decrease of 6 acres** (Figure 13). The largest area of remaining beds remained in the north-central shoreline of the pond.
- Water chestnut covered an estimated total of 2 acres, a **reduction of approximately 4 acres from pre-treatment conditions** (Figure 14). No beds were observed anywhere in the main portion of the pond. However, an area of sparse plants was observed at the western periphery of open water in the pond.

Fanwort Cover
Chartley Pond
2020

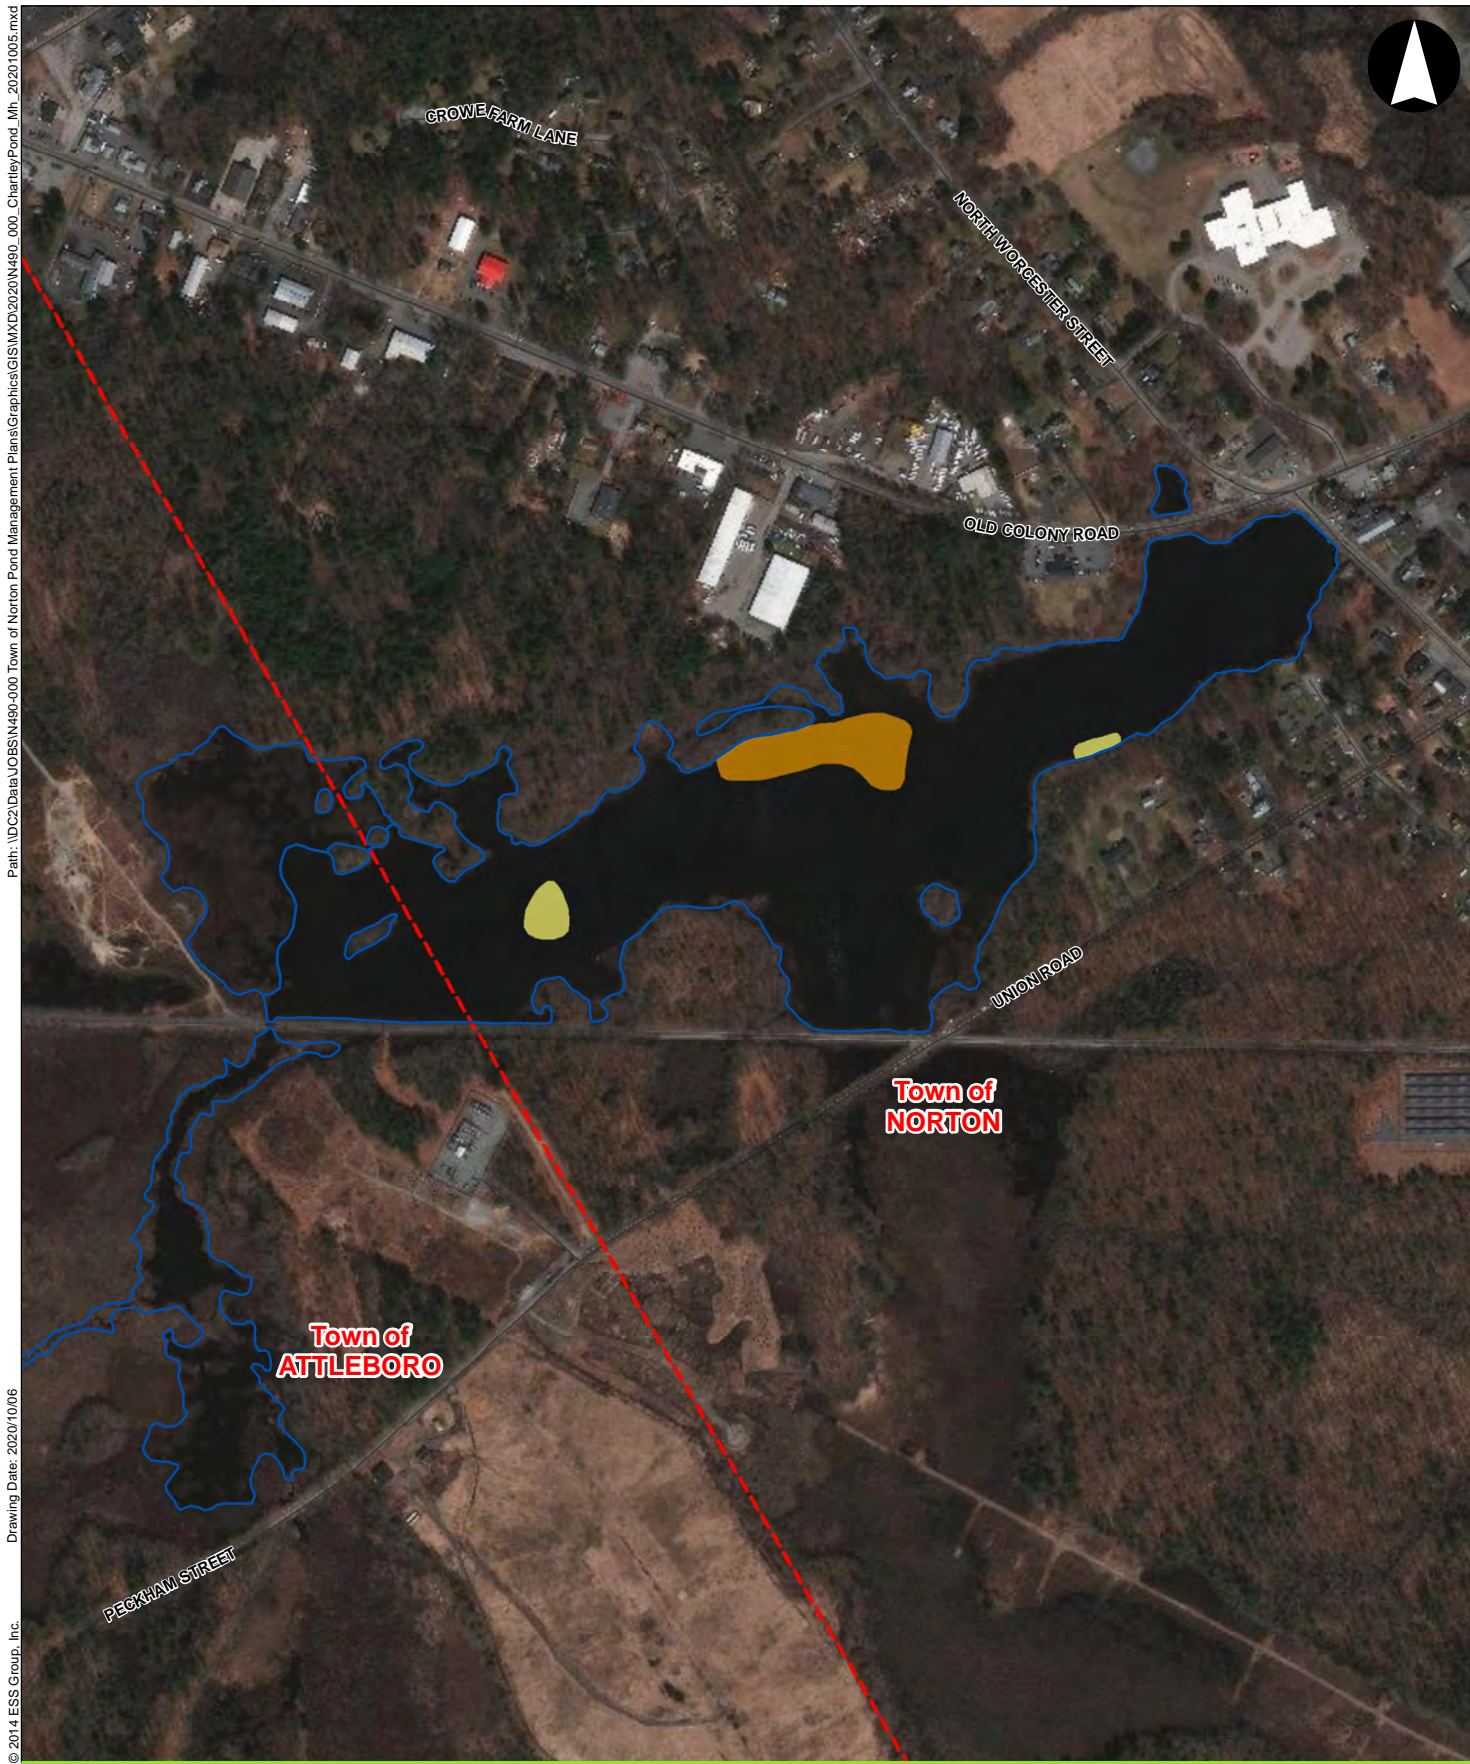
Figure 13

- Sparse (0.5 acres)
- Patchy (2.1 acres)
- Dense (0 acres)

Variable-leaf Milfoil Cover
Chartley Pond
2020

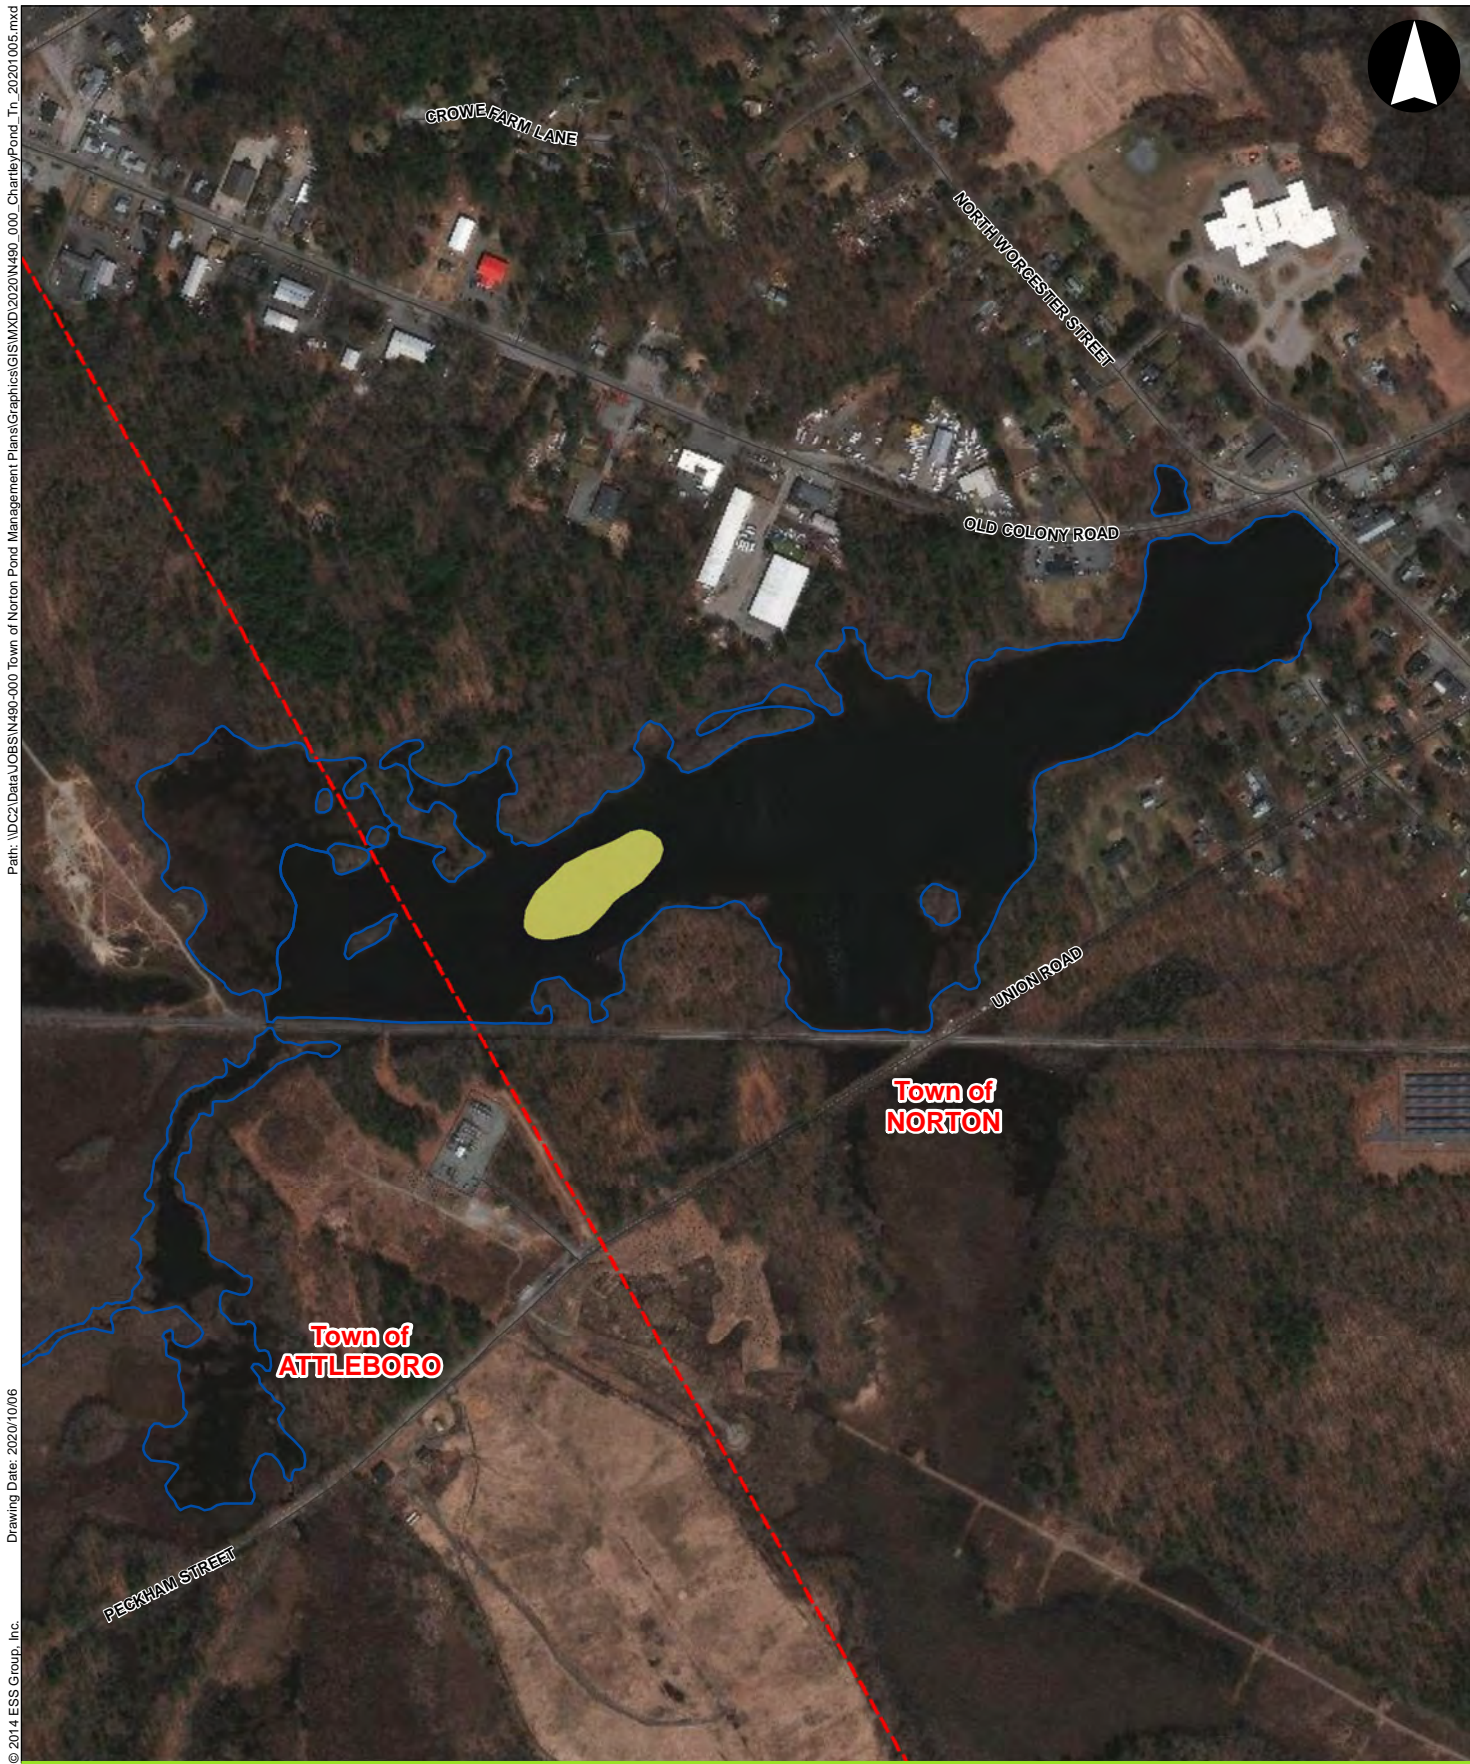
Figure 14

Water Chestnut Cover
Chartley Pond
2020
