# 2021 Lakes and Ponds Annual Report

Norton, Massachusetts

Project No. N490-000.18  
October 29, 2021

**Town of Norton Vegetation Management**  
Norton, Massachusetts

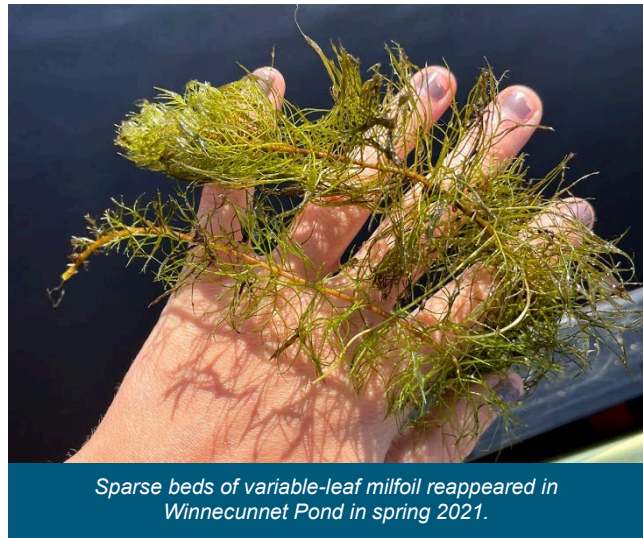
- No fanwort (*Cabomba caroliniana*) was documented in Winnecunnet Pond. However, given the early timing of the survey (May), fanwort would have still been in early growth stages at the time.
- Variable-leaf milfoil covered an estimated total of approximately 58 acres, primarily consisting of sparse beds (Figure 1). This was a **decrease** of 42 acres from pre-treatment conditions in 2020.

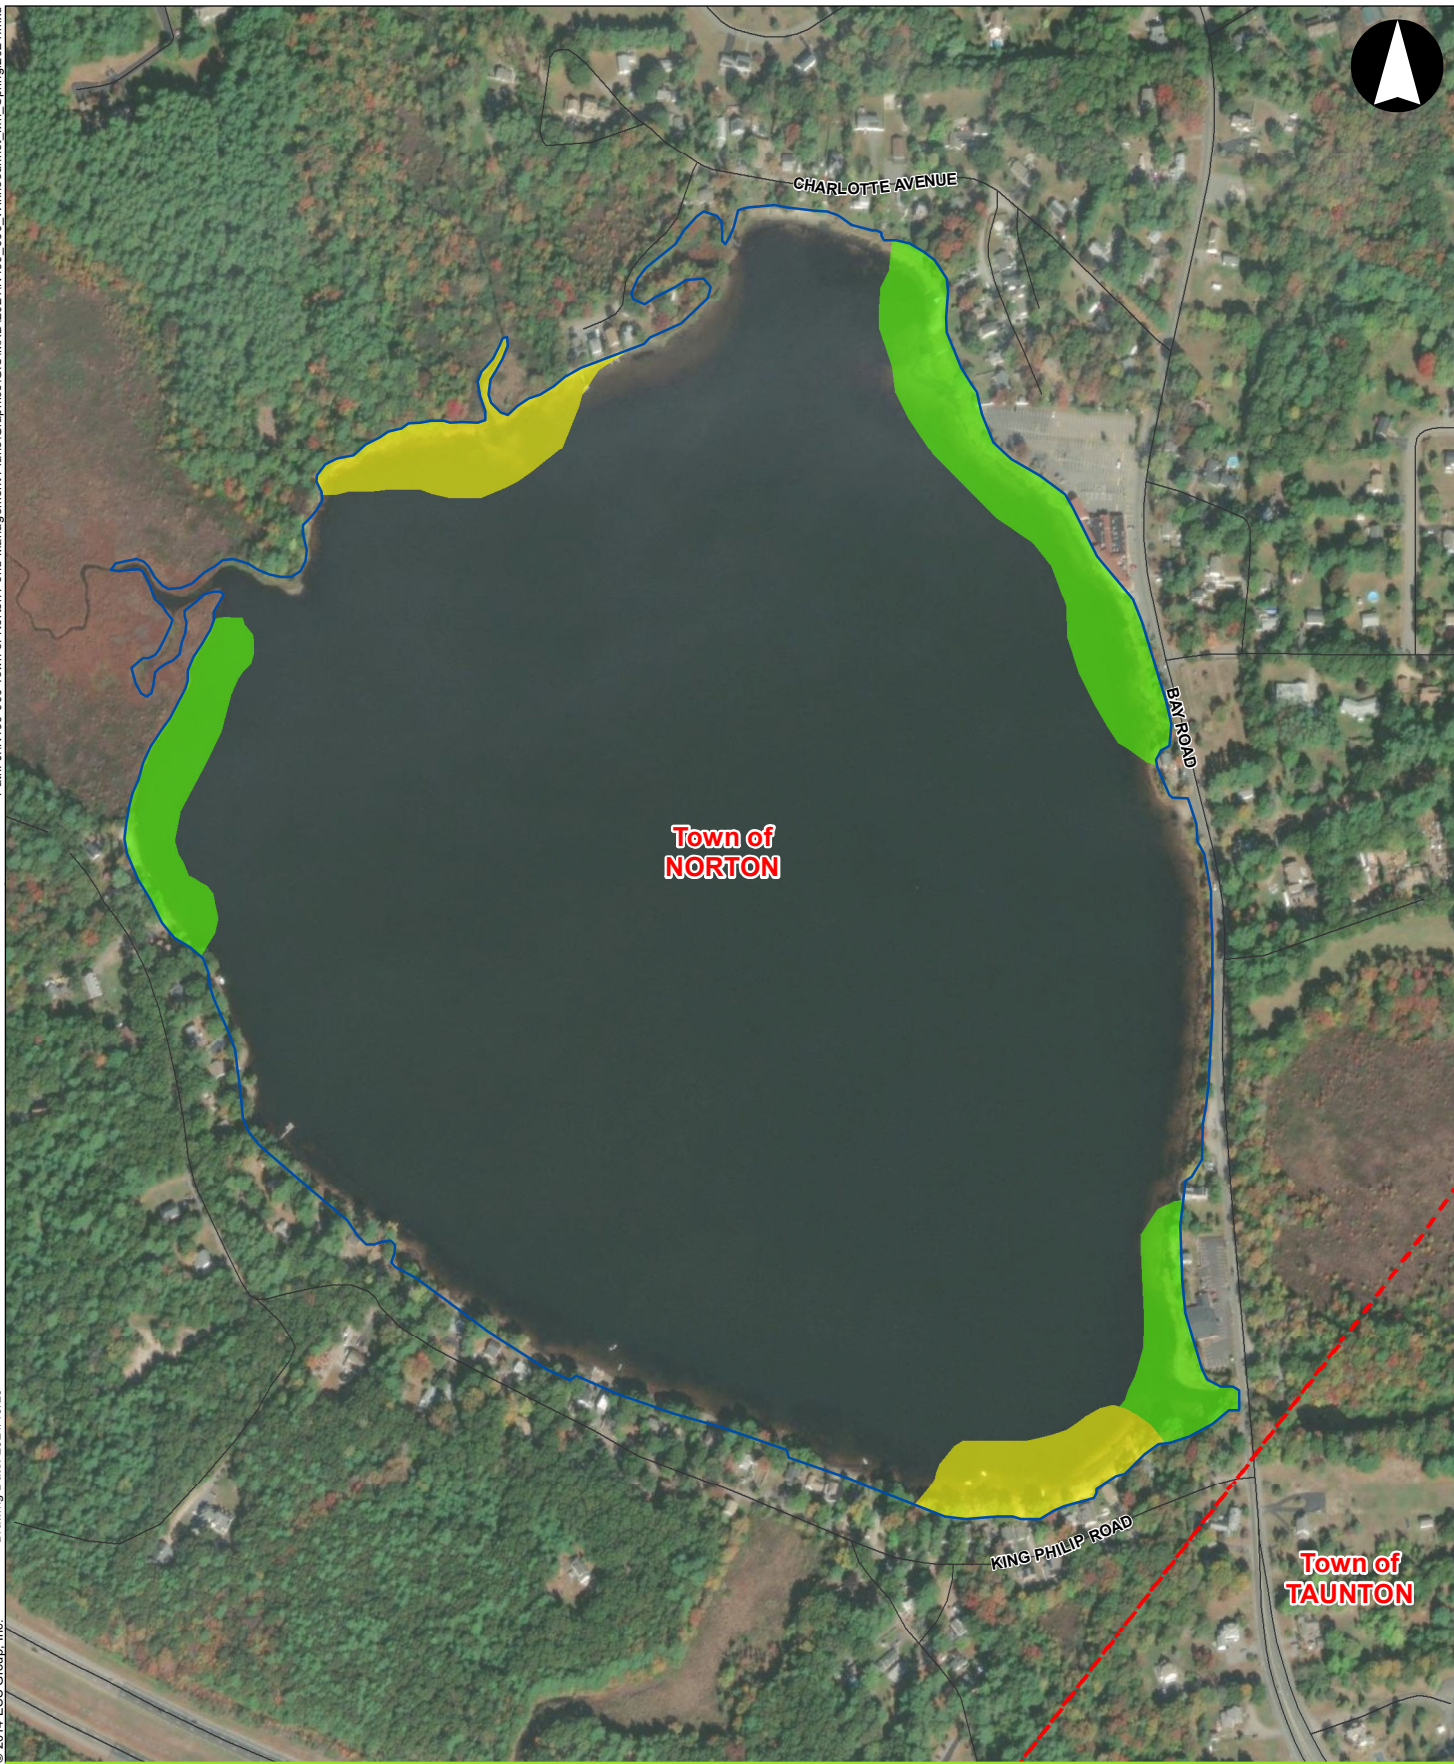
**Figure 1**

The 2021 early season survey at Winnecunnet Pond documented only variable-leaf milfoil (*Myriophyllum heterophyllum*) in Winnecunnet Pond. Regrowth of this target species in the year following a Sonar (fluridone) treatment year was considered undesirable. However, it was not entirely unexpected, as some limited regrowth of this species has occurred in prior years following treatment.

- Sparse (10.3 Acres)
- Patchy (5.3 Acres)

**Early Season Variable-Leaf Milfoil Cover**  
**Lake Winnecunnet**  
**June 2, 2021**

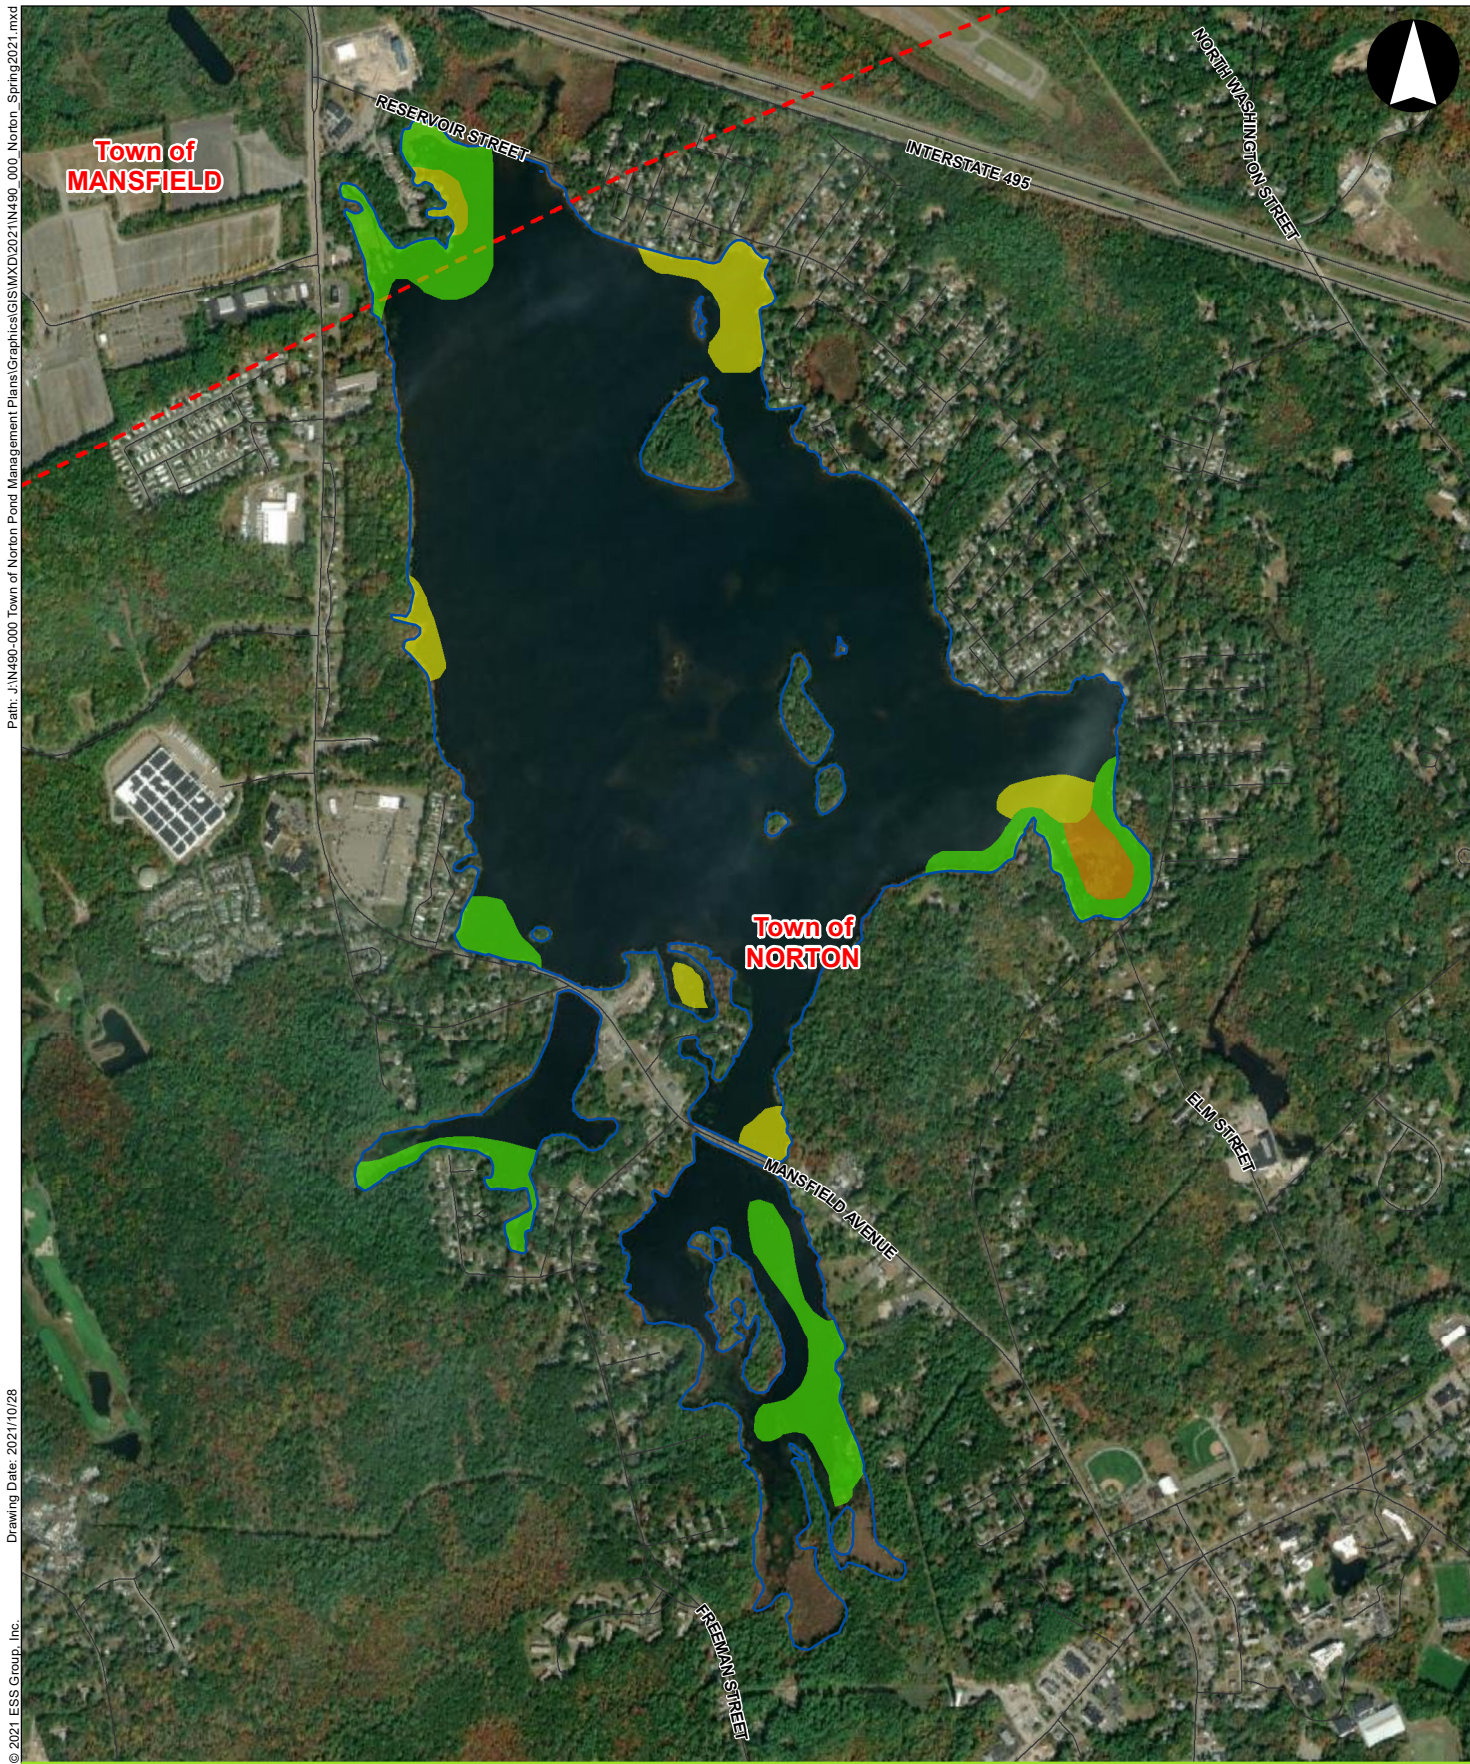
**Figure 2**

- Fanwort covered approximately 81 acres, primarily consisting of sparse beds (Figure 2). This represents an **increase** of 53 acres compared to the pre-treatment survey in 2020. However, most beds were sparse to patchy with only one area of dense growth.

**Pre-Treatment Fanwort Cover**  
**Norton Reservoir**  
**May 26-27, 2021**

- Sparse (53.4 Acres)
- Patchy (22.7 Acres)
- Dense (4.9 Acres)
- Lake Shoreline
- Town Boundary

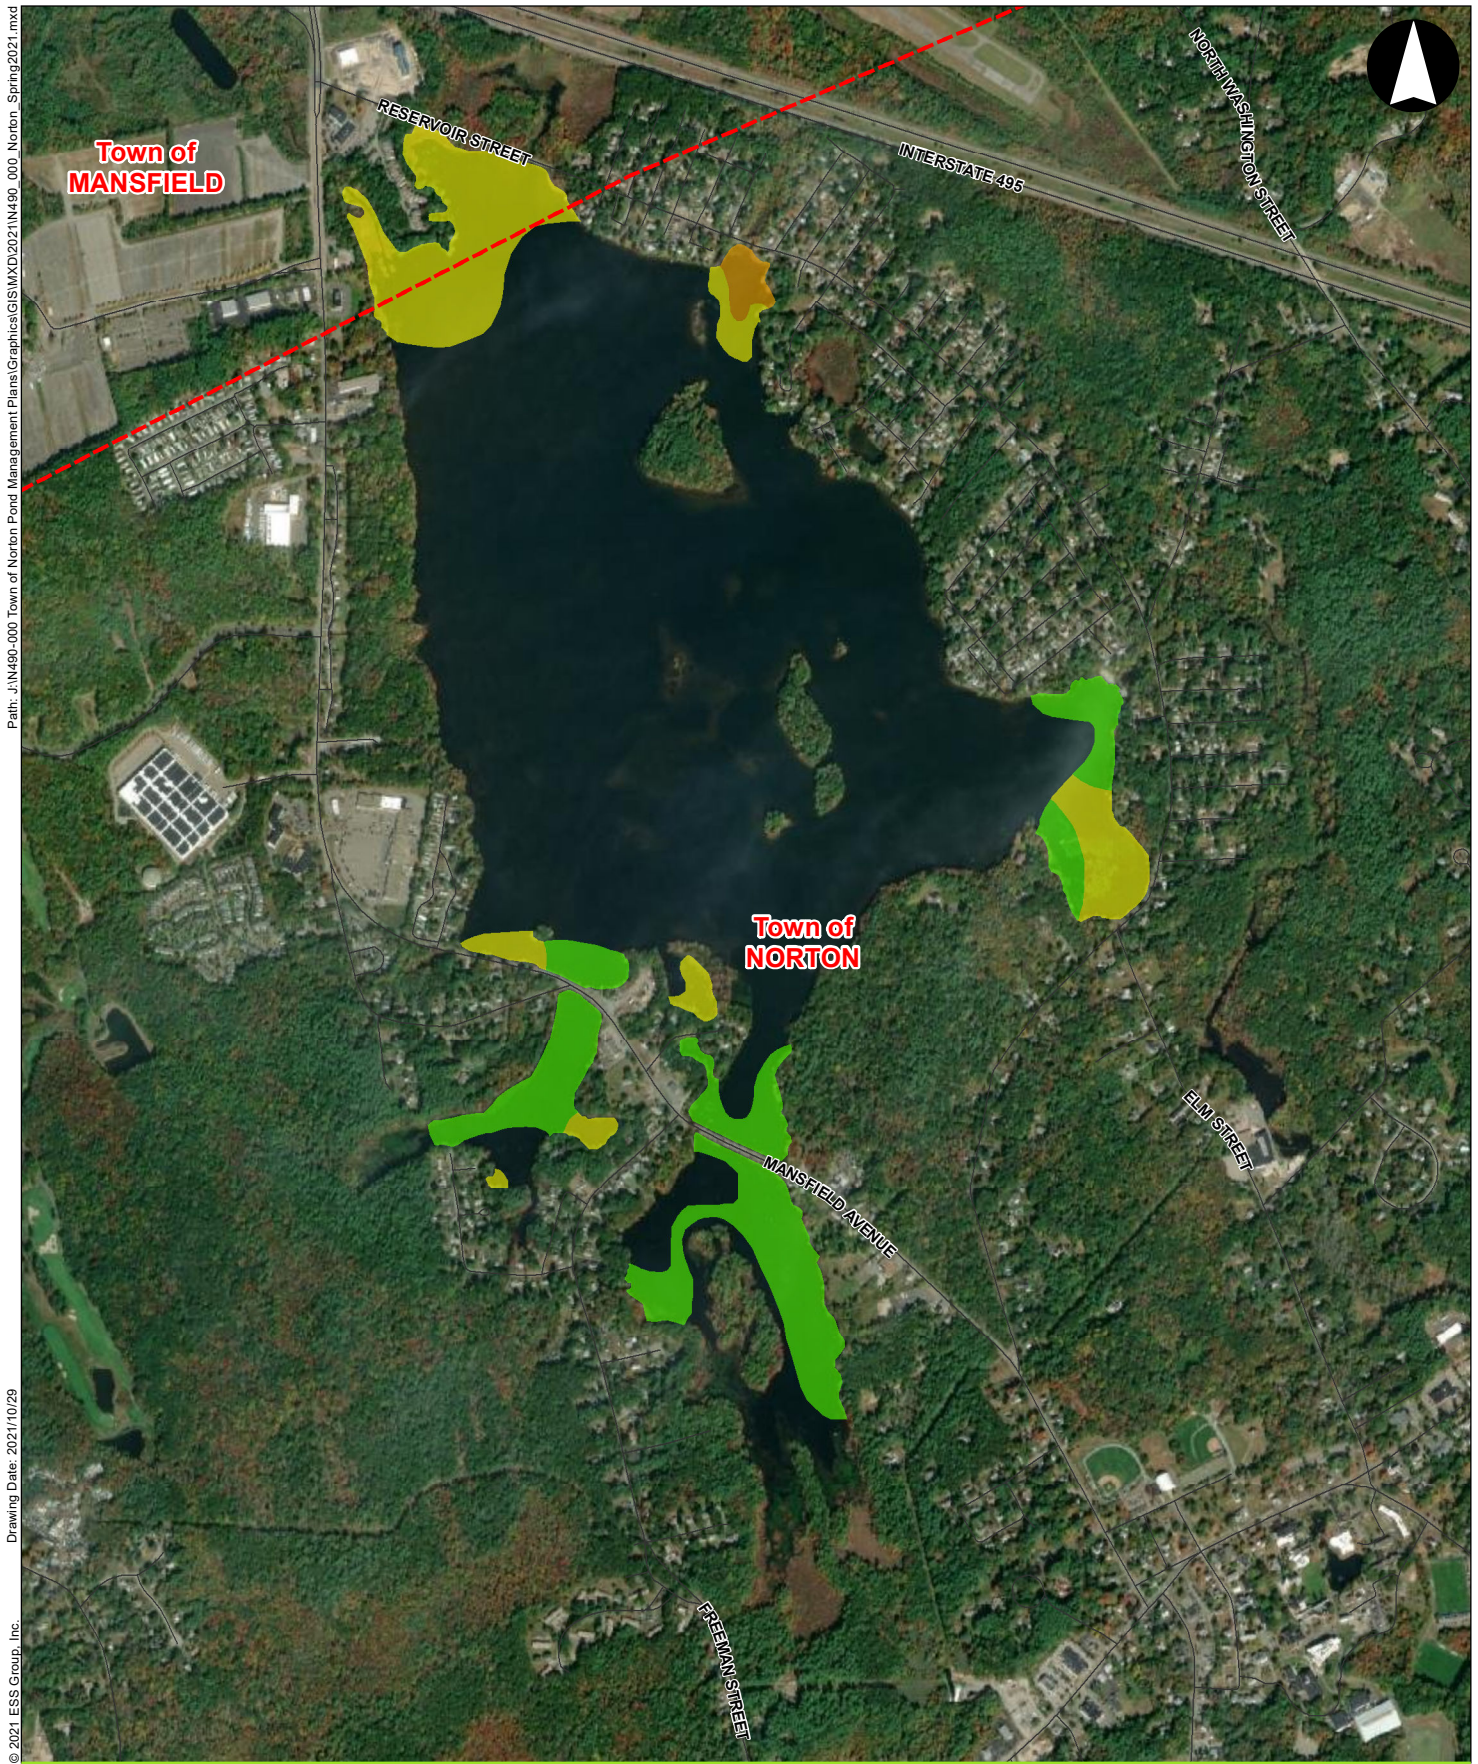
**Figure 3**

- Variable-leaf milfoil covered an estimated total of 111 acres, primarily consisting of sparse to patchy beds (Figure 3). This represents an **increase** of approximately 3 acres from 2020 pre-treatment conditions. However, most beds were sparse to patchy with only one area of dense growth.

- Sparse (55.6 Acres)
- Patchy (51.9 Acres)
- Dense (3.3 Acres)

**Pre-Treatment Variable-Leaf Milfoil Cover**  
**Norton Reservoir**  
**May 26-27, 2021**

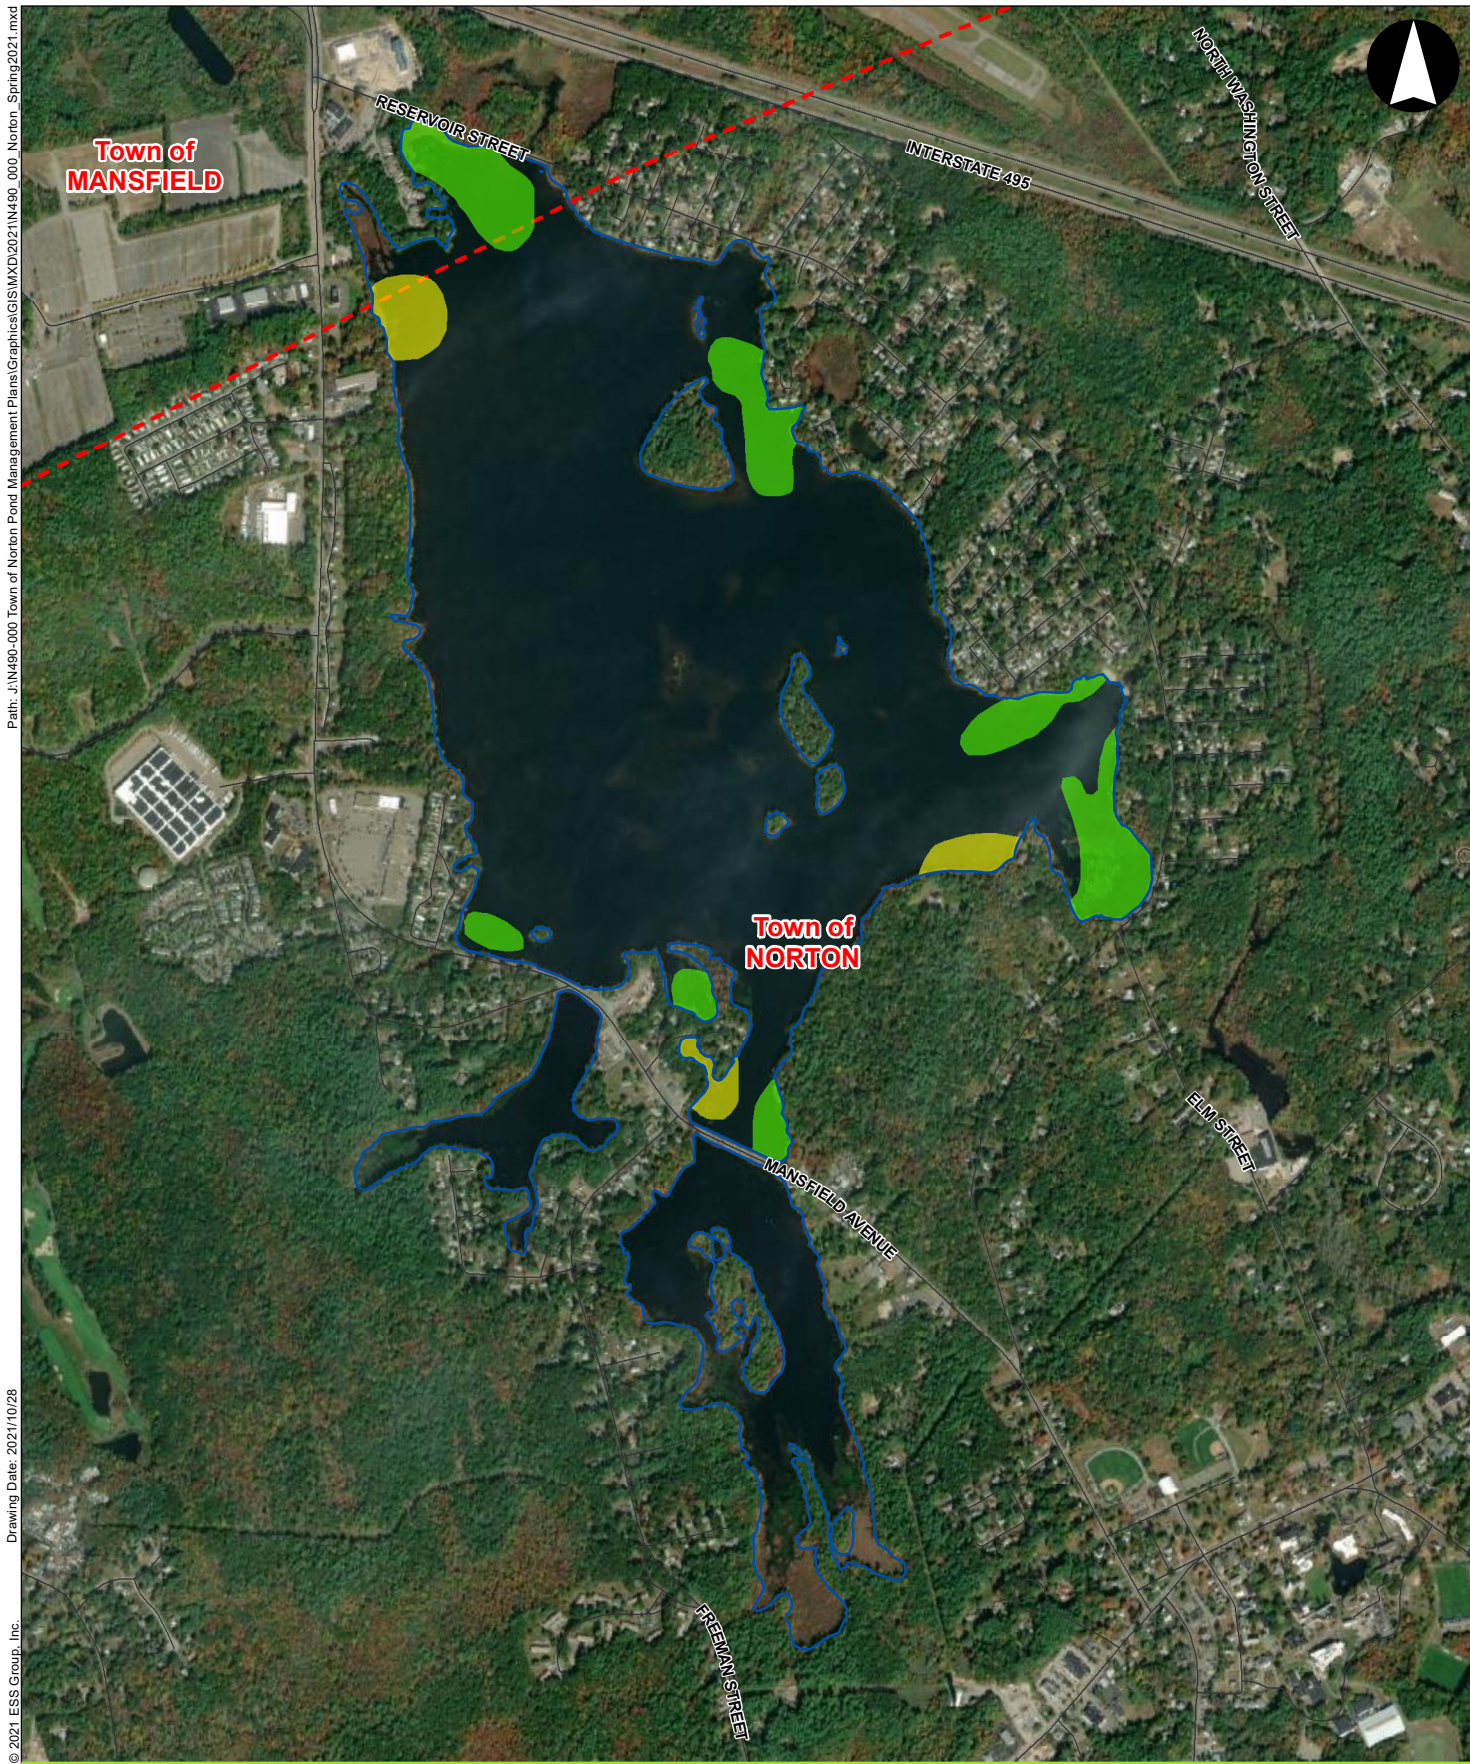
Figure 4

- Curly-leaf pondweed was documented in 58 acres with sparse to patchy beds located mainly in protected coves (Figure 4). Compared to 2020, the total acreage covered was **similar**, even though the distribution of the beds shifted. However, the density of curly-leaf pondweed beds was lower in most of the areas where it was found. Curly-leaf pondweed is an annual species and completes its life cycle by late June or early July in most years. Therefore, it is usually only impacted by management actions that are implemented by May. Additionally, this species reproduces by hardy winter buds (turions), which accumulate at the bottom of the reservoir, forming a sort of “seed bank” that may regenerate plants the following year.

**Pre-Treatment Curly-Leaf Pondweed Cover**  
Norton Reservoir  
May 26-27, 2021

- Sparse (44.5 Acres)
- Patchy (13.1 Acres)

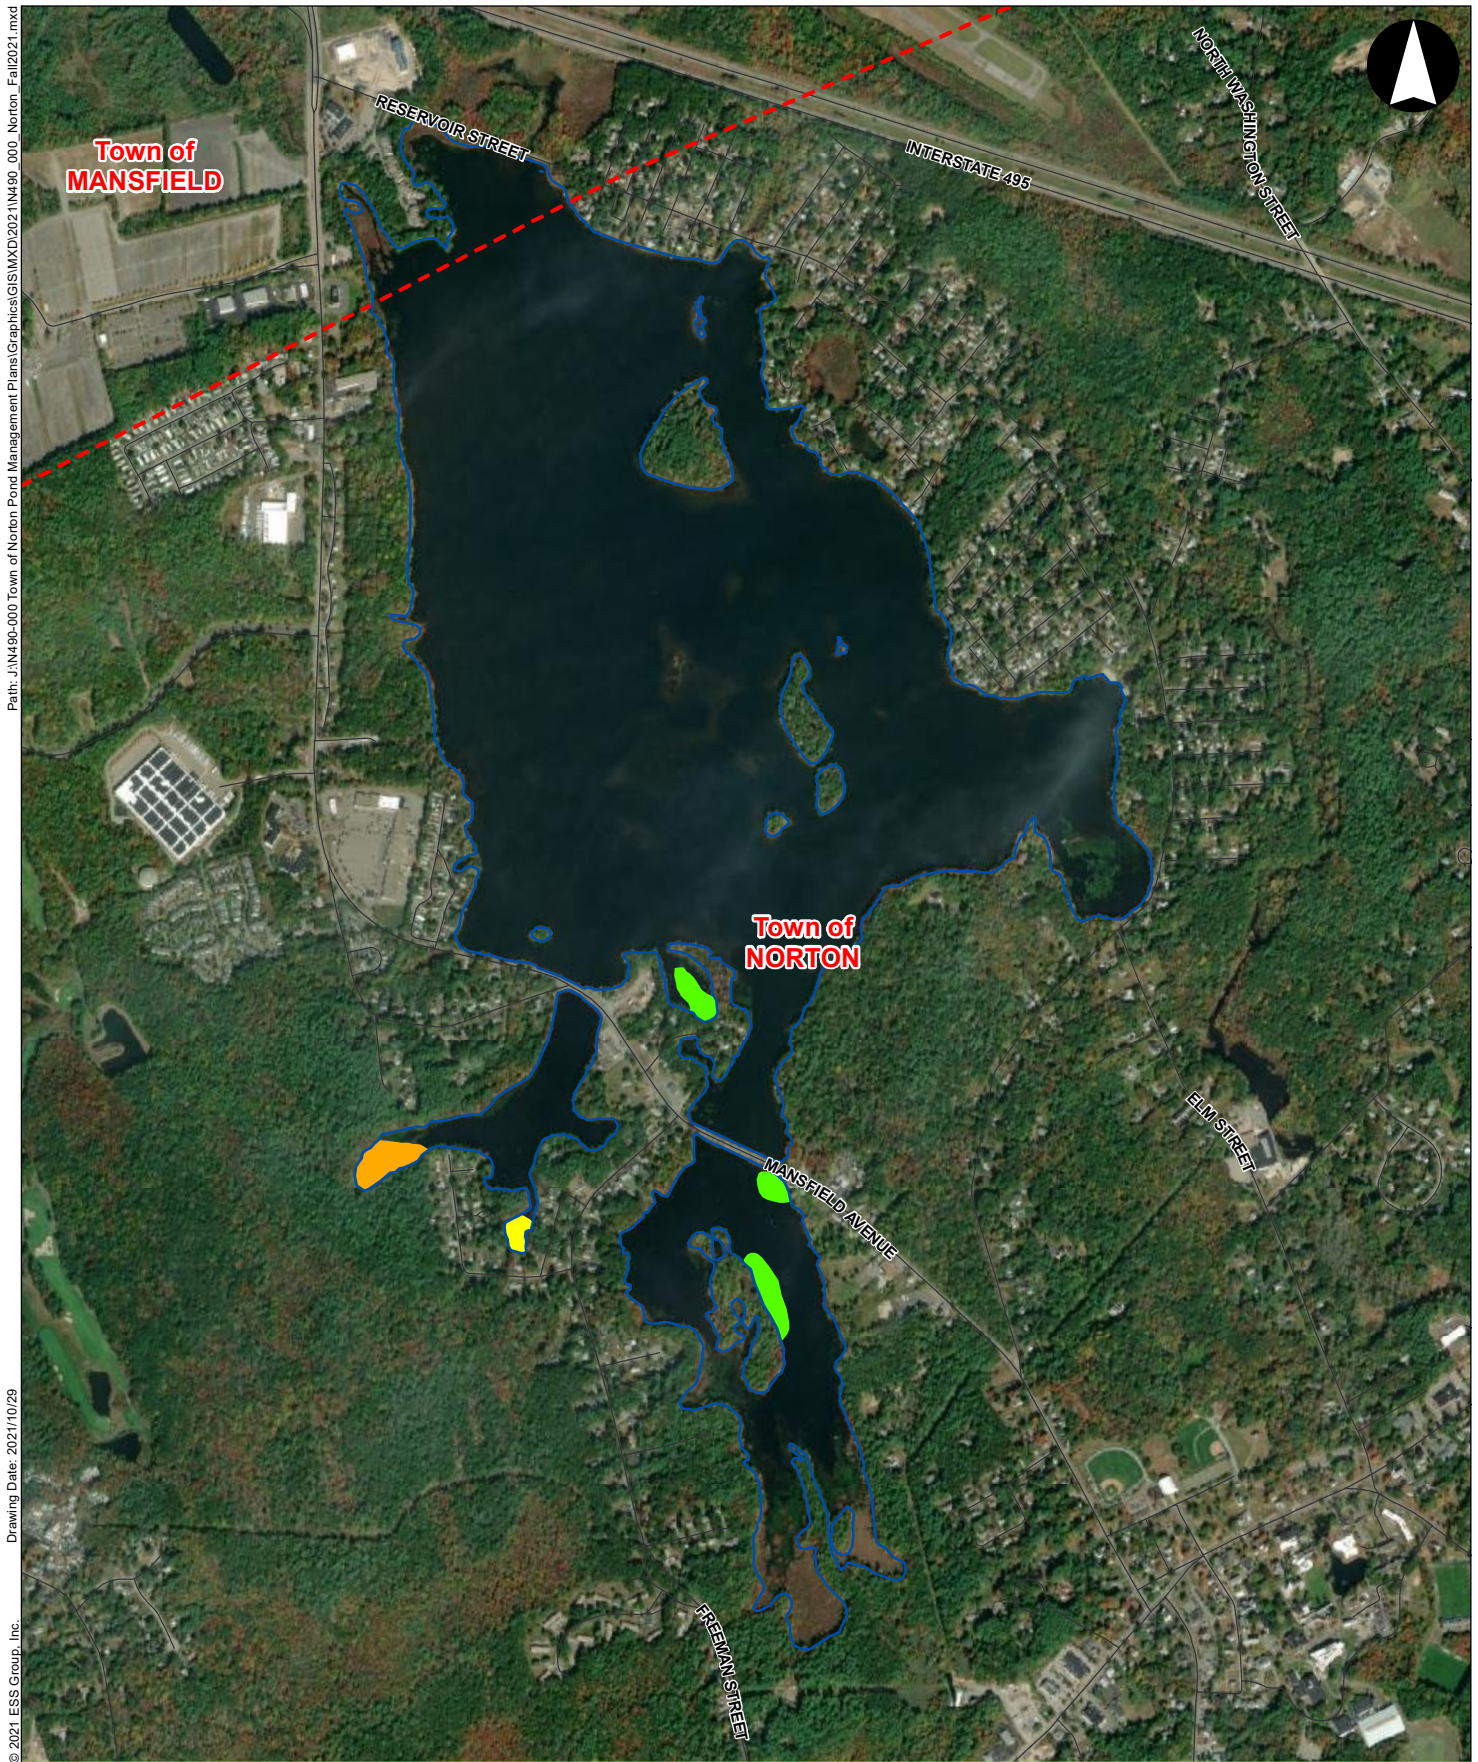
**Figure 5**

- Water chestnut was found in one bed in the main basin and several additional beds in the sub-basins south of Route 140 (Figure 5). Total water chestnut coverage observed was approximately 7 acres, which represents an **increase** of almost 5 acres from the pre-treatment survey in 2020. However, most of this growth consisted of very sparse beds. Therefore, actual conditions had not degraded as much as suggested by the total acreage.

**Pre-Treatment Water Chestnut Cover**  
**Norton Reservoir**  
May 26-27, 2021

- Sparse (4.5 Acres)
- Patchy (1.0 Acres)
- Dense (2.5 Acres)
- Lake Shoreline
- Town Boundary

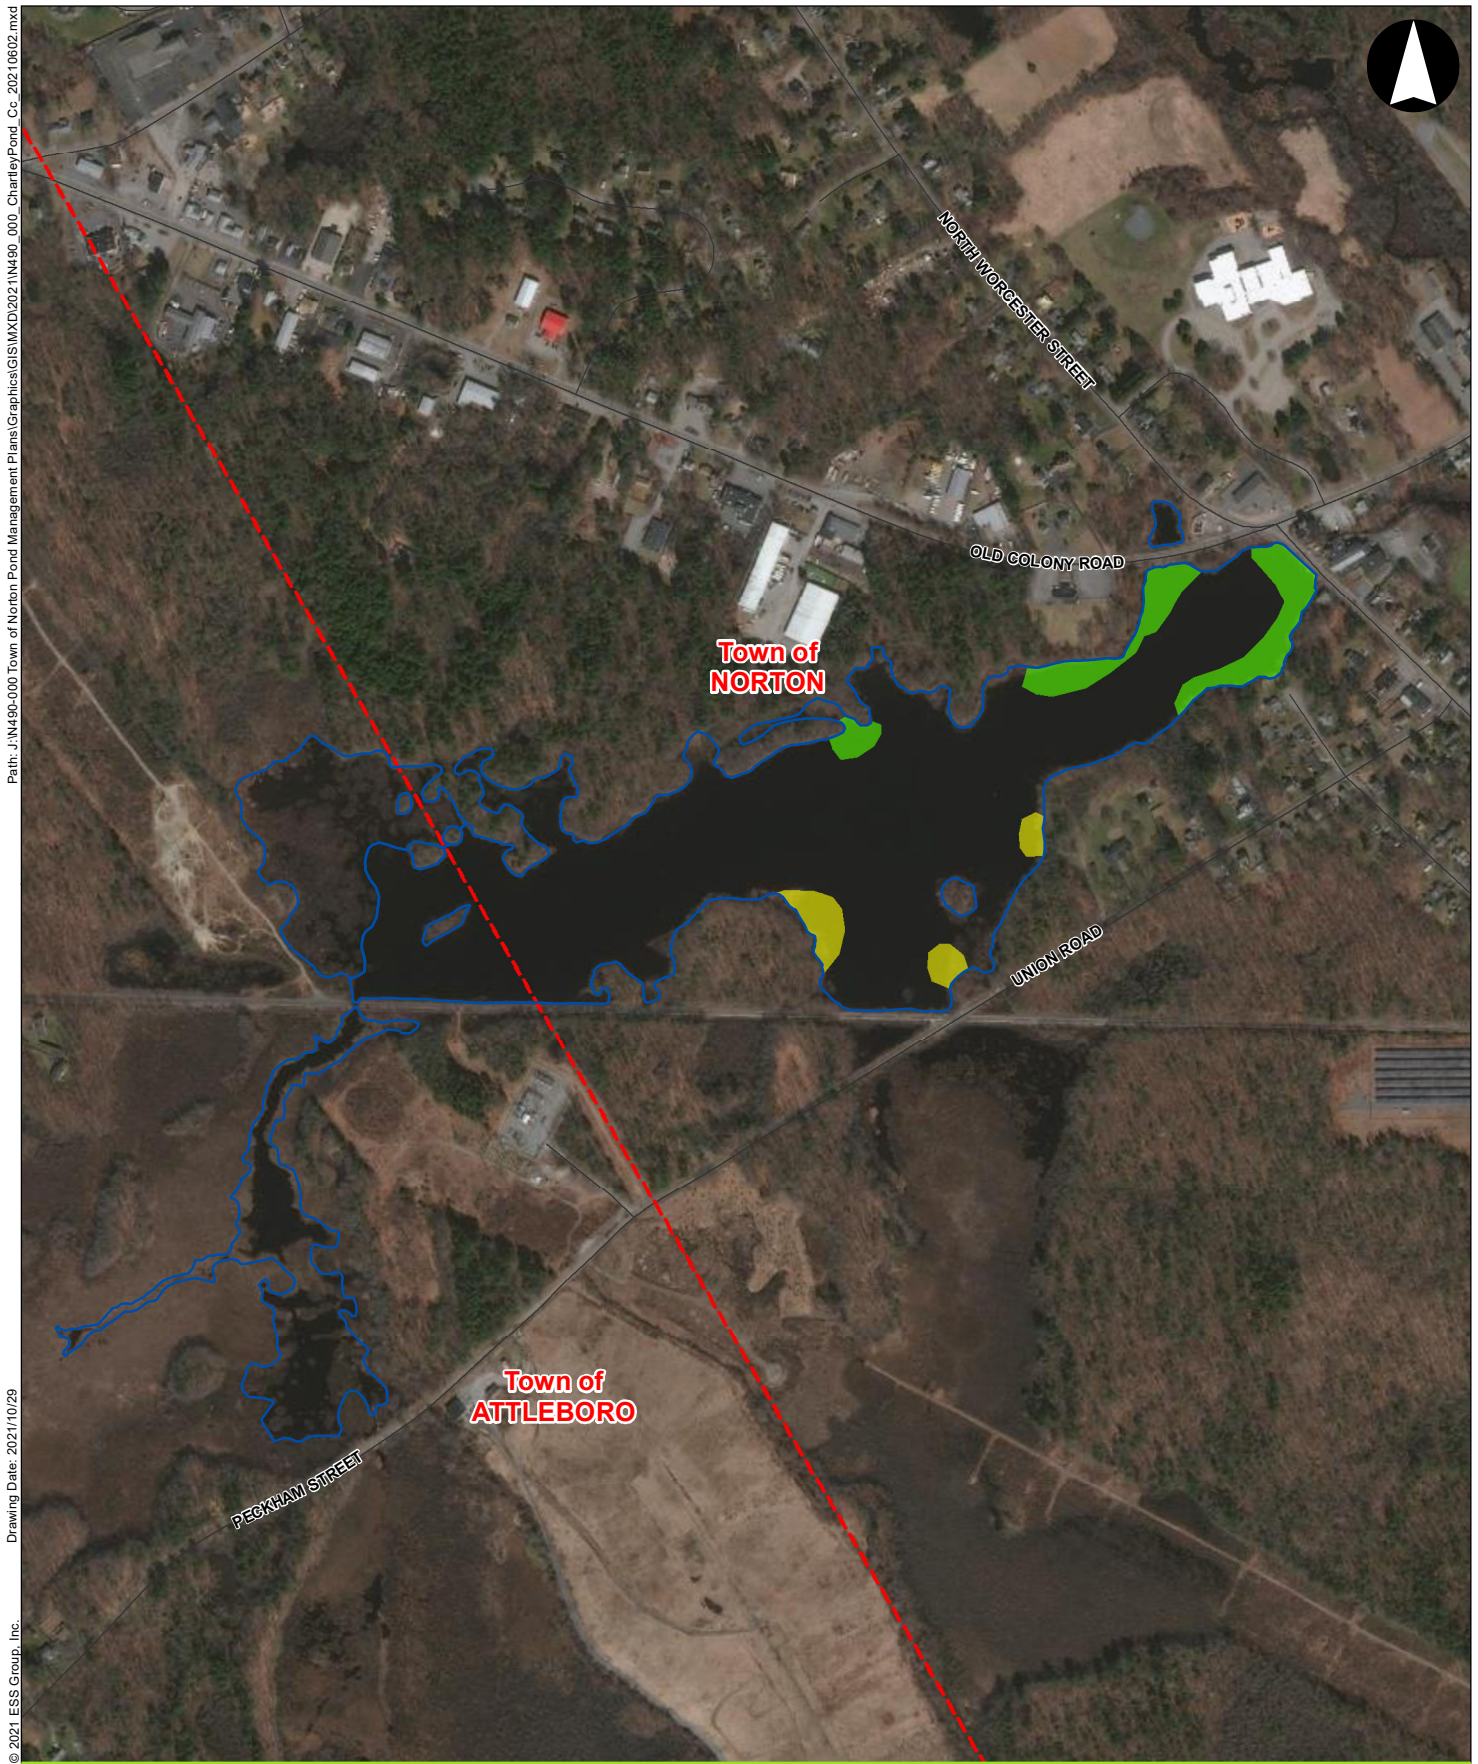
**Figure 6**

**Pre-Treatment Fanwort Cover**  
**Chartley Pond**  
**May 18, 2021**

- Sparse (3.5 acres)
- Patchy (1.4 acres)
- Dense (0 acres)
- Town Boundary

- Fanwort covered approximately 5 acres of the pond during the 2021 pre-treatment survey (Figure 6). This represents an **increase** of close to 2 acres from early-season growth in 2020.
- Variable-leaf milfoil was documented as sparse to dense beds covering approximately 13 acres of the pond (Figure 7), an **increase** of 7 acres over the 2020 pre-treatment area.
- Water chestnut covered approximately 3 acres of the pond (Figure 8). This represents a **decrease** in of 3 acres growth from pre-treatment conditions in 2020. Additionally, all beds consisted of sparse growth.

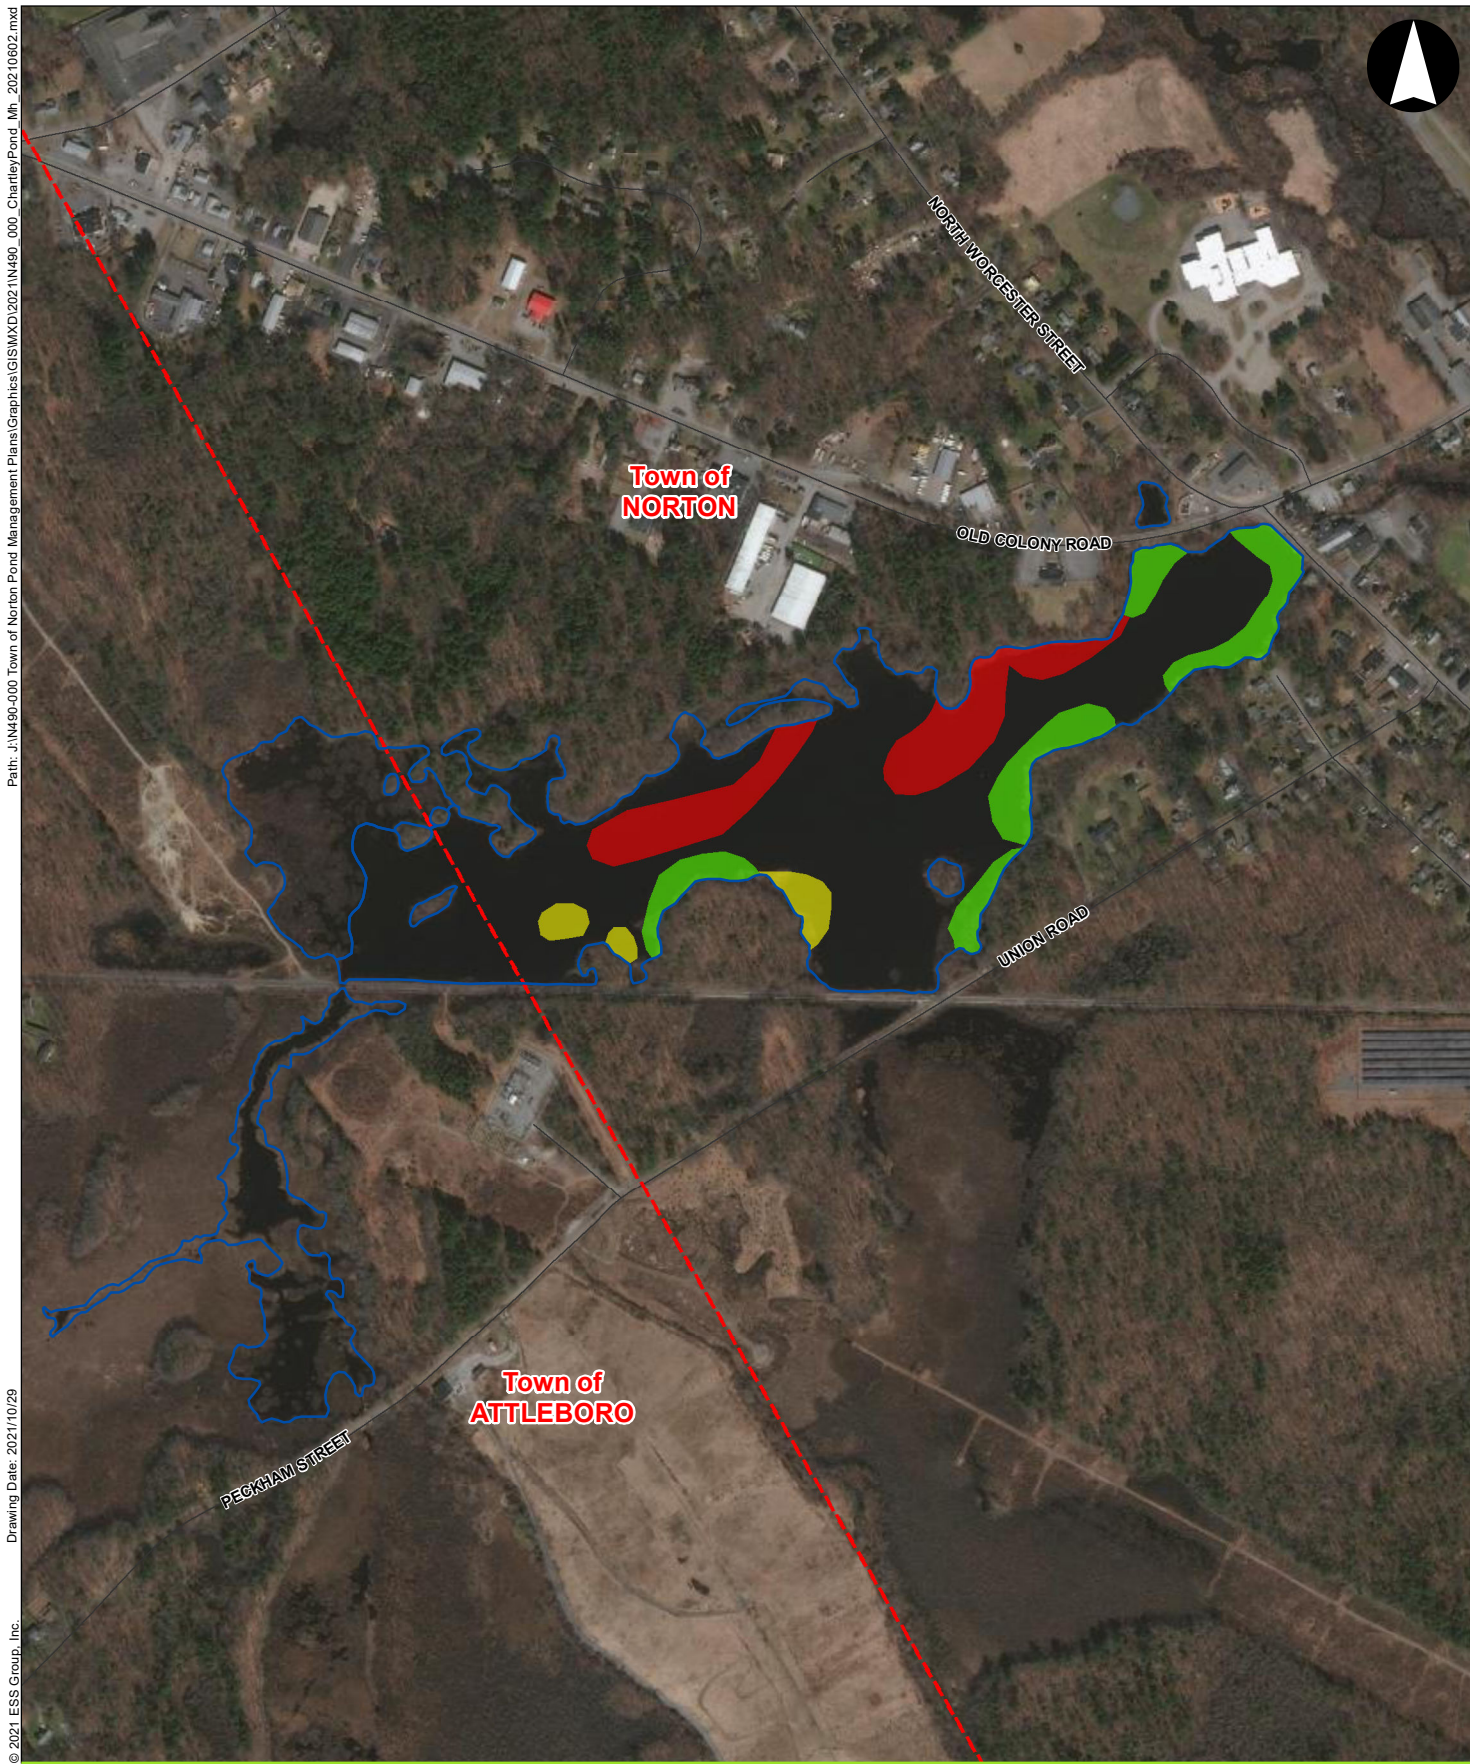
**Figure 7**

**Pre-Treatment Variable-leaf Milfoil Cover**  
 Chartley Pond  
 May 18, 2021

- Sparse (5.7 acres)
- Patchy (1.4 acres)
- Dense (6.0 acres)
- Town Boundary

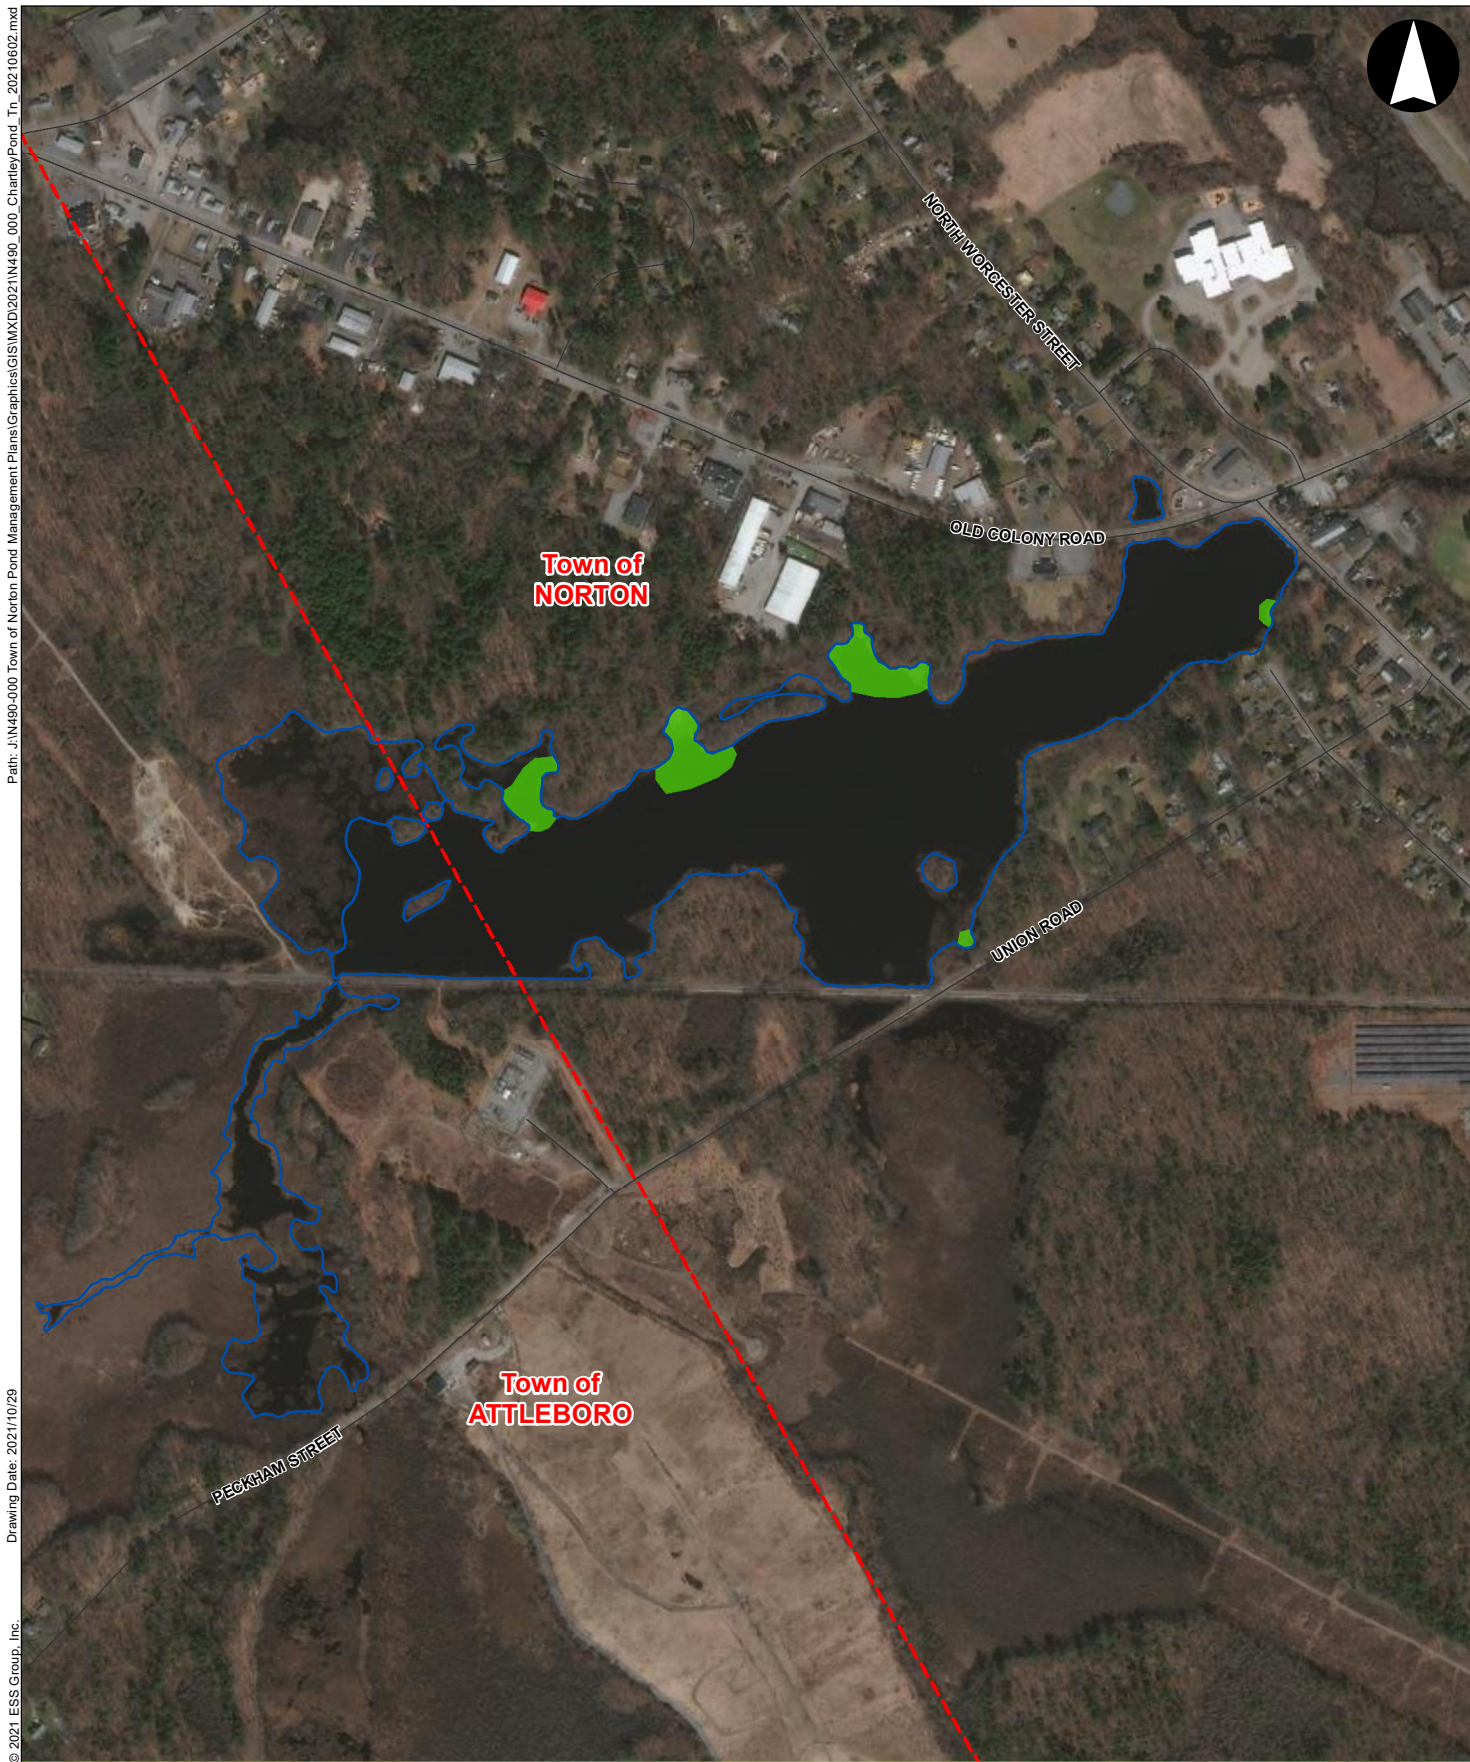
**Figure 8**

**Pre-Treatment Water Chestnut Cover**  
**Chartley Pond**  
May 18, 2021

- Sparse (2.9 acres)
- Patchy (0 acres)
- Dense (0 acres)
- Town Boundary

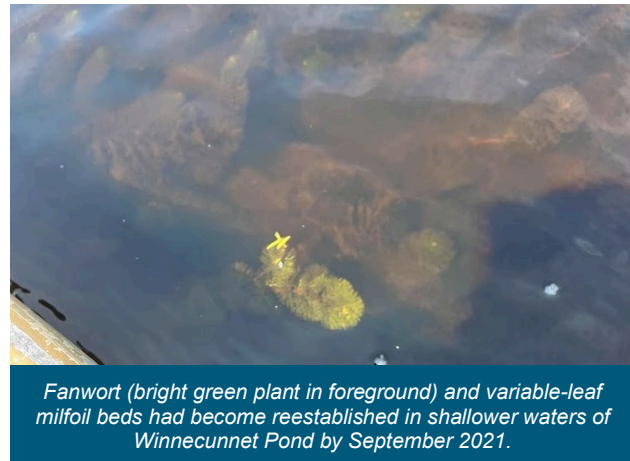
- Fanwort covered an estimated total of 3 acres (Figure 9), an **increase** from post-treatment conditions in 2020, when it was not observed. The beds were patchy and located along the northwestern shoreline.
- Variable-leaf milfoil covered an estimated total of 42 acres (Figure 10), an **increase** from post-treatment conditions 2020, when it was not observed. The beds were dense near the shoreline, forming a ring of growth around most of the pond with some incursions of sparse or patchy growth into deeper waters, as well.
