# 2021 Lakes and Ponds Annual Report

Norton, Massachusetts

Project No. N490-000.18  
October 29, 2021

**Town of Norton Vegetation Management**  
Norton, Massachusetts

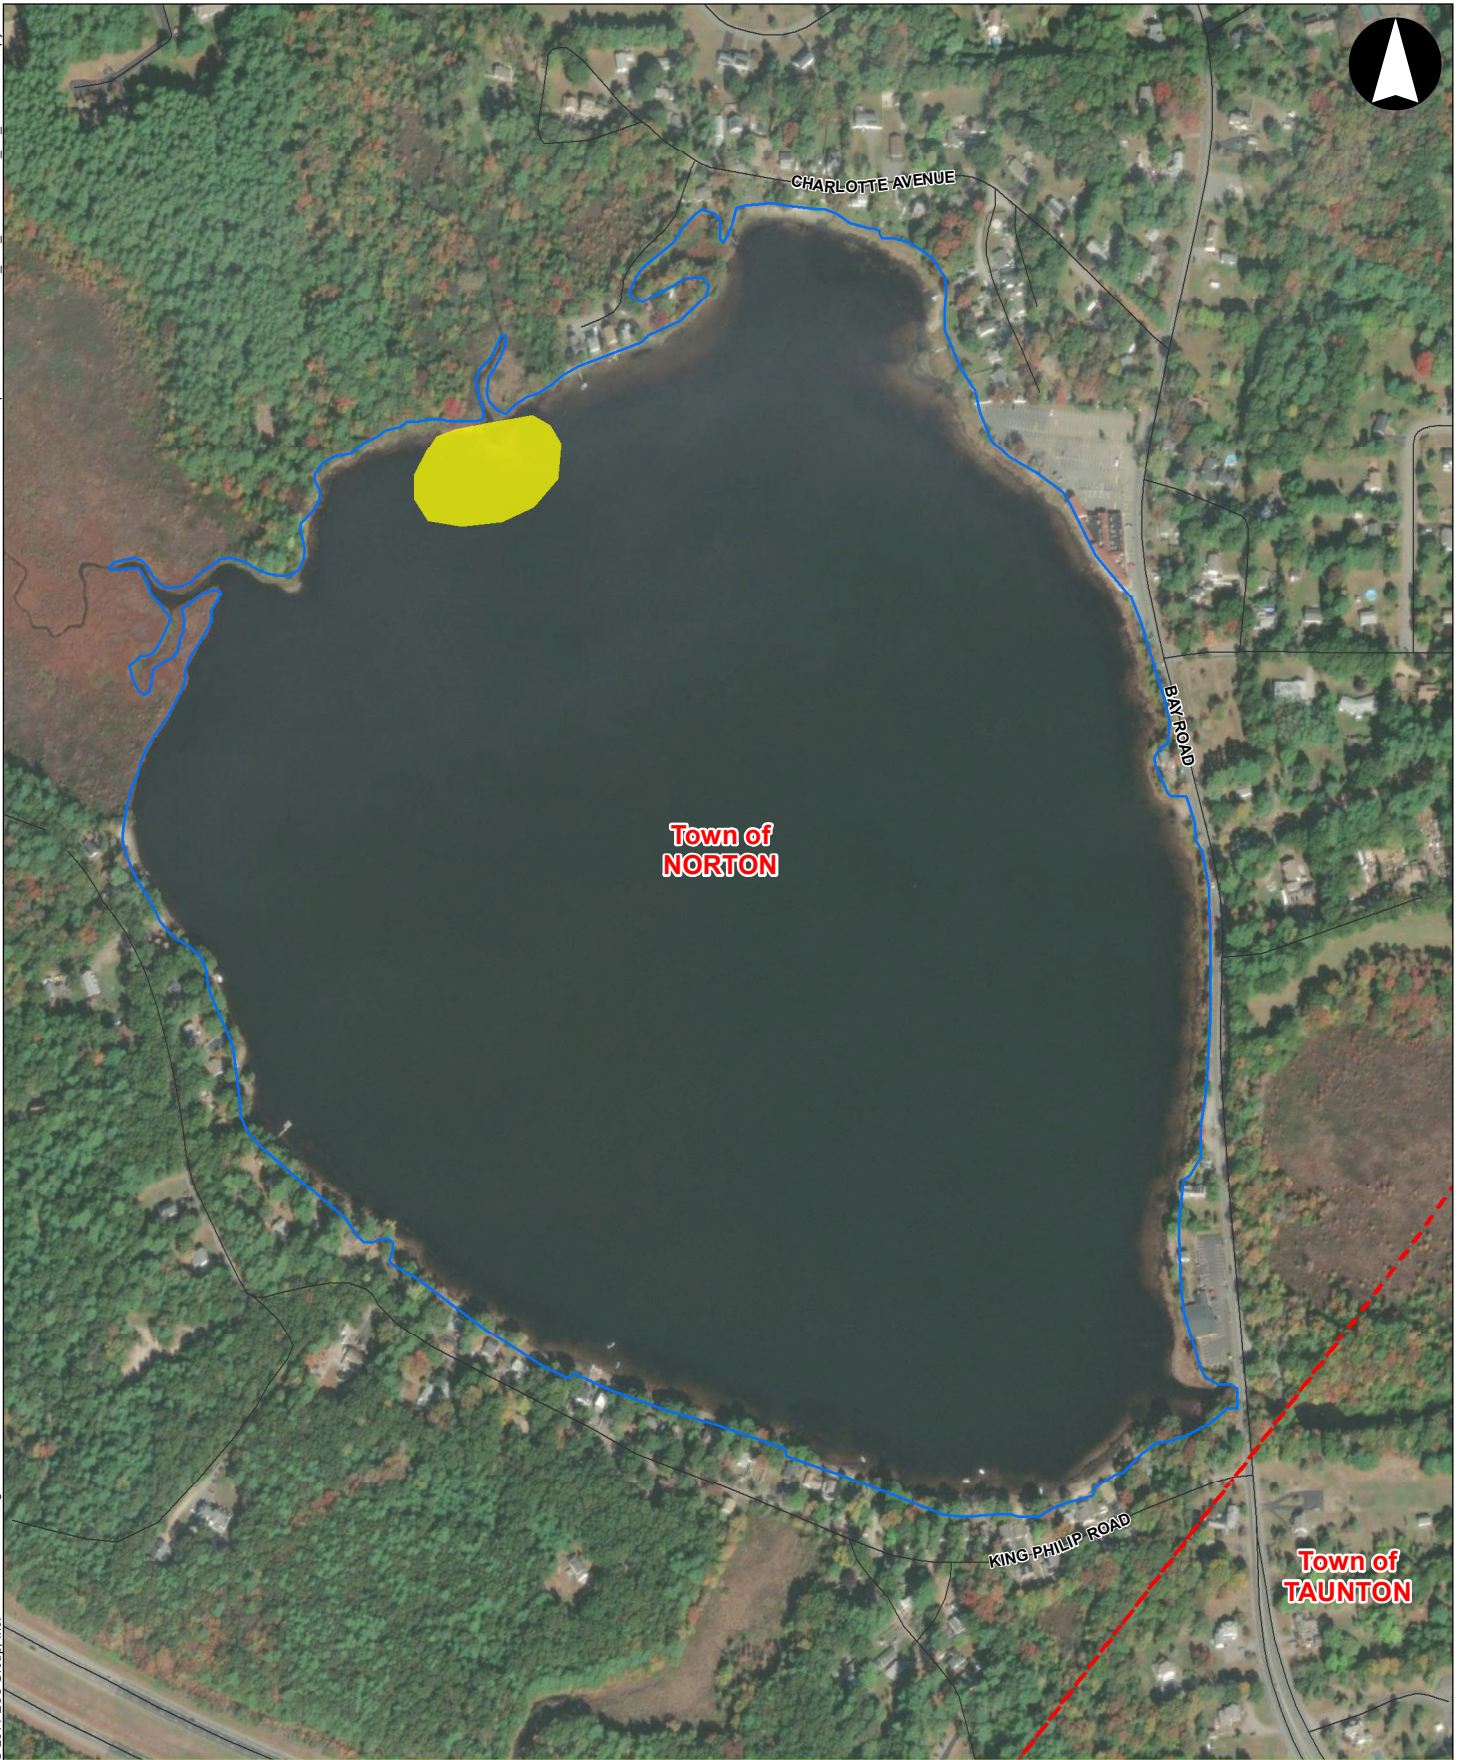
**Figure 9**

- Fanwort covered an estimated total of 3 acres (Figure 9), an **increase** from post-treatment conditions in 2020, when it was not observed. The beds were patchy and located along the northwestern shoreline.
- Variable-leaf milfoil covered an estimated total of 42 acres (Figure 10), an **increase** from post-treatment conditions 2020, when it was not observed. The beds were dense near the shoreline, forming a ring of growth around most of the pond with some incursions of sparse or patchy growth into deeper waters, as well.

**Late Season Fanwort Cover**  
**Lake Winnecunnet**  
**September 14, 2021**

- Patchy (3 acres)
- Town Boundary

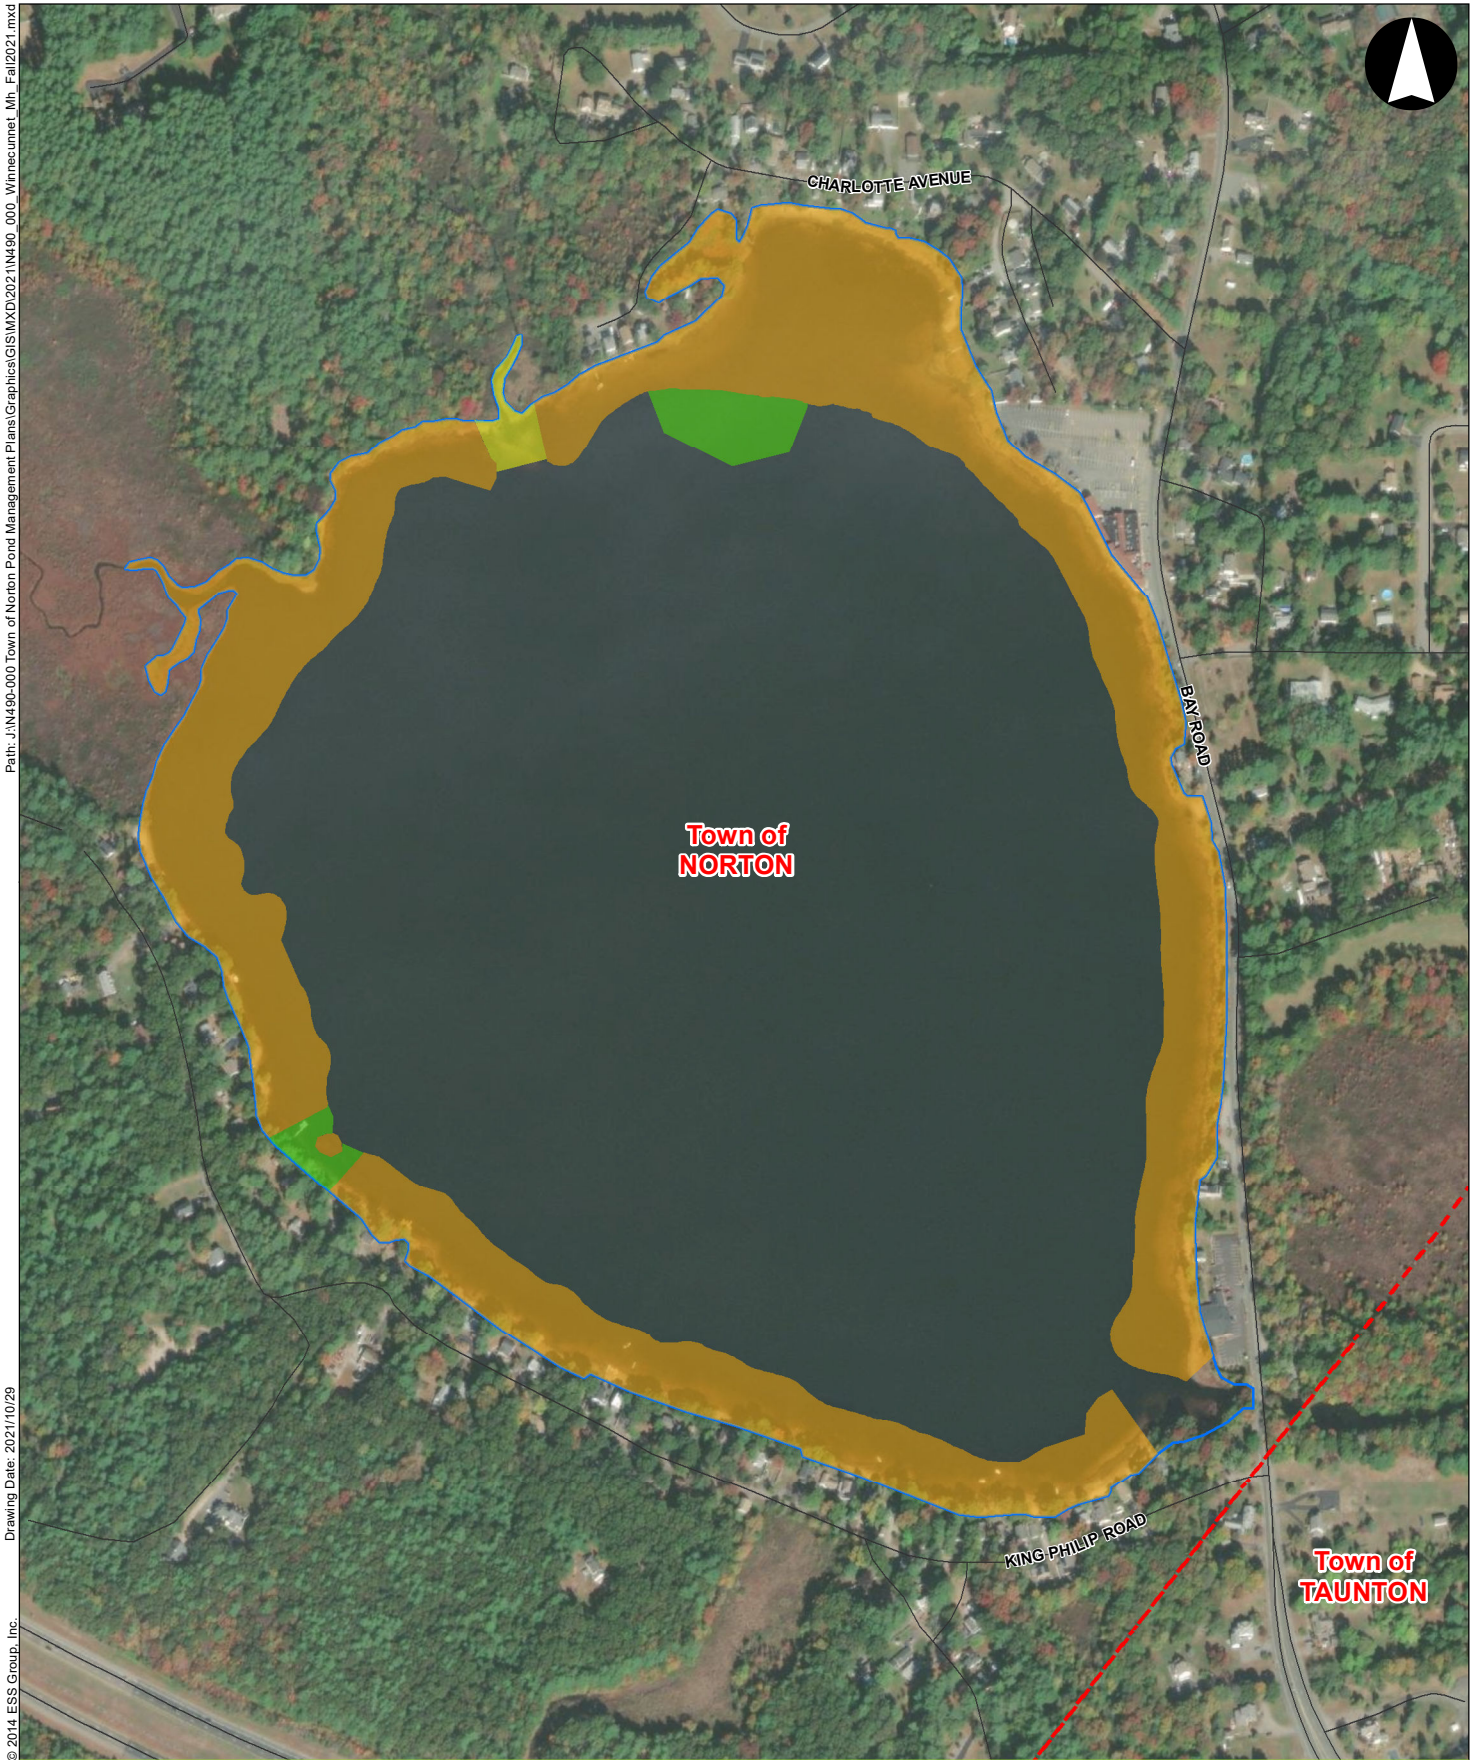
**Figure 10**

**Late Season Variable-Leaf Milfoil Cover**  
Lake Winnecunnet  
September 14, 2021

- Sparse (1.8 acres)
- Patchy (0.6 acres)
- Dense (39.1 acres)
- Town Boundary

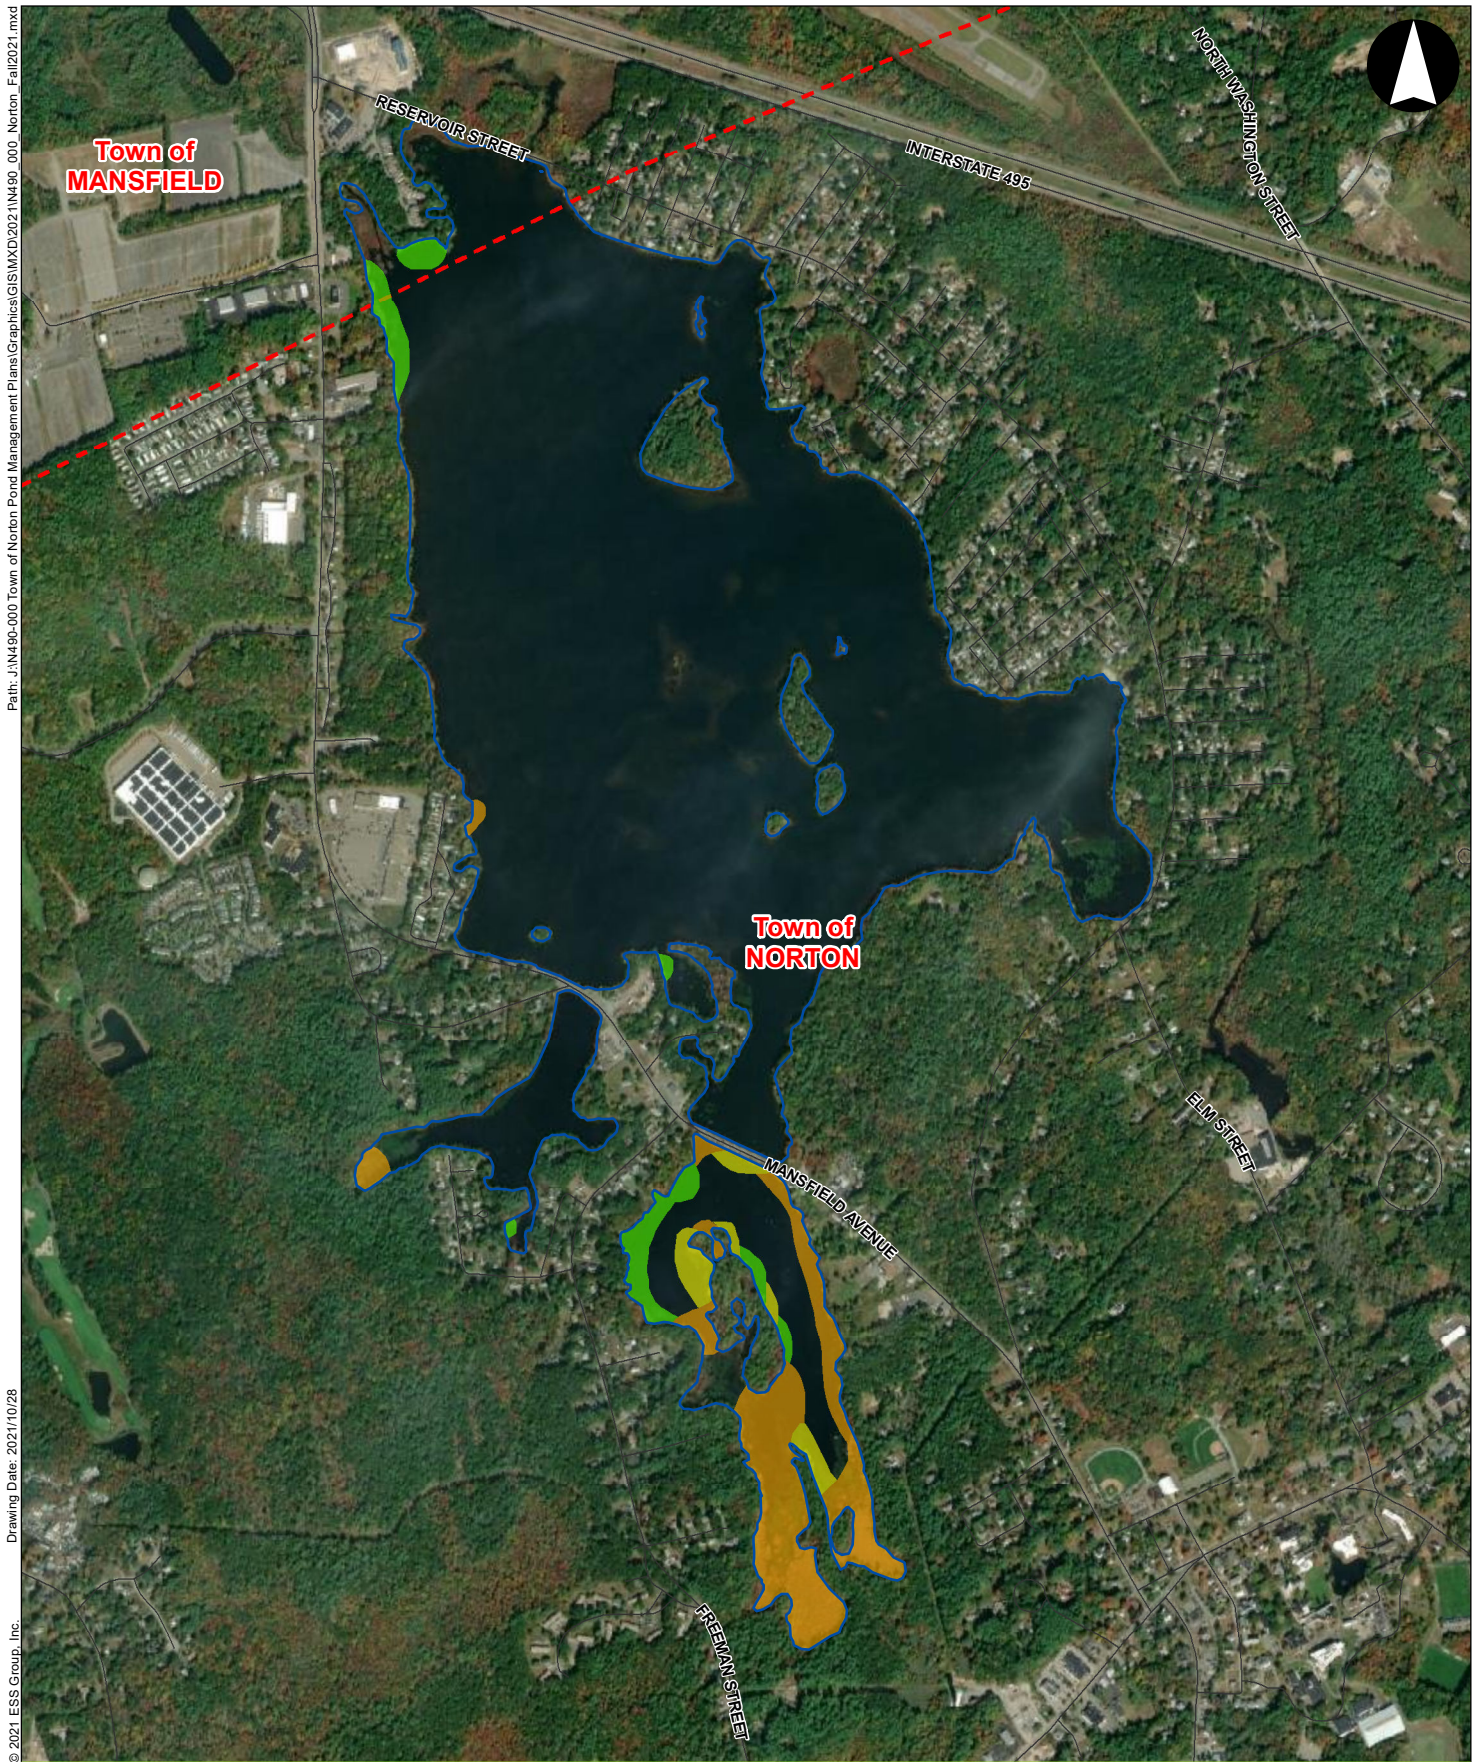
**Figure 11**

- Fanwort covered an estimated total of 51 acres (Figure 11), a **decrease of approximately 30 acres from pre-treatment conditions and a year-over-year decrease of 3 acres**. The beds located in the main basin of the reservoir were substantially reduced compared to recent years, confined to just a few small and mostly sparse beds. The only portion of Norton Reservoir that experienced an increase in fanwort growth was the southernmost sub-basin to the south of Route 140. However, fanwort growth in this basin was mainly confined to shallower waters.

**Post-Treatment Fanwort Cover**  
**Norton Reservoir**  
**September 21, 2021**

- Sparse (11.3 Acres)
- Patchy (5.7 Acres)
- Dense (33.5 Acres)
- Lake Shoreline
- Town Boundary

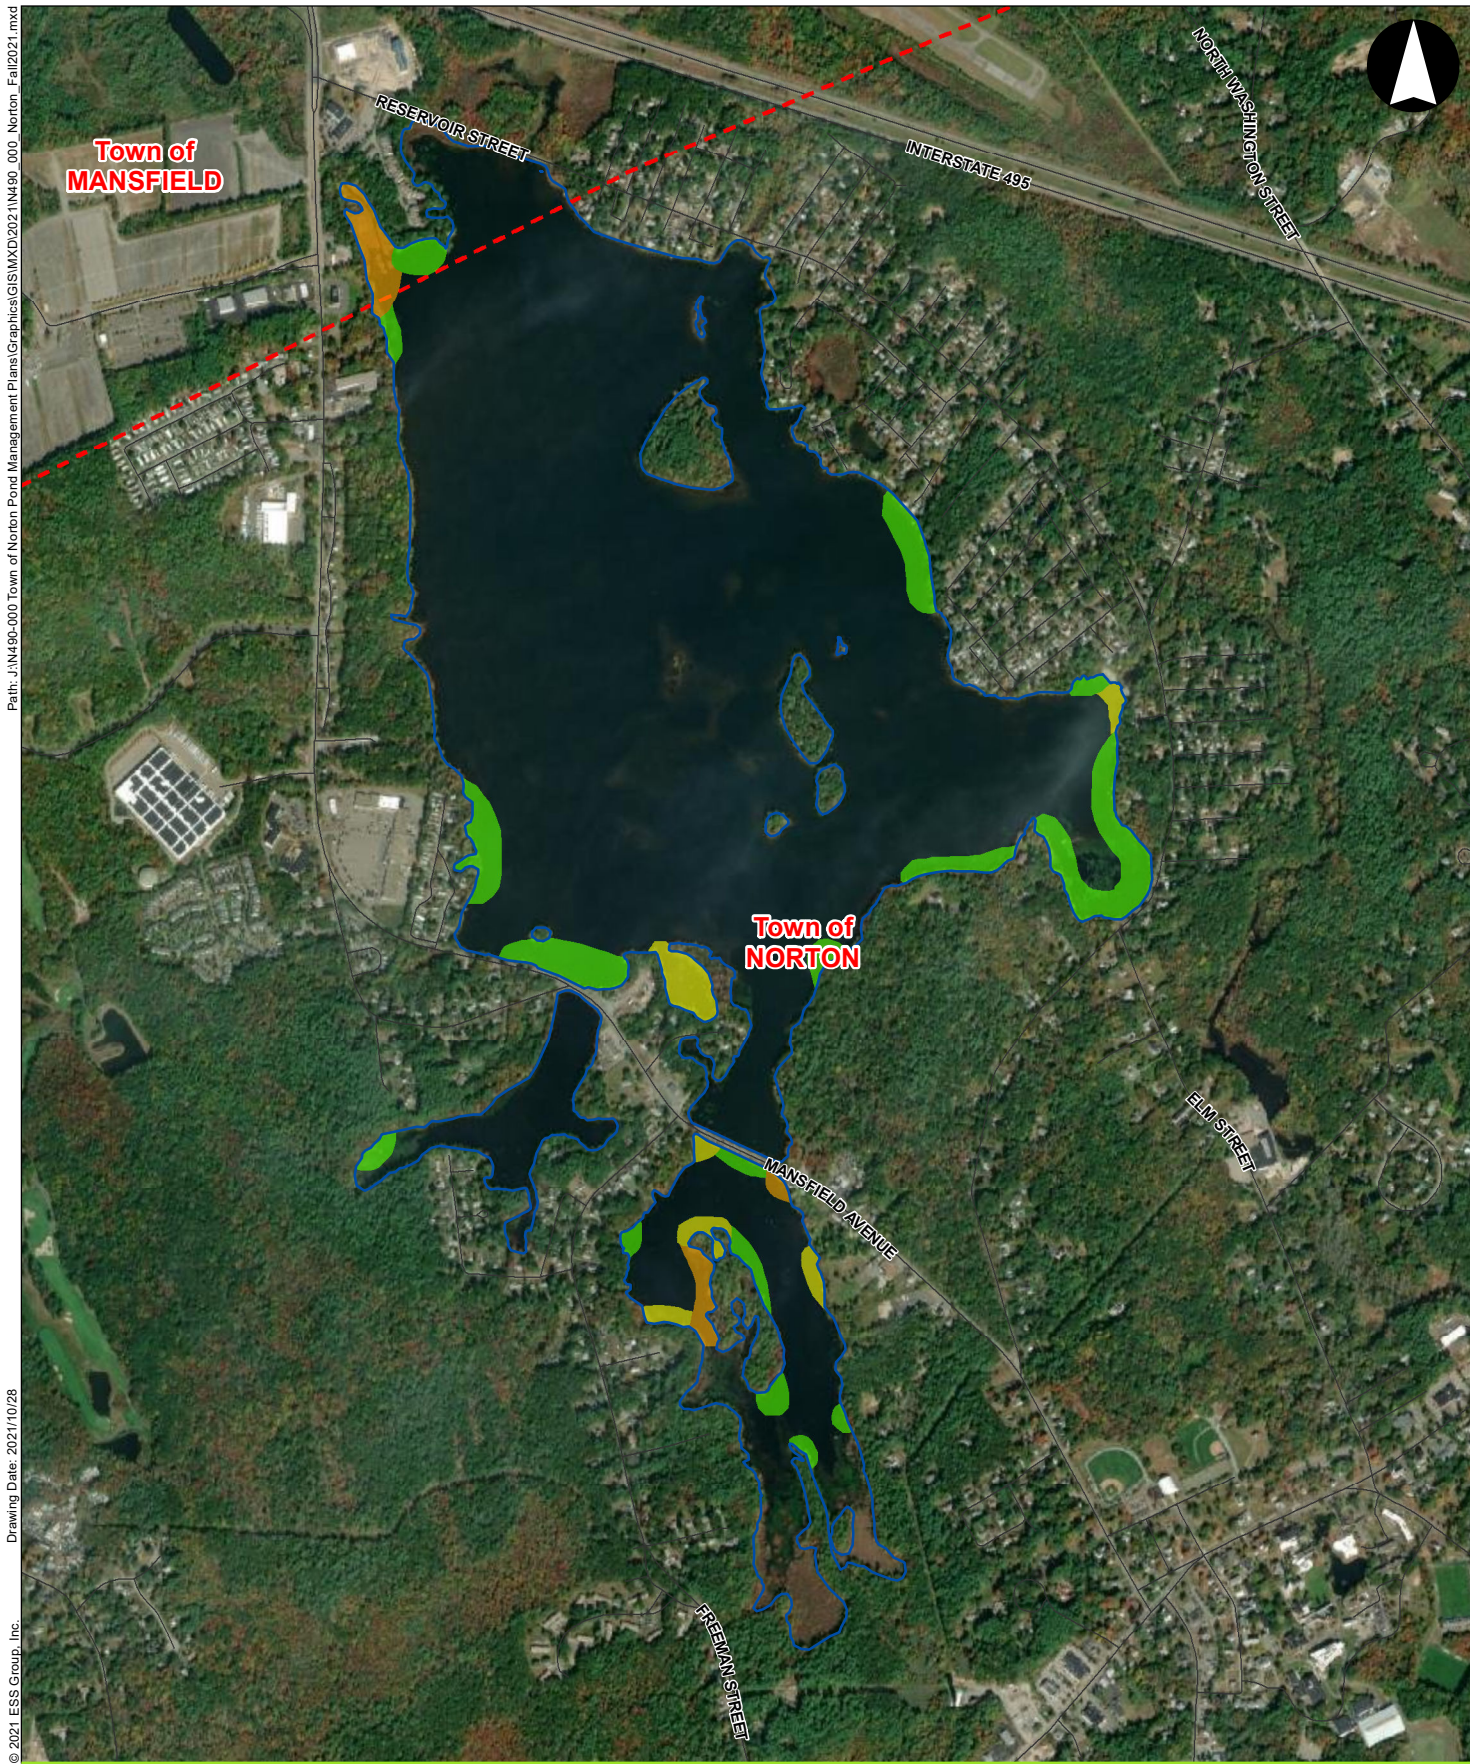
**Figure 12**

- Variable-leaf milfoil covered an estimated total of 52 acres (Figure 12), a **decrease of approximately 59 acres from pre-treatment conditions and a year-over-year decrease of 48 acres**. As with fanwort, the infestation of variable-leaf milfoil in the main basin was substantially reduced compared to recent years. Growth was also heavily reduced in the two sub-basins to the south of Route 140
- Water chestnut covered an estimated total of 1 acre (Figure 13), a **decrease of approximately 4 acres from pre-treatment conditions and similar year-over-year to 2020**. However, remaining beds were dense, suggesting that hand harvesting efforts were insufficient to address all of the growth in one of the sub-basins south of Route 140.

**Post-Treatment Variable-Leaf Milfoil Cover**  
**Norton Reservoir**  
**September 21, 2021**

- Sparse (36.1 Acres)
- Patchy (8.6 Acres)
- Dense (7.3 Acres)
- Lake Shoreline
- Town Boundary

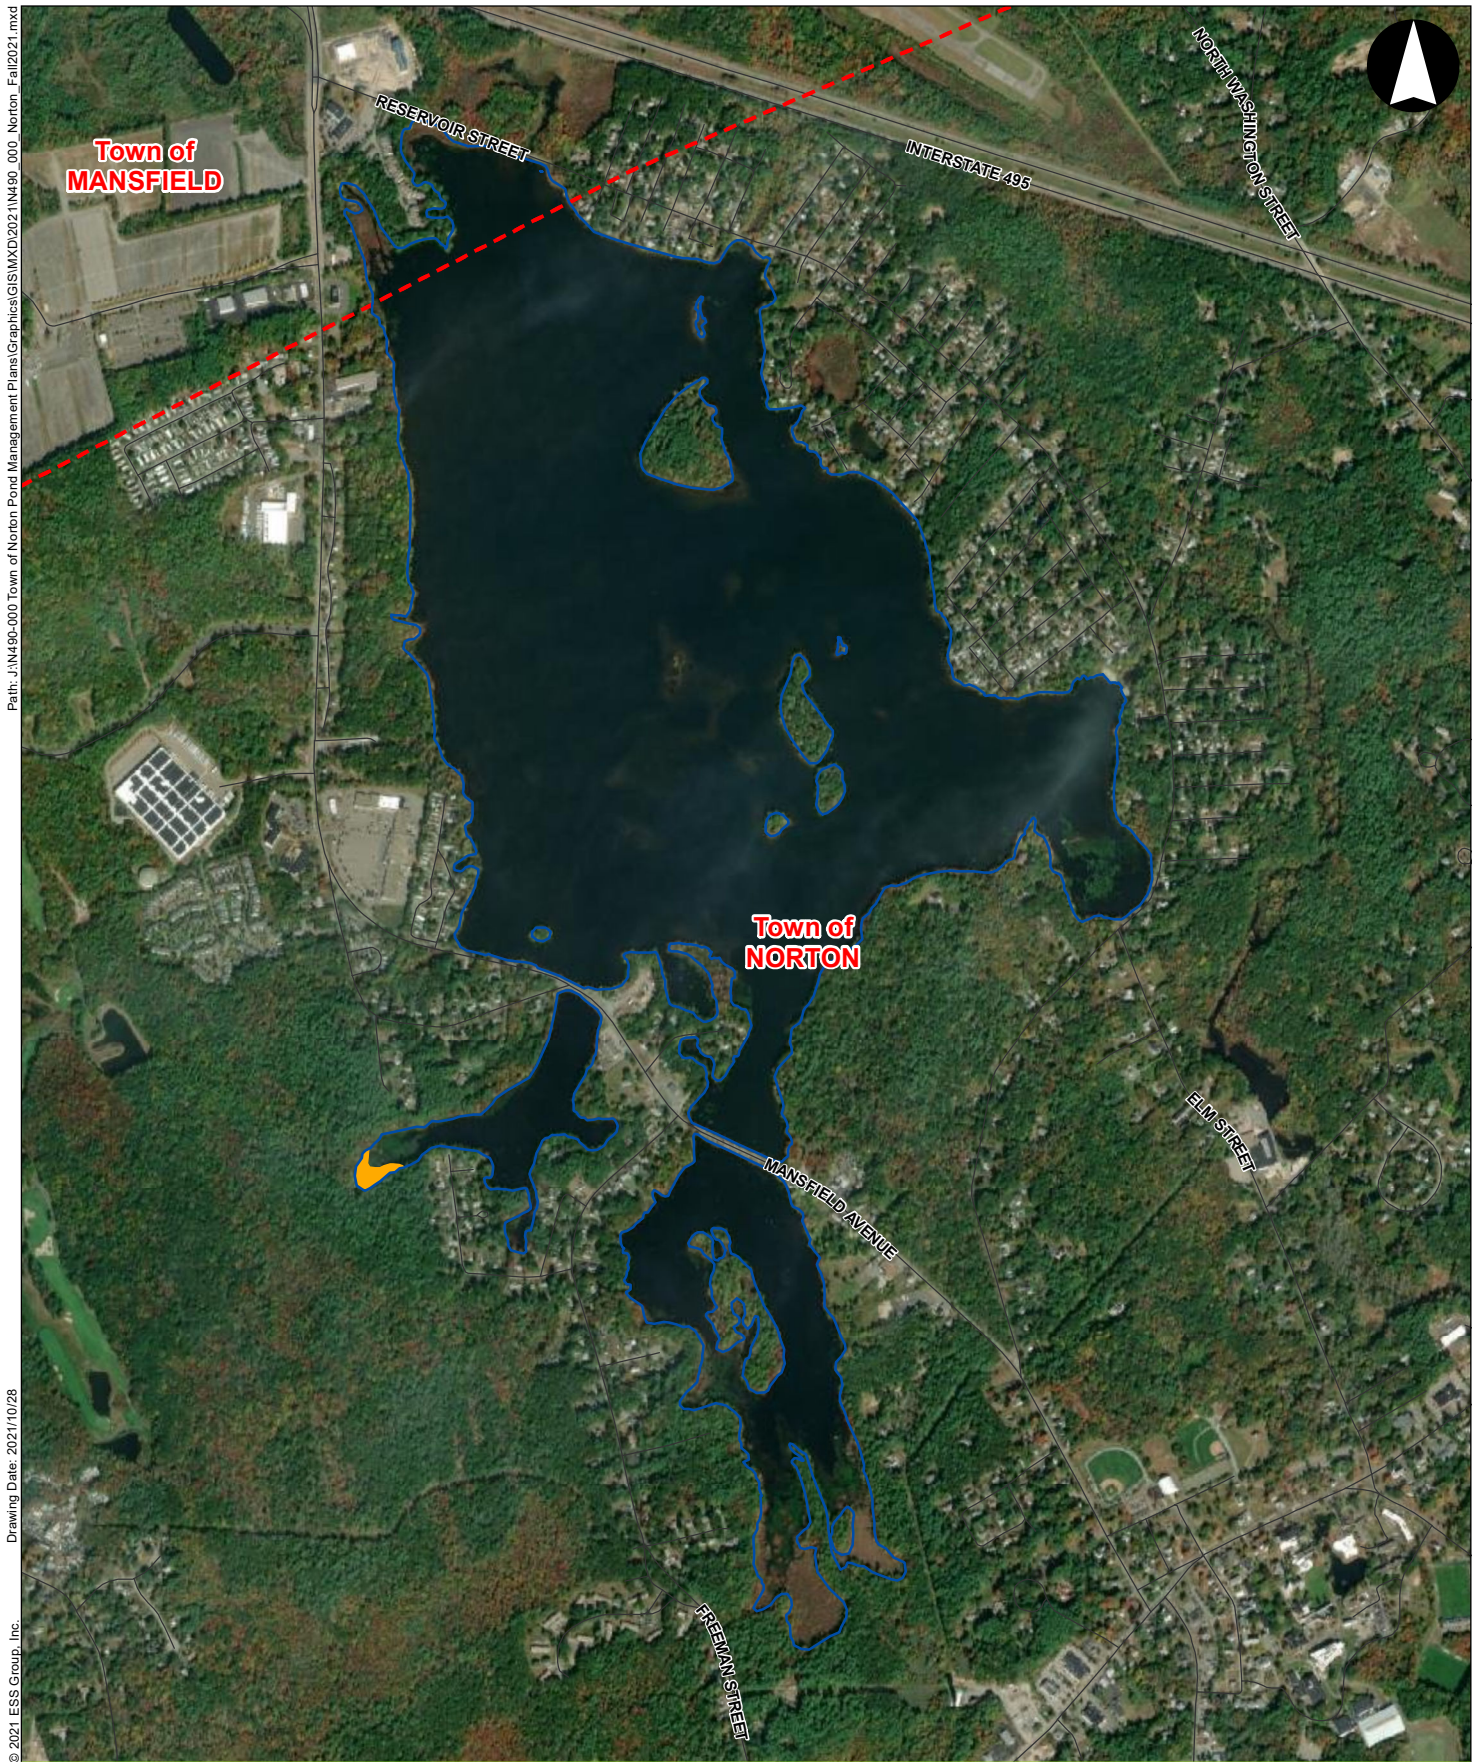
**Figure 13**

**Post-Treatment Water Chestnut Cover**  
**Norton Reservoir**  
**September 21, 2021**

- Dense (1.1 Acres)
- Lake Shoreline
- Town Boundary

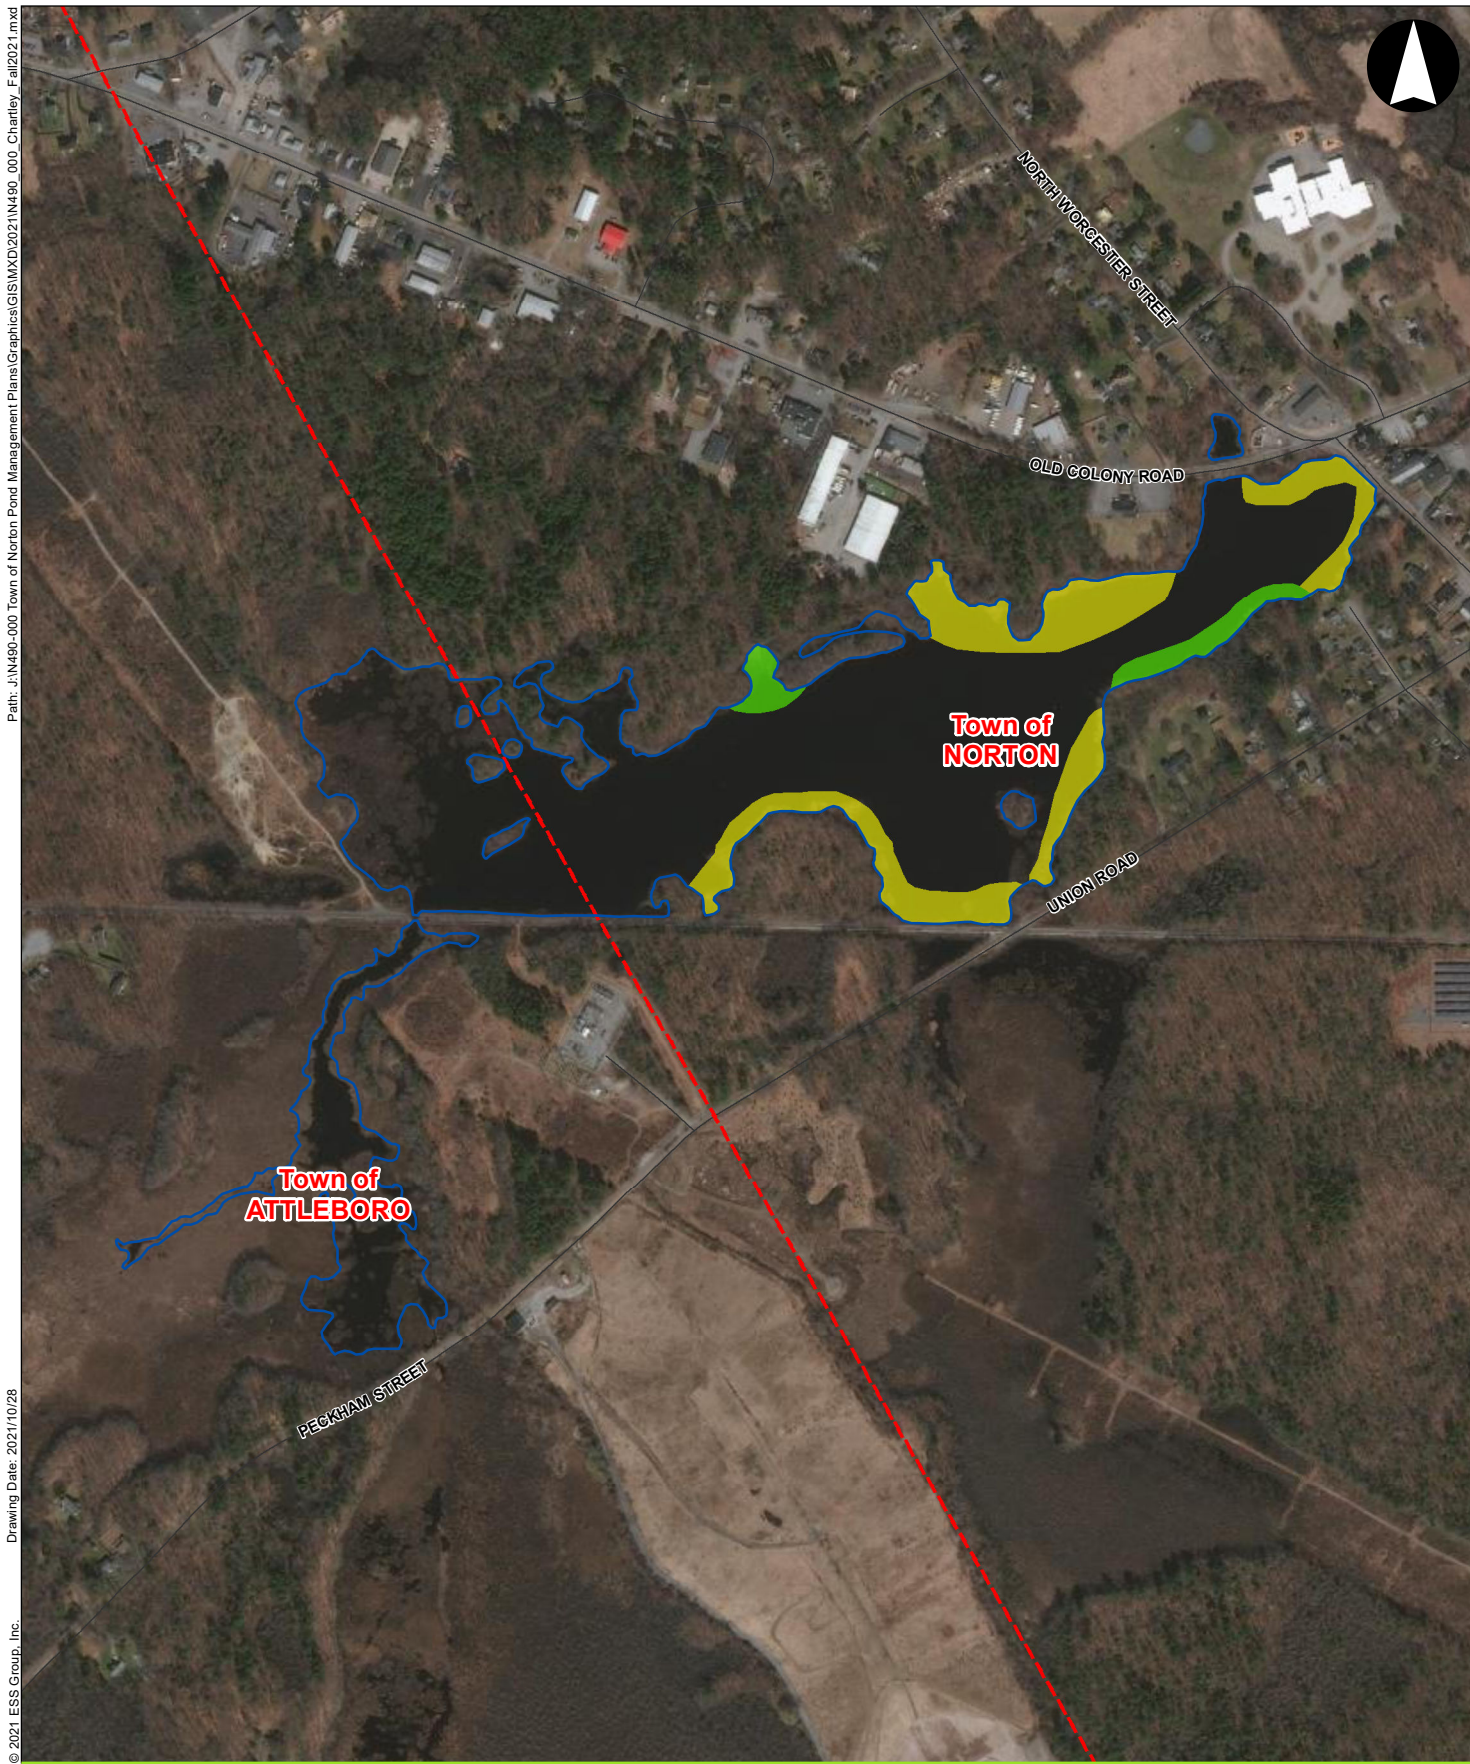
**Figure 14**

- Fanwort covered an estimated total of 11 acres (Figure 14), an **increase from pre-treatment conditions and on a year-over-year basis**. However, the density of the plants within the beds was greatly decreased, resulting in sparse to patchy growth. The remaining beds were mostly confined to shallower waters along the shoreline. Most of the remaining beds were healthy-looking although chlorosis (leaf bleaching) – a sign of fluridone-induced damage – was evident in some of the remaining beds.

**Post-Treatment Fanwort Cover**  
**Chartley Pond**  
**September 15, 2021**

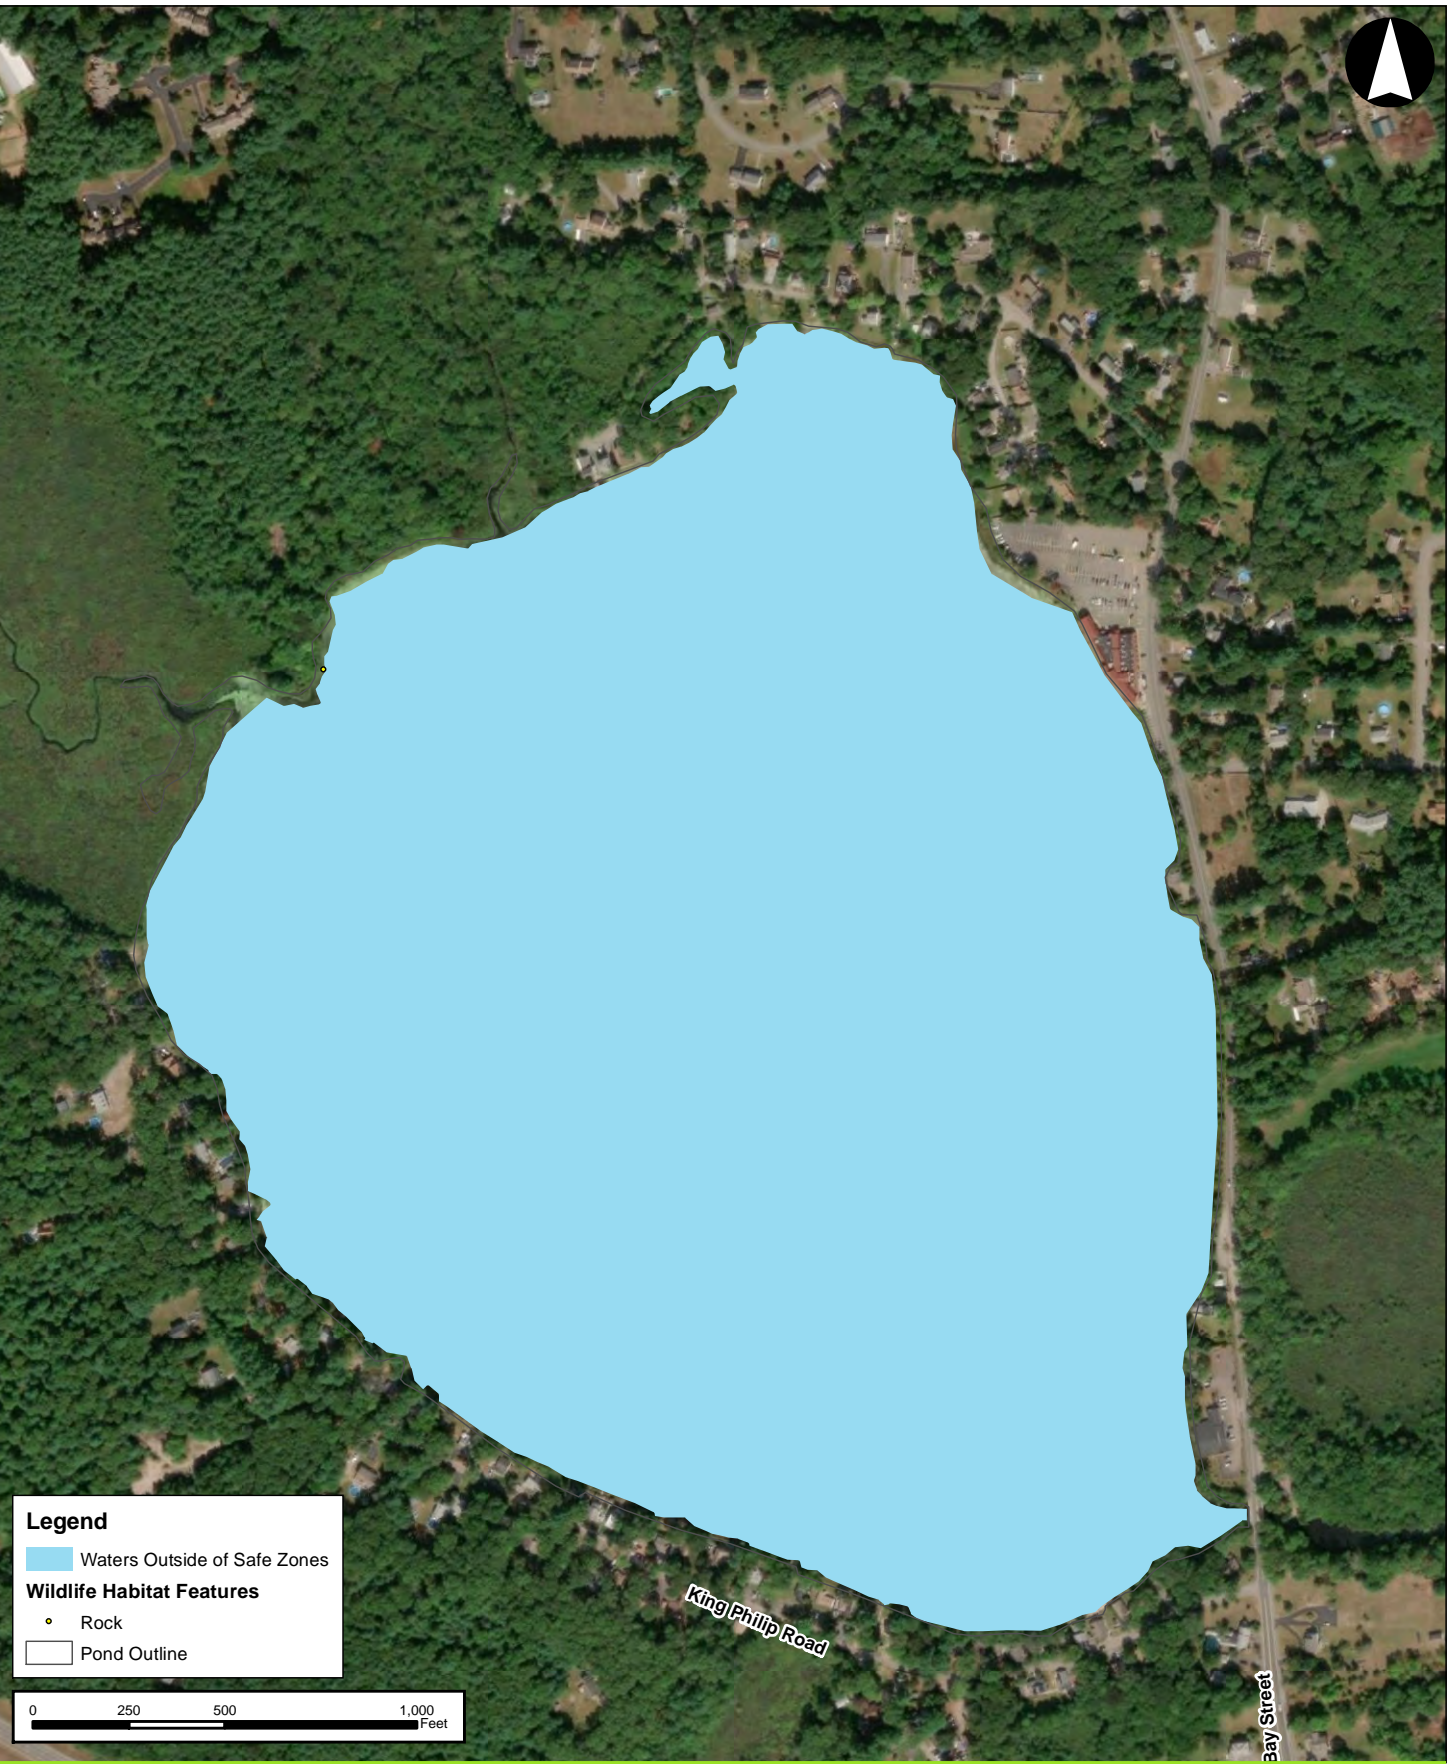
Figure 16

Assumes a 5' safe zone around perimeter of the waterbody and around stands of indigenous emergent hydrophytes, stands of indigenous aquatic plants, rocks, trucks, roots, stumps, and limbs. Assumes a 40' safe zone around muskrat houses and islands. See Order of Conditions for additional details.

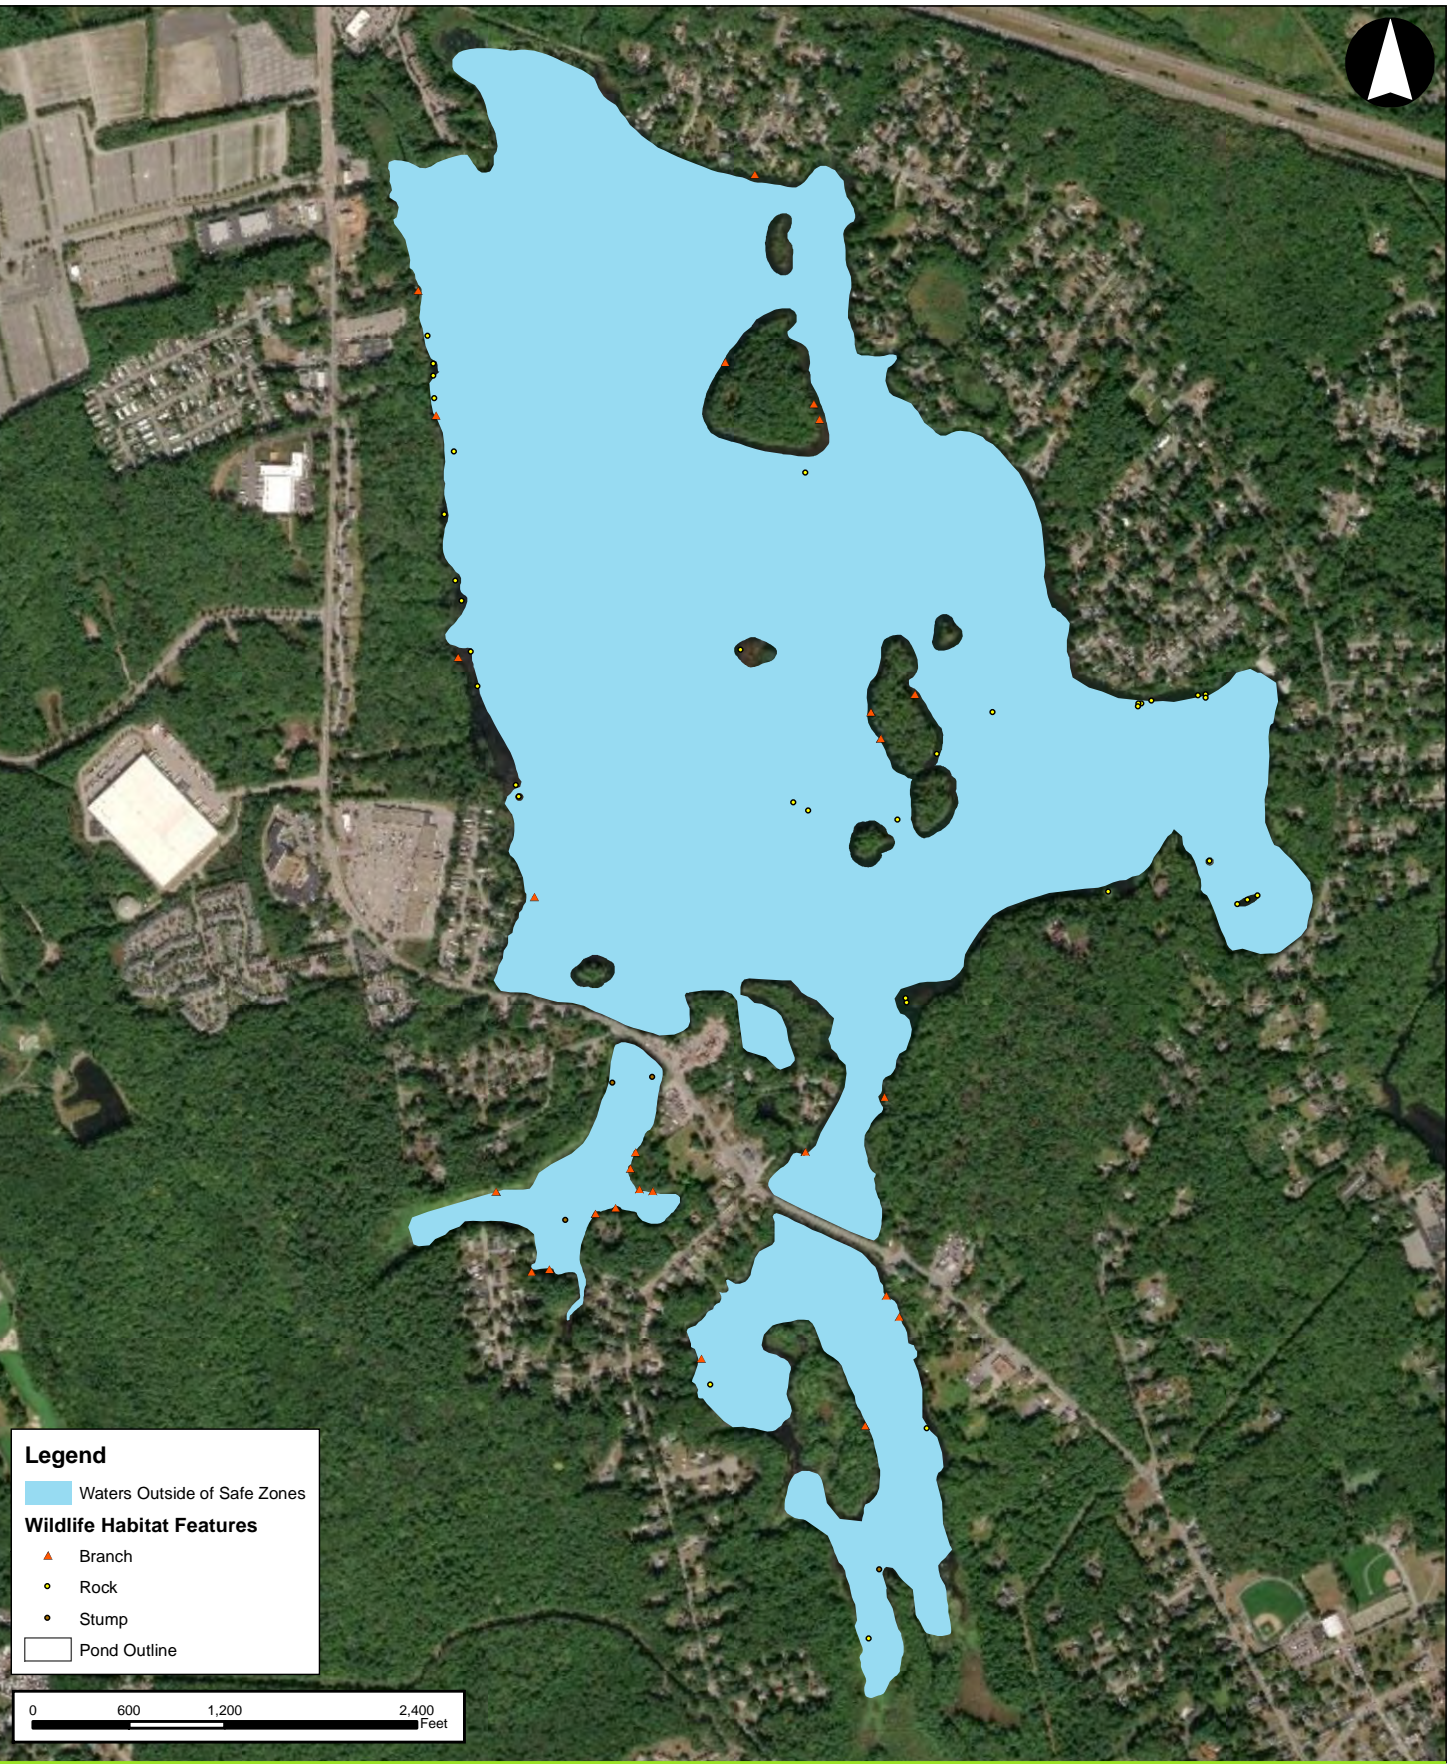
**Figure 17**

Assumes a 5' safe zone around perimeter of the waterbody and around stands of indigenous emergent hydrophytes, stands of indigenous aquatic plants, rocks, trunks, roots, stumps, and limbs. Assumes a 40' safe zone around muskrat houses and islands. See Order of Conditions for additional details.
