SECTION 4 Environmental, Inventory, and Analysis

Geology, Soils, Topography

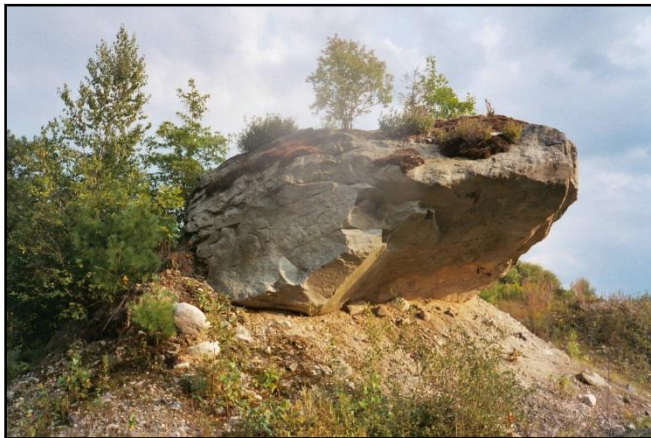
Photo of glacial erratic submitted by Christopher Cox
